## **Durable Retrofitting of Concrete Structures**

### **ABSTRACT**

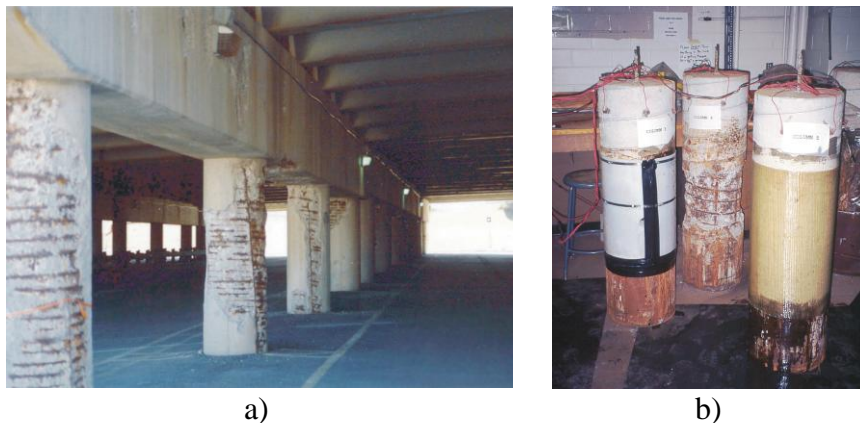
Recently, a number of columns were tested in that frame to develop solutions for the durable rehabilitation of columns such as those shown in Figure 2. The columns and girders in the bridge structure shown in the figure had deteriorated primarily due to the corrosion of steel reinforcement which was primarily caused by chlorides from the de-icing salts. Freeze-thaw and wet-dry cycles further intensified the rate of deterioration. It was observed that spiral steel had corroded to a point that its contribution toward load carrying capacity and deformation capability had reduced to a minimal level. The bridge was built in the 1960s and

the damaged condition shown in Figure 2a is before the repair was carried out in 1996. The columns varied in sizes between 920 mm and 1010 mm in diameter.

**Fig. 2. Corrosion Damage in (a) Bridge Structure and (b) Lab Specimens**

The laboratory experiments had indicated that the level of damage in the bridge columns (Figure 2) was such that spiral steel had completely lost its effectiveness due to corrosion. It was decided not to add a new steel spiral but to compensate for it by providing a GFRP wrap. Before the repair was carried out, only the loose concrete on the surface of the bridge columns was removed with the help of a steel brush. The corroded steel and the contaminated concrete were not removed from any of the columns. The plastic sheet formwork was not used in any of the columns considering the premature failure observed in the lab specimen. Although several columns were repaired, three of the columns that used three different repair schemes were treated as field test specimens and monitored for their long-term performance.

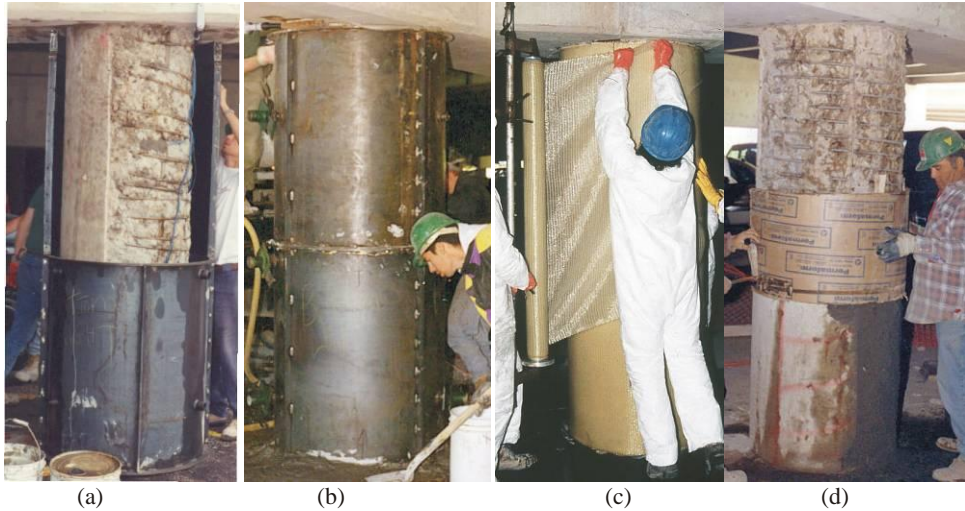
**Fig. 6. Repair of Bridge Columns**

*Column 124-1* was repaired with expansive concrete grout using steel formwork (Figure 6). The grout which replaced the original 50 mm thick cover concrete and had the following mix

*Column 124-2* was repaired using commercial non-shrink grout which was pumped in place with the steel formwork. The grout mix proportions by weight were: pre-blended sanded grout 75 kg, 6 mm crushed stone 25 kg, silica fume 3 kg, water 15 kg and superplasticizer. Four days later, the steel forms were removed and the column was wrapped in polyethylene sheet and GFRP in the same way as Column 124-1. Eight days after the application of grout, this column was also instrumented in a manner similar to that used for Column 124-1.

*Column 124-3* was built to its original shape with EMACO-based mortar. No formwork was needed for this mortar (Figure 6d). A protective epoxy coating was applied six days later followed by the FRP wrapping and instrumentation similar to that in Column 124-1. The gauges were applied to this column eight days after grout application.

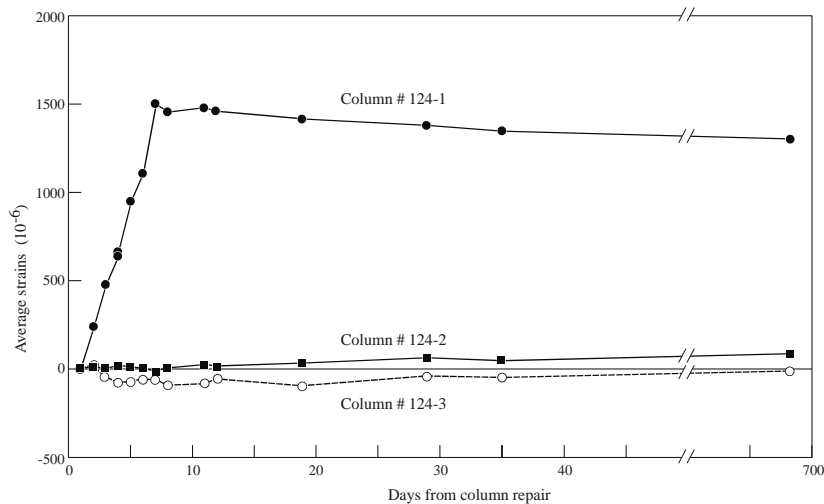
Monitoring of the bridge columns has been carried out at regular intervals since the repair. This included the corrosion potential readings from half cells and the lateral strain data collection from the electric strain gauges in addition to regular visual observations. Figure 7 shows average lateral strain in FRP against time for the three columns. As expected, Column 124-1, repaired with expansive cement, showed substantial early age expansion while no significant lateral strain was measured in GFRP wrap in the other two columns. The maximum tensile strain in GFRP measured in Column 124-1 was approximately 0.16% that was observed ten days after grouting. This represented about 10% of GFRP rupture strain. Lateral GFRP strain in all columns remained fairly constant for about two years indicating stable expansive cement behaviour and no significant creep in the GFRP wrap.

**Fig. 7. Lateral Strain in GFRP in Repaired Bridge Columns**

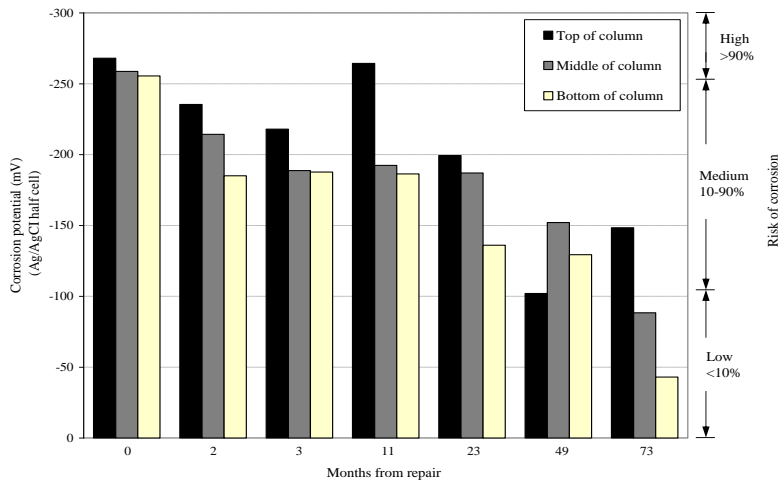
Table 2 shows the half-cell potential measurements of three repaired columns taken over a period of six years. The potentials can be used to estimate the risk and probability of corrosion activity in concrete at the time of measurement [Broomfield 1997]. If the potential over an area is less than  $-256\text{mV}$ , there is a greater than 90% probability that reinforcing steel corrosion is occurring; if it is in the range of  $-106$  to  $-256\text{mV}$ , the risk is intermediate, but the probability of corrosion is unknown; and if it is larger than  $-106\text{mV}$ , there is a greater than 90% probability that no reinforcing steel corrosion is occurring. Soon after the repair, based on the average of potential measurements at three locations along the height of each column, the risk of corrosion in repaired columns 124-1 and 124-2 was high, and in column 124-3 it was intermediate. After six years, the risk of corrosion in columns 124-1 and 124-2 was intermediate and low in 124-3. Reduction in the corrosion activity and risk of corrosion can be clearly seen in Figure 8 which shows the average corrosion potential in three columns at different locations along their heights. It can be concluded that GFRP wraps have protected the columns from adverse environmental effects thus starving the corrosion of essential ingredients, oxygen and water, resulting in reduced corrosion activity.

**Fig. 8. Corrosion Potential and Risk in Repaired Bridge Columns**

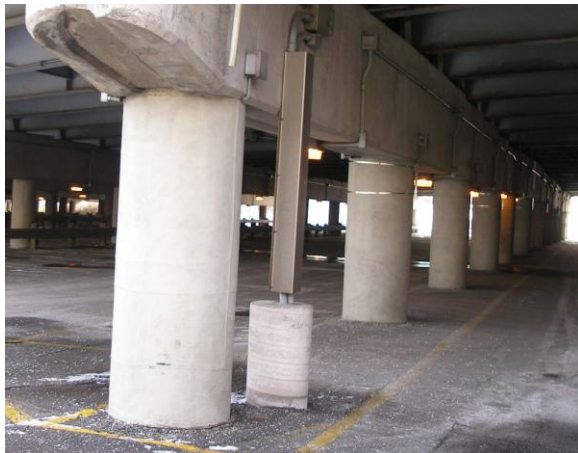
**Fig. 9. Repaired Columns after Thirteen Years of Service**

Visual inspection over thirteen years and field data on strain and corrosion rate indicated a sound performance of the retrofit techniques for the columns. No distress or deterioration was observed in the repaired columns after thirteen years of service as shown in Figure 9. The risk
