Investigation and Repair Work for Superstructures of Jetty Deteriorated by Chloride Induced Corrosion and ASR in the Osaka Port Container Terminal

In this paper, the outline of the investigation for the deterioration members of the concrete superstructure of jetty in C1 to C4 berths of Osaka Port Container Terminal is described. And also, the design and execution of repair work in C3 berth already executed in 2009 is explained.

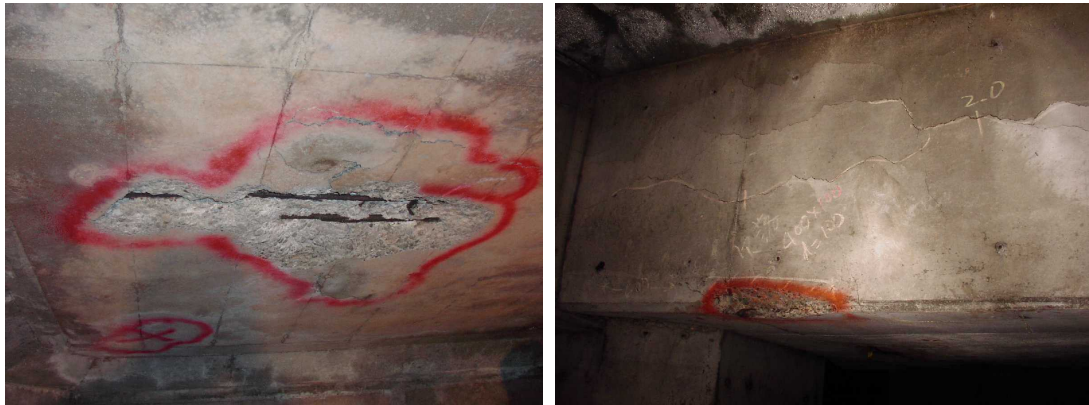
Figure 3. An example of degradation caused by chloride induced corrosion and ASR

As the result of this visual observation, a lot of degradations of concrete caused by the chloride induced deterioration (corrosion induced crack, peeling, flaking etc.) were confirmed. In addition, a lot of degradations of concrete caused by the ASR (map cracks, white deposits etc.) were confirmed in these superstructures.

An example of degradation caused by chloride induced corrosion and ASR confirmed by visual observation is shown in Figure 3.

(a) Chloride induced corrosion of reinforcing bar of a slab

(b) Cracks of a beam caused by ASR

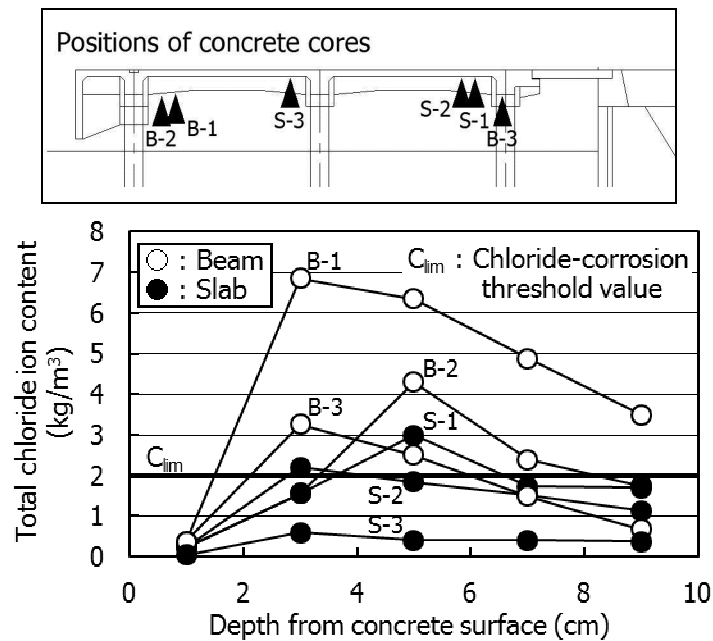
Figure 4. Examples of distribution of total chloride ion content in concrete

Concerning the chloride induced deterioration; Figure 4 illustrates the examples of distribution of total chloride ion content in concrete. In these superstructures, cover of reinforcing bar was about 60 – 70mm in beams and 40 – 60mm in slabs. It can be understood that the chloride ion content in concrete of beams was larger than that of slabs, and the chloride ion content in concrete at the depth of reinforcing bar in beams were about 2 –

5kg/m³ and in slabs were about 0.5 – 3kg/m³. Also, corrosion of reinforcing bar was comparatively prominent in beams, and that in slabs was observed as partial degradation. However, although about 40 years have passed after construction of these structures, penetrated chloride ion content in concrete seems to be comparatively little. It is assumed that the chloride penetration into concrete was influenced by the curtain wall (Amino et al, 2008). Furthermore, all results show that the chloride ion content in surface layer of concrete were very little. This seems to be influenced by the carbonation of surface layer of concrete, because the measured carbonation depths of concrete were about 15 – 25mm.

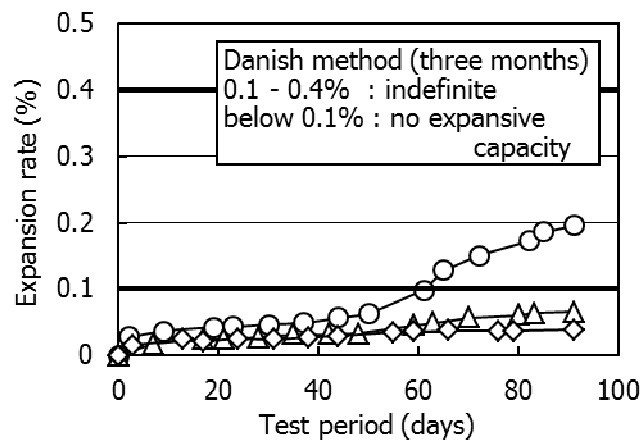
Figure 5. Examples of the result of residual expansion test for concrete cores

Concerning the degradation caused by ASR, the progress of ASR was confirmed by the reaction limb of coarse aggregates and the test results of chemical analysis for the deposits. Examples of the results of residual expansion test for concrete cores are shown in Figure 5. In Danish Method, ASR expansion of concrete core is accelerated by soaking in the saturated solution of sodium chloride in 50 degrees Celsius. Almost all measured data of expansion rate after 91 days acceleration were below 0.1%. Although one data showed the expansion rate of 0.2%, it can be diagnosed that the ASR expansion almost converged. Still more, as shown in Figure 6 (a), because the damage of asphalt pavement was confirmed in several points along the run way of trailer, the asphalt pavement of these damaged areas were removed. The many cracks of concrete slabs were observed under the damage of asphalt pavement as shown in Figure 6 (b). These cracks of concrete slabs seemed to have occurred by the repeated load of heavy vehicles to the ASR cracks.

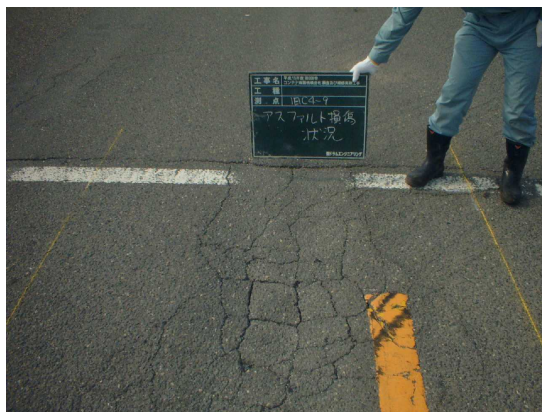
(a) Damage (cracks) of asphalt pavement

Figure 6. Damage of asphalt pavement and cracks of concrete slab

| Object | Countermeasure for degraded member | Intent of countermeasure (mainly for corrosion prevention of reinforcing bar) |
|---|---|---|
| (d) Pavement | Removal and restoration of damaged slab concrete and asphalt pavement, restoration using liquid-applied membrane waterproofing simultaneously (Considering restraint of ASR progress and ooze of free lime from slab) | |

When repairing the pavements (top surface of slab), rapid restoration work was required by the restriction of cargo handling work. Therefore, damaged slab concrete was removed up to the back of reinforcing bars and was restored with high early set concrete containing steel fiber (slump : 5cm, water cement ratio : 0.40, content of steel fiber : 100kg/m³). Finally, asphalt pavement was restored by using liquid-applied membrane waterproofing with methyl-methacrylate resin simultaneously.

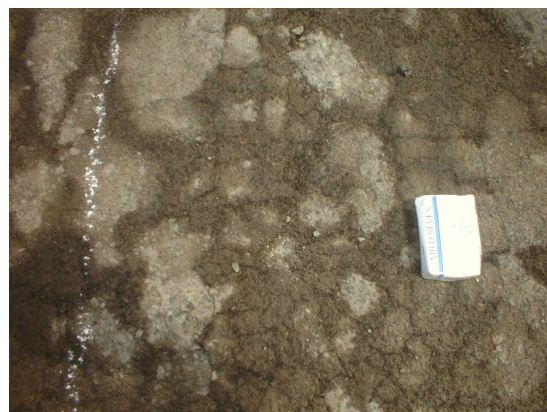
(b) Cracks of concrete slab under the damaged asphalt pavement

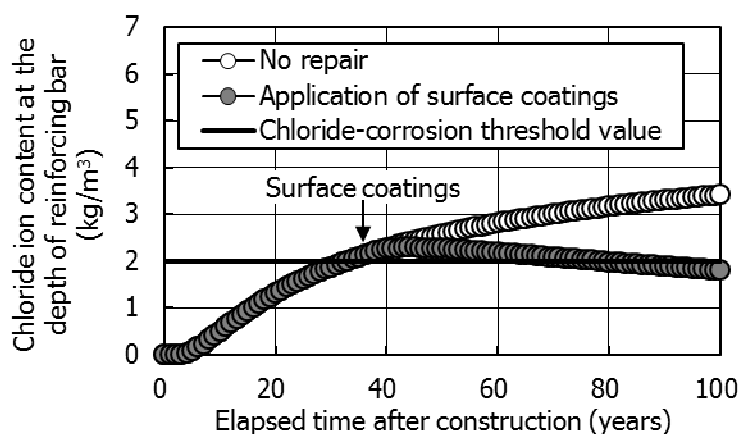
Figure 8. Result of calculation of chloride ion penetration (example of beam)

As for beams and slabs on lower side of superstructures, calculation of chloride ion penetration into concrete in the future using measured data of chloride ion content in concrete as shown in Figure 8 was performed, and necessity of repair itself and application of surface coatings were assessed according to the result of former calculation. As a result, it was assumed that the application of surface coatings for beams would not be effective, so cathodic protection method premising the preventive maintenance was selected for all beams taking the importance of beams into consideration. Here, the concrete was suffering from ASR, but supposed residual expansion capacity was below 0.4%. So, referring to the abovementioned Guideline, cathodic protection method was selected giving priority to the

prevention of steel corrosion. On the other hand, as regards the slabs, it was assumed that there was nothing to worry about the corrosion of reinforcing bar because of the little volume of penetrated chloride ion content. According to this, it was determined that the slabs would be unnecessary to be repaired for the moment, and follow-up maintenance (routine inspection) was selected. Here, for already degraded area, it was necessary to apply patch repair in the members of beams, slabs and pile heads. Moreover, as regards the pavement (top surface of slab), after the removal and restoration of damaged slab concrete, both damaged asphalt restoration and liquid-applied membrane waterproofing were selected to prevent the relapse of asphalt damage by restraining the water penetration into the minute ASR cracks.

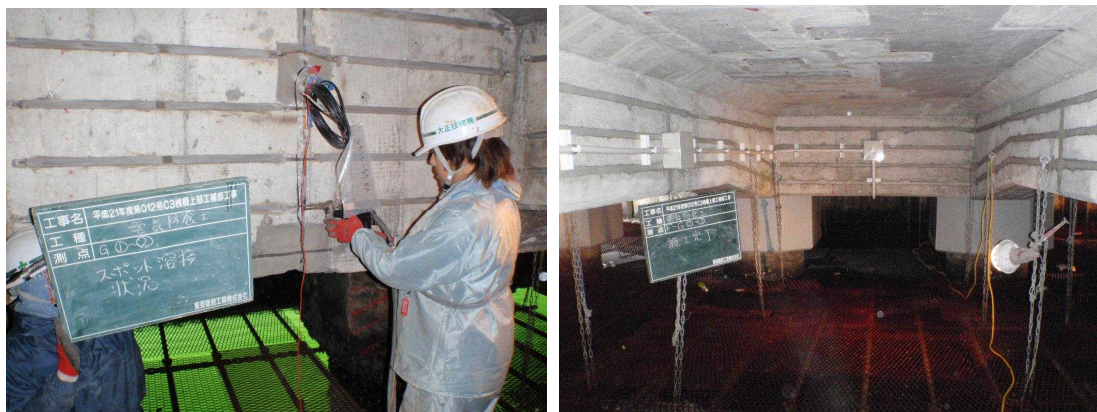
Figure 10. State of setting anodes and completion of cathodic protection

(a) State of spot welding in setting anodes

(b) State of completion of cathodic protection

Repair Method. Execution of repair work was conducted according to the flow represented in Figure 9. At first, the approach slabs (precast slab connecting revetment to jetty) were removed in order to secure the delivery entrances for scaffold materials and repair materials. And, patch repair was executed by plastering for one repair area of less than 0.25m² and by wet mixed splaying for one repair area of over 0.25m². As the cathodic protection system for beams, rod-typed anode system (ribbon mesh anode system) which has many execution results was adopted to make visual observation easy after setting anodes. Figure 10 shows the states of spot welding in setting anodes and completion of cathodic protection. In the execution of patch repair, cover concrete was removed up to the back of reinforcing bars, and cement mortar was used for the area in where cathodic protection method was applied, as well as polymer cement mortar was for other methods. After the execution of cathodic protection, measured potential differences of depolarization at the all monitoring points were confirmed as the values of over 100mV by using reference electrode.
