Long Term Effects of Section Repair Method applied to PC Girders damaged by Chloride Attack

ABSTRACT

This paper reports the results of follow-up survey on the repair effect at about 10 years after applying three types of section repair methods to a real pre-tensioning PC girder damaged by chloride attack. In this research, three repair materials were used for each method, such as polymer-cement mortar including corrosion inhibitor with lithium nitrite, non-shrinkage cement mortar including corrosion inhibitor with amino alcohol, cement paste and mortar with chlorine ion adsorbent. Also, these methods were partially applied under PC wires passed through the repaired and the unrepaired portions. As a result, it was found that the repair effects could be expected for about 10 years in case of less than about 4.5 kg/m³ of chlorides contained in the unrepaired portion, although corrosion cracks due to macro-cells occurred near the boundary of the repaired and the unrepaired portions in case of about 6.8 kg/m³.

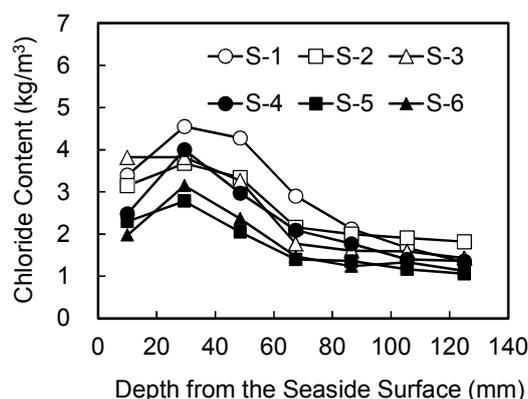
Figure 5. Distribution Profiles of Chloride Content in the Web Concrete (before Repairing)

The distribution profiles of chloride content at the locations shown in Figure 3 before repairing are shown in Figure 5. The procedure of measurement of chloride content was as follows; as the first step, core-samples were taken by penetrating the web of girder. Secondary, each core-sample was sliced at every 20mm from the seaside surface to the landside surface, and the total chloride content for each slice was measured according to JIS A 1154 [Methods of test for chloride ion content in hardened concrete].

From this figure, it was found that the amount of chloride ion penetration from the seaside is larger than that from the landside. Also, the chloride content at the depth of 20 - 40 mm from the seaside surface was 2.8 - 4.6 kg/m³ (the cover thickness of reinforcement such as stirrups and PC wires were around 20 - 40 mm). On the other hand, the chloride content at the depth of 20 - 40 mm from the landside surface was 1.1 - 1.8 kg/m³. The carbonation depth of the seaside was 3.5 mm and that of landside was 4.0 mm.

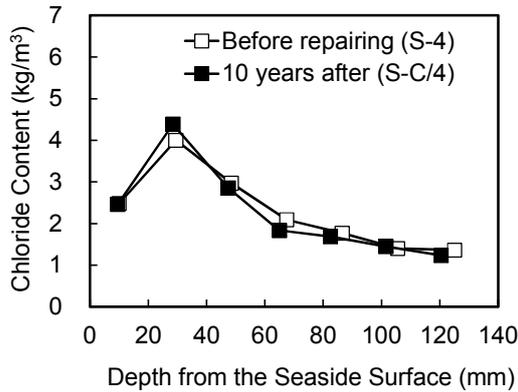
(a) Unrepaired

As seen in Figure 6(a), it was recognized that chloride ions had not been supplied from the outside for about 10 years because the distribution profile after about 10 years was almost consistent with that before repairing. On the other hand, the tendencies could be confirmed that chloride contents of concrete between two section repair parts of the seaside and the landside became smaller at about 10 years after repairing than those before repairing, as shown in Figure 6(b), (c) and (d). This was assumed to occur by diffusing chloride ions from the inner existing concrete into the section repair parts and/or adsorbing the repair materials.

6.8 kg/m³ of chloride content at the depth of reinforcement was measured in the lower flange of the seaside. It was assumed to be 6.8 kg/m³ of chlorides contained in the unrepaired portion before repairing because chloride ions had not been supplied from the outside for about 10 years as shown in Figure 6(a). Therefore, it could be recognized that the amount of chlorides contained in the unrepaired portions was greatly influenced on the occurrence of corrosion due to macro-cells when the section repair method was partially applied to the RC and/or PC structures damaged by chloride attack in the state of remaining the unrepaired portions. In this research, it was found that the repair effects could be expected for about 10 years in case of less than 4.5 kg/m³ of chlorides contained in the unrepaired portion, although corrosion cracks due to macro-cells in case of 6.8 kg/m³.

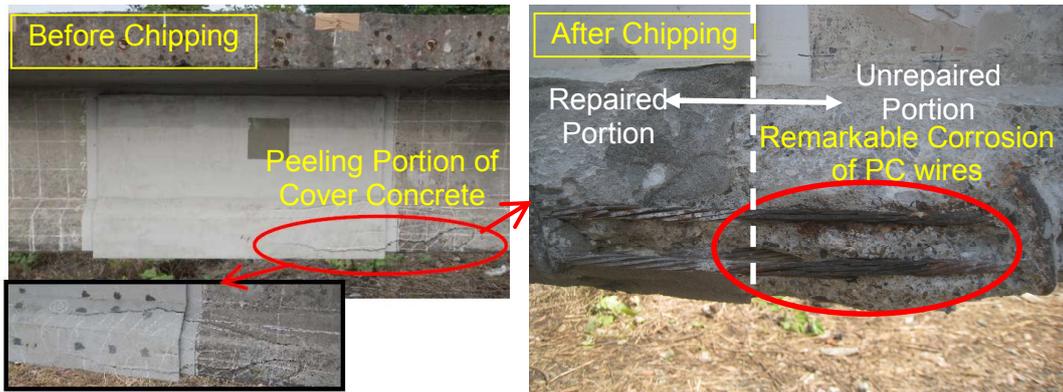
(a) Repair Material with Lithium Nitrite

External Observation of Surveyed Girder. The results of external observation on the surface of the seaside at about 10 years after repairing are shown in the left side of Figure 7. The changes of appearance on both the repaired and the unrepaired portions of the landside were not confirmed for all types of methods at that time. However, cracks were confirmed near the boundary of repaired and unrepaired portions of only the lower flange of the seaside. Particularly, the wide range of peeling of cover concrete had occurred in case of using the repair materials with lithium nitrite.

Corrosion Situations of PC Wires due to Macro-cells. The observation results of PC wires near the boundary of repaired and unrepaired portions after chipping cover concrete of the lower flange of the seaside are shown in the right side of Figure 7. As seen in these figures, remarkable corrosion of PC wires in the unrepaired portions and near the boundary was observed. The result of electrical potentials of PC wires at the lower flange between the ranges of the section repair method with lithium nitrite and that with amino alcohol is shown in Figure 8. This measurement was conducted before chipping cover concrete. The potentials of PC wires in the repaired portions were nobler than those in the unrepaired portions. In

In the section repair method using the polymer-cement mortar including corrosion inhibitor with lithium nitrite, the section was repaired by plastering. In addition, the surface on the repaired portion was coated with epoxy resin by using scraper or roller after hardening the mortar.

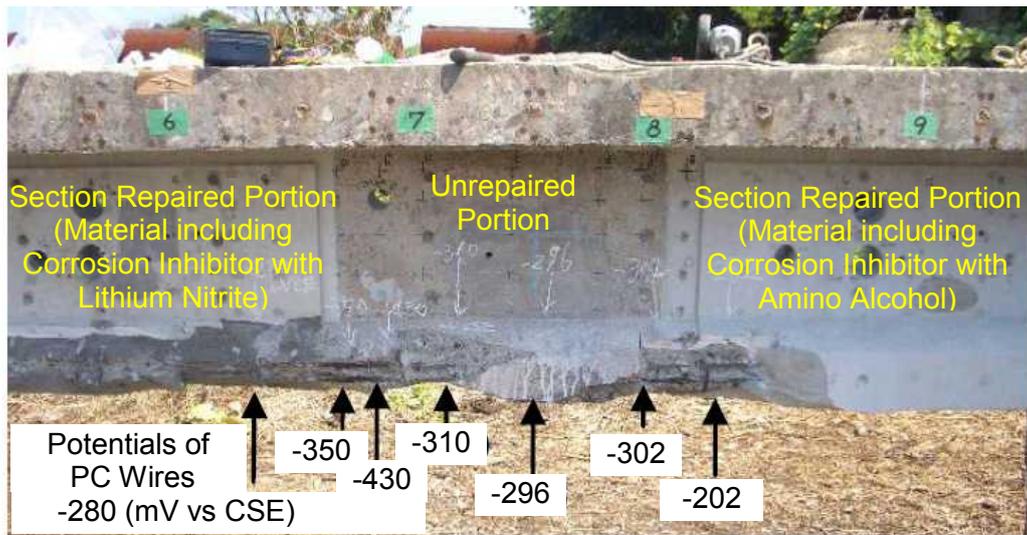
Figure 8. Electrical Potentials of PC Wires

addition, the differences of the potentials of PC wires near the boundary between the repaired and the unrepaired portions were drastically made large, such as the difference of 70mV in case of using the repair material with lithium nitrite and that of 100mV in case of the material with amino alcohol. Therefore, it could be recognized that corrosion due to macro-cells was obviously formed between the repaired and the unrepaired portions when the section repair method was partially applied under reinforcement passed through the repaired and the unrepaired portions.

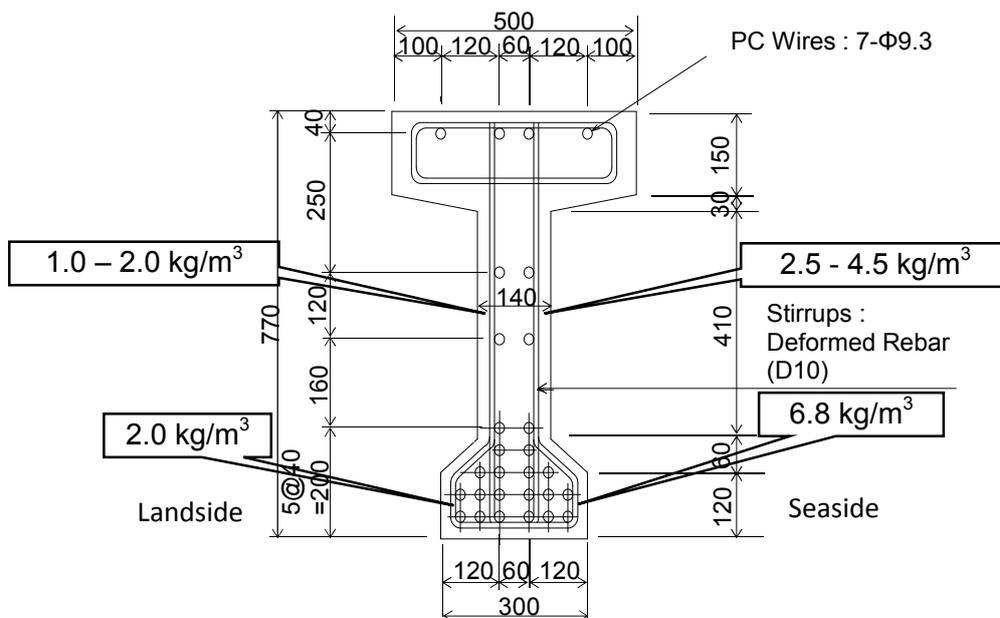
Figure 9. Chloride Content at the Depth of Reinforcement

The measurement of chloride content at the depth of 30 mm and 50 mm (around the reinforcement) from the concrete surface at the lower flange were added to that at the web of girder shown in Figure 6, because corrosion cracks due to macro-cells occurred near the boundary of repaired and unrepaired portions. The analysis samples of drilled powder were collected from the lower flange at the unrepaired portion between the portions of the section repaired method with lithium nitrite and with amino alcohol. The result is shown in Figure 9.
