Effect of Grout Filling Condition on Corrosion of Prestressing Steel in Existing Prestressed Concrete Bridges

Shu Kobayashi^{1*}, Yuichi Kitano^{1*}, Hideaki Taniguchi^{1*}, Yasushi Kunitomi^{1*}
Yoshitomi Kimura^{2**} and Taku Hanai^{3***}

¹Japan Prestressed Concrete Contractors Association, JAPAN,

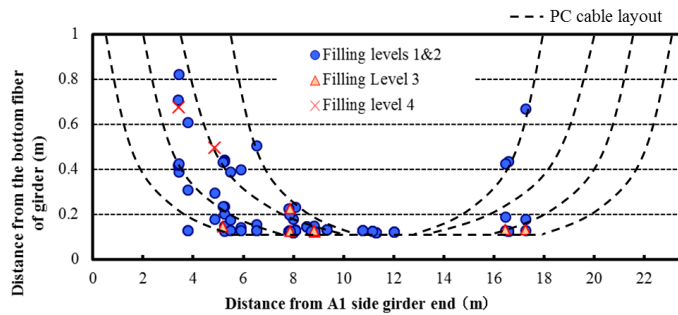
Figure 5. Grout filling condition of cable anchored at E bridge upper deck

Results of confirmation of grout filling conditions are shown in **Figure 3** and **Figure 4**. Among 342 cases investigated, filling levels 1 & 2 and filling levels 3 & 4 accounted for 322 cases (94%) and 20 cases (6%), respectively. While the ratio of cases with filling levels 3 & 4 found in cables anchored at upper deck was relatively high (particularly in the bend portion), there were also some cases involving cables anchored at girder end. Additionally, grout filling condition with a focus on cables anchored at upper deck is shown in **Figure 5**. According to this, filling level 4 was located at up to 0.5 m below the upper deck. In addition, as grout stuck to the duct, it was found that the void cavity ran further back. (**Figure 6**) By contrast, the grout was filled in the upward bend portioning section of the opposite side. Based on such a condition, the effect of bleeding is unlikely, and it is inferred that an unfilled part was left along the down grade line of the grout injection side (due to rapid injection of grout with high fluidity) where the grout flowed too fast.

Additionally, it was confirmed that for the total of 342 cases investigated, the main cable of this bridge has nearly no corrosion, and no trace of water penetration was confirmed in the duct of cable anchored at upper deck where unfilled grout was confirmed.

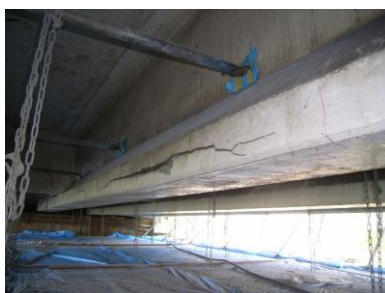
a) Before chipping (G3 girder of the first span)

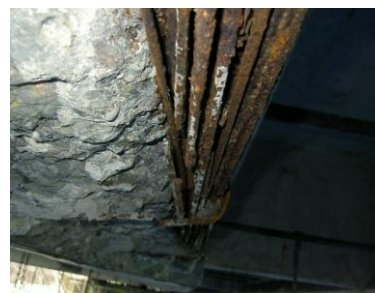
b) After chipping of the same place shown left (breakage of C3 cable)

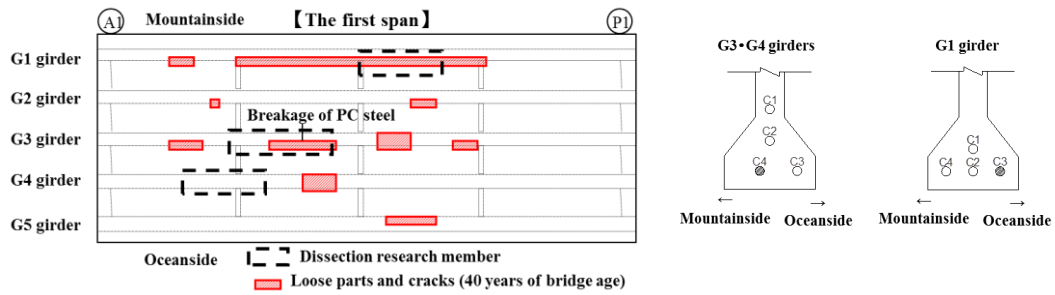
C bridge is a 5-span simple post-tensioned PCT girder bridge placed in service in 1967. Since the main cable using "24 ϕ 7 mm" has about twice the capacity of "12 ϕ 7 mm" which was commonly used at that time, four cables were anchored only at girder end for each main girder. It was constructed at a location adjacent to the Sea of Japan coast line, and because deteriorations such as cracking and delamination due to corrosion of the steel became significant after having been exposed to severe chloride attack environment for long time period, its service was finished in September, 2010 (at 43 years of service) on the premise of reconstruction. (Figure 7) Removal of this bridge was performed by cutting each girder into 6 or 7 pieces longitudinally after cutting the cast-in-place deck slabs between the main girders. Grout filling investigation was performed for the main girder cut planes. Additionally, steel corrosion investigation was performed, with a focus on the first span with the most severe damages identified as shown in Figure 8, for G1 girder (region where reduction of the section was identified for about half of PC steel in the past investigation), G3 girder (region where reduction of the section of entire PC steel of C3 cable and some breakages were identified in the past investigation), and G4 girder (region where damages have occurred after 40 years of service without having past damage/repair history), and for G4 girder of the fourth span which shows second-worst damage.

Figure 8. Damage condition of C bridge main girder bottom flange and member sampling location (left), and cable layout (right)

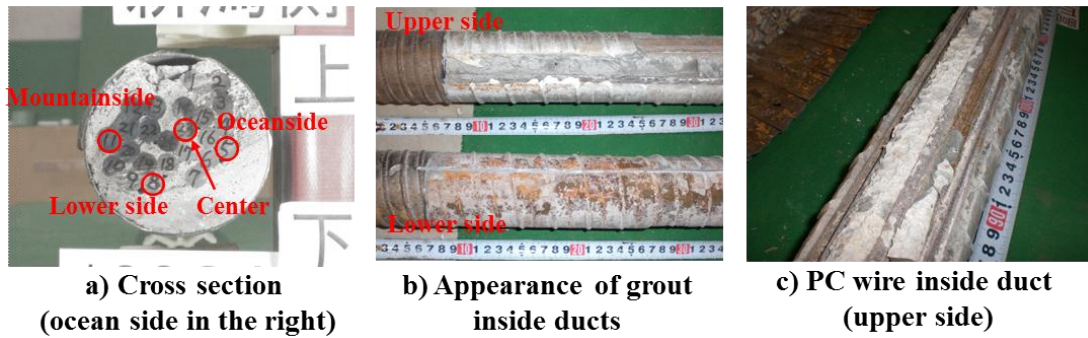
Steel corrosion investigation. Figure 11 shows conditions of duct, grout, and PC wire of the C4 cable that was demolished from G3 girder in the first span as a duct conduit piece and then broken up. Only minor corrosion cases were found in some parts of the duct. As for grout filling condition, filling levels were 2 that had some voids gaps in the cut plane, but the main cable was still covered by grout. However, the grout of upper side was brittle, and crush of some portions during removal of the duct, bubbles, and traces of settling were confirmed as well. While this cable was collected from the location near the area (breakage of C3 cable at the same location was confirmed) where the most significant damage was found in this bridge, it was confirmed that corrosion of PC wire was minor. That is, it can be determined that the PC steel corrosion can be controlled as long as grout is mostly filled even under a significant chloride attack environment.

Figure 11. Dissection research of C4 cable of G3 girder of the first span in C bridge

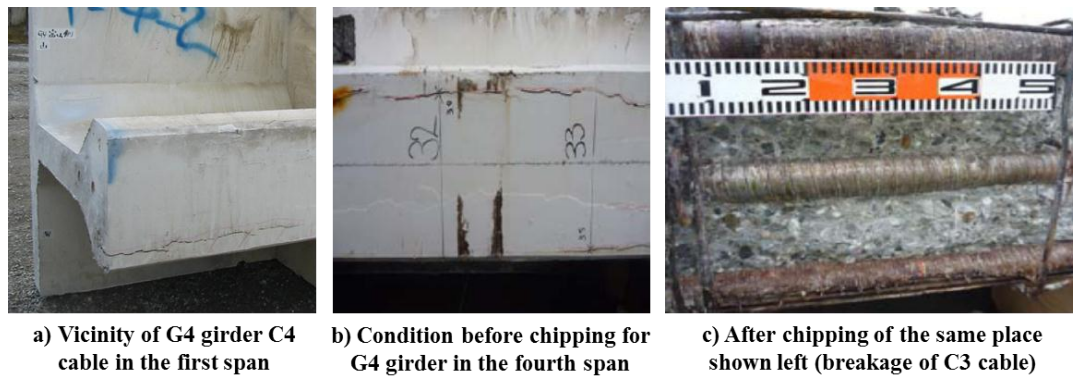
Figure 14. Damage condition at the part with filled grout (C bridge)

Additionally, **Figure 13** shows the mass reduction rates of G3 girder C3 cable in the first span (which has the most significant damage), and cables having the same covering in the first span including G1 girder C3 cable (which has the second most significant damage), G4 girder C4 cable (which used to be an undamaged sound part, but newly damaged), and G4 girder C3 and C4 cables (which has the highest damage outside of the first span) in the fourth span. This time, the mass reduction rate exceeded 10% where cracking was significant enough to separate concrete in areas with loss of duct and unfilled grout (or, it fell off during duct sheath removal) as shown in the above **Figure 7**. However, the mass reduction rate was 10% or less, averaging about 4%, where the extent of cracking remained in the longitudinal direction axial cracks at the bottom surface of lower flange as shown in **Figure 14**.
