## **A study on the reinforced concrete column with the alkali-silica reaction in Hanshin Expressway viaducts**

The structure of the reinforced concrete rigid frame is numbered as P369, shown in Figure 1. It was built in 1983. The history of the inspection is shown in Table 1. The concrete mix proportion is not stored as the construction record.

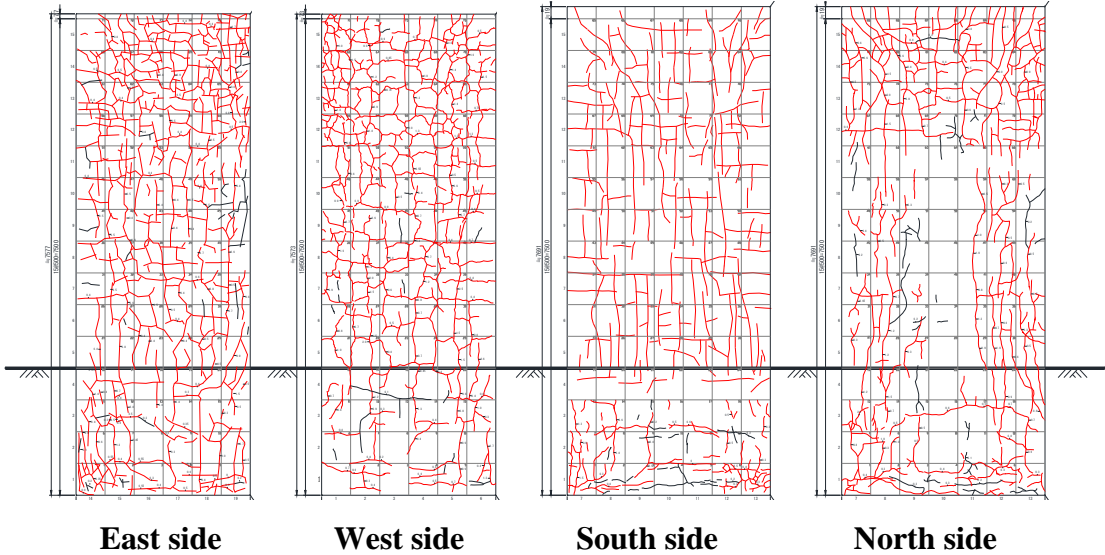
**(a) The left column**

The crack distribution on the column surface is shown in Figure 2. The cracks are distributed all over the column surface. The total length of the cracks is 1,070.6m. The crack density is 5.4 m/m<sup>2</sup>. Since the value of 5.4 m/m<sup>2</sup> is much more than the judging standard crack density of ASR, 1.0 m/m<sup>2</sup> in Hanshin Expressway maintenance manual (Hanshin Expressway Company, 2008), ASR is suspected with the two columns. The large crack with 10mm width

**Figure 2. The crack distribution on the column surface**

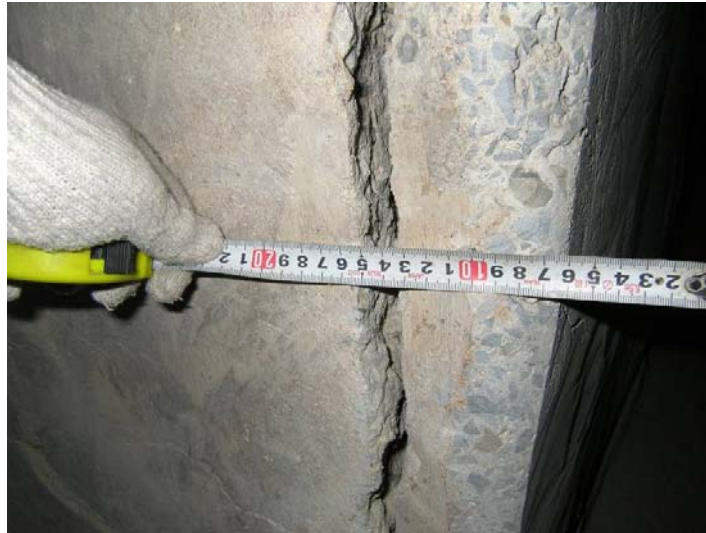
is detected at the corner of the column bottom, shown in Figure 3. The water supply from the ground is supposed to be the main reason for the crack growth in the column bottom.

**Figure 3. More than 15 mm crack at the corner of the column bottom**

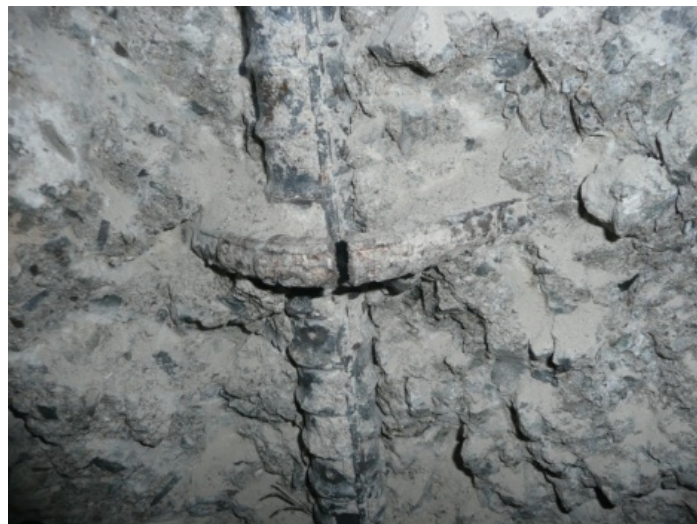
The reinforcing steel rupture of the tie hoop is shown in Figure 4. The 120 points of the corner of the column are investigated by the destructive or non-destructive method. The reinforcing steel rupture is confirmed at 70 points out of 120. The 70 points are located in the bottom or intermediate height of the column. It is not clear that the reinforcing steel is electric furnace or blast furnace.

**Figure 4. The reinforcing steel (tie hoop) rupture**

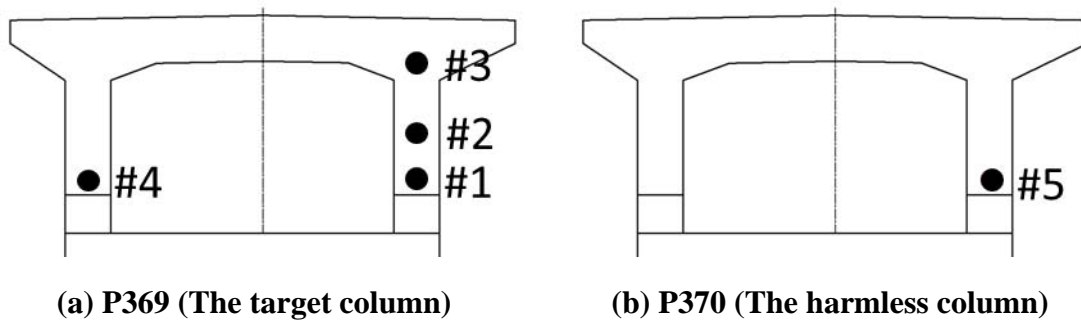
Figure 5. The location of the cores

The core location is shown in Figure 5. The target columns are P369. In order to compare P369 with the harmless column, the #5 core is taken from P370 that is the adjacent pier in the same construction unit where the same concrete material was used. The relationship between the compressive strength and the static modulus of elasticity is shown in Figure 6. The design compressive strength of concrete in P369 and P370 is  $27 \text{ N/mm}^2$ . The solid line in Figure 6 indicates the standard relationship between the compressive strength and the static modulus of elasticity by Japan Society Civil Engineers (JSCE, 2007). The modulus of elasticity of the #1, #2 and #4 cores is found to deteriorate from the JSCE solid line.

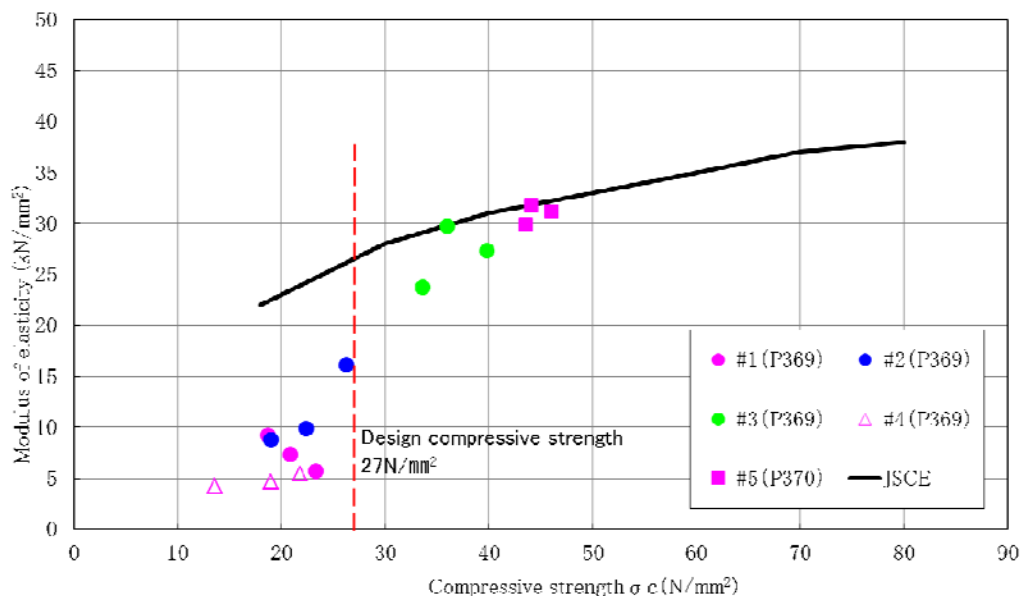
Figure 6. The relationship between the compressive strength and the static modulus of elasticity

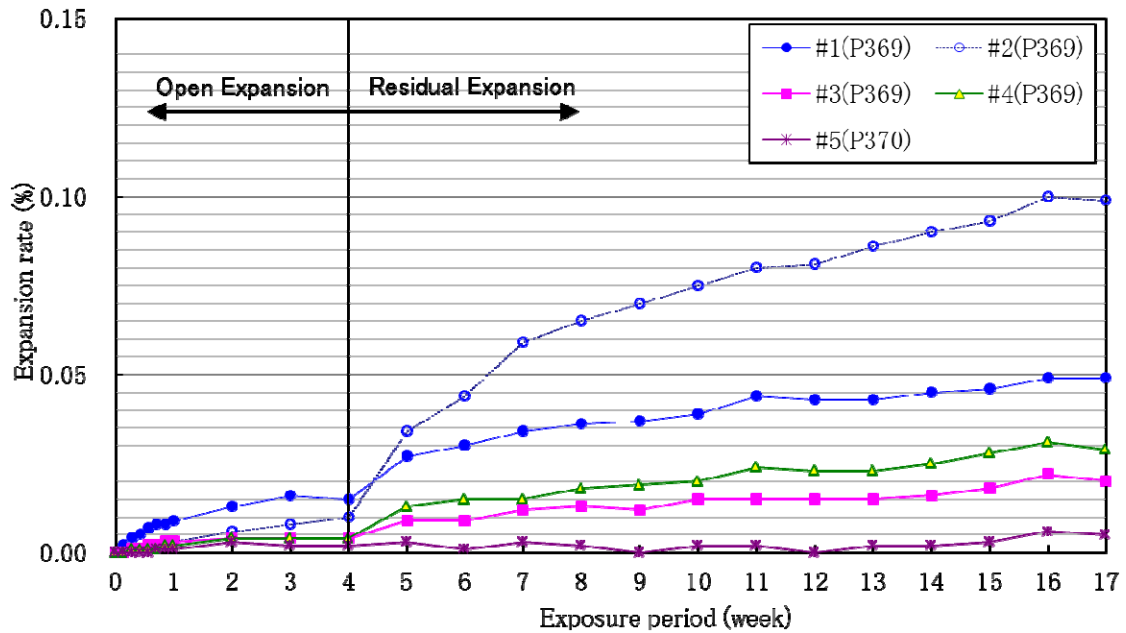
The accelerated test of residual expansion capacity (the JCI-DD2 method) is conducted using the 5 cores. The relationship between the exposure period and the expansion rate is shown in Figure 7. The total expansion rate of the #2 core reaches 0.1% that is the judging standard of ASR. In the #2 core, the residual expansion rate occupies 90% of the total expansion rate that means the #2 section has high capacity of ASR expansion in the future.

**Figure 7. The relationship between the exposure period and the expansion rate of the 5 cores**

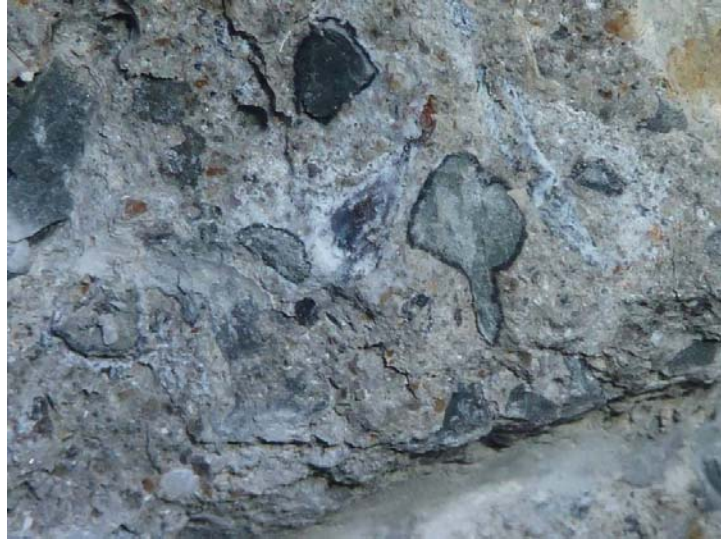
The aggregate visual observation is conducted in P369. From the observation, the gel and the reaction ring are detected, shown in Figure 8. The alkali reactive aggregates such as cristobalite and microcrystalline quartz are observed in in all cores. The aggregate component is the andesite 60 % and the sandstone 40 % in the #1 and #4 cores. On the other hand, the aggregate component is the andesite 5 %, the sandstone 85 % and the mudstone 10 % in the #3 and #5 cores. The andesite component percentages of the #1 and #4 cores are larger than those of the #3 and #5 cores. Although the pessimum condition of the aggregate component is not clear, the difference of the andesite component percentages can affect the reactivity level of ASR.

**Figure 8. The gel and the reaction ring observed in P369 concrete**
