## **The Importance of Good Design, Maintenance and on-time Repair Work for Long Service Life of Structures**

Lojze Bevc

Slovenian National Building and Civil Engineering Institute, Slovenia  
Dimičeva 12, SI-1000 Ljubljana, lojze.bevc@zag.si

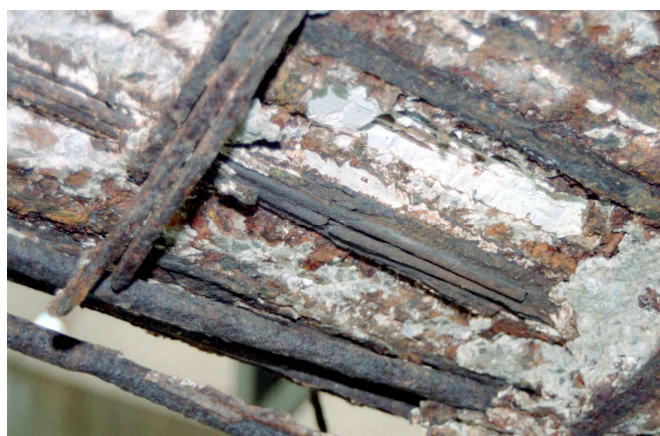
In 1989 a systematic periodical inspection of bridges on the whole network of national roads and highways began. In 19<sup>th</sup> year the general inspection of bridge structure from the ground level revealed extensive corrosion damages on many main outer girders of the superstructure and both cantilever parts of the deck plate. Heavy deterioration was visible also on the surface of both sidewalks. After 2 years a major inspection of the whole bridge was carried out for the first time since the structure was built. It revealed the seriousness of the corrosion damages of the main girders. A few edge girders had heavily corroded tendons up to half number of all tendons in the cross section and approximately one third of all outer girders had 1 to 3 corroded tendons. There were more intensive damages on the right structure than on the left one. Heavily corroded tendons are shown in figure 1.

**Figure 1: Heavily corroded tendons with broken wires**

The main sources for the leakage were inadequately grouted holes for the fixing rods of formwork under cast-in-place joints between prefabricated deck slab elements. Another source was heavy deterioration of the sidewalks and seals of the joints between the sidewalks' prefabricated elements. Therefore, the immediate action was the closure of the emergency lane of the right structure because the heaviest corroded girders were along that

- Contaminated and damaged concrete was removed with high water pressure technique.
- Locations with removed concrete of the girders were reinstated with hand applied or sprayed concrete depending on the depth of the removed deteriorated and contaminated concrete.
- Removed concrete in the area of the removed corroded tendons was replaced with cast-in-place concrete.
- Heavily corroded tendons were cut out and replaced with external flat tendons.
- Steel anchorage boxes for the anchorage of the external tendons were installed by prestressed high tensile rods at both ends of the girders.
- Saddles for the external tendons were fixed by bolts at the middle spans of the girders.
- Deteriorated concrete on cantilever part of the deck was removed and repaired by sprayed concrete.
- All sidewalks' precast elements were removed and replaced with massive cast-in-place concrete sidewalks.

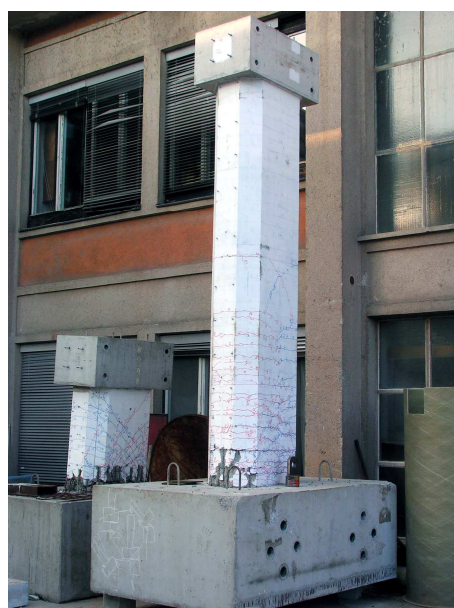
**Figure 2: Short and high column models after finished experiments**

The models were cast in steel formwork. The tall column was made in several stages with the same formwork. The models were made of self consolidating concrete of the design concrete class C50/60. The models were tested in horizontal position and in the transverse direction. Axial load ratio for the short column was 0,061 and for the tall one 0,066. The short column failed in shear with delamination of the concrete and buckling of bars in compression zone. The tall column failed in flexure with delamination of concrete and buckling of the bars in compression zone. At the bottom part of the tall model wide cracks

appeared at the level of the reinforcement overlapping. Through the hole in the column footing the propagation of cracks and other damages (delamination, buckling of reinforcement) on the inner side of the column were observed. The results of the laboratory experiments were used in nonlinear analysis of the real structure. The analysis showed that during an earthquake event only the behavior of the short columns may become problematic. One of the possible solutions of the strengthening of the short columns was to add a new layer of the concrete on the outer side of the column. This new layer would prevent premature buckling of the longitudinal bars at the bottom of the columns. The new concrete layer of the 10 cm thickness was reinforced with longitudinal reinforcement, which was not anchored in the footing. The distance between the longitudinal bars is 10 cm. The distance between the stirrups is 10 cm as well. To verify the behavior of the strengthened column, the scaled model 1:4 of the strengthened short column was built in the laboratory and tested on the cycling loading. Figure 3 shows the unstrengthened and the strengthened models after finished tests.

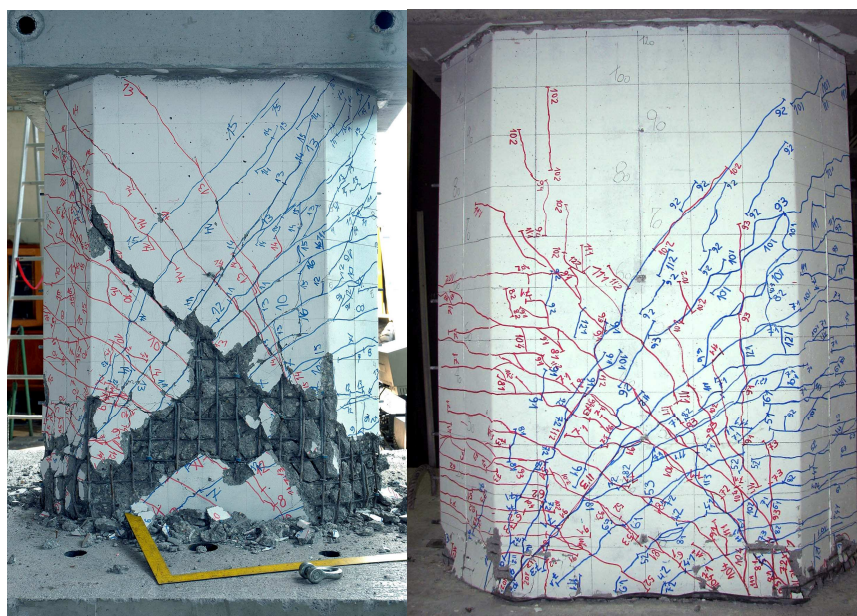
**Figure 3: The original and the strengthened model of short column after finished test**

Local delamination of the new layer and concrete surface on the inner side of the column began at 15 mm horizontal displacement. Local buckling of some vertical bars was also observed. A few longitudinal bars were ruptured at the bottom of the column at 28 mm of horizontal displacement. Additional longitudinal bars ruptured at displacement of 36 mm. At the same time a larger area of concrete delaminated on the inner side of the column and many inner longitudinal bars buckled. The results of the tested model of the strengthened short column showed satisfactory behavior during cycling loading. The hysteresis behaviors of both models obtained during the tests are presented in figure 4. Based on results of tested models and nonlinear analysis of the viaduct it was recommended to add a new reinforced concrete layer (10 cm thick) over the whole height of the short columns. The added new longitudinal reinforcement should not be anchored into the footings.

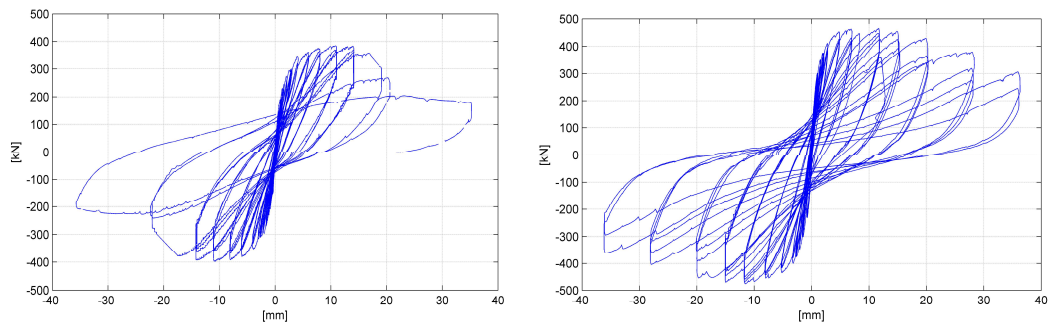
**Figure 4: Hysteresis behavior of the original and the strengthened model of short column**

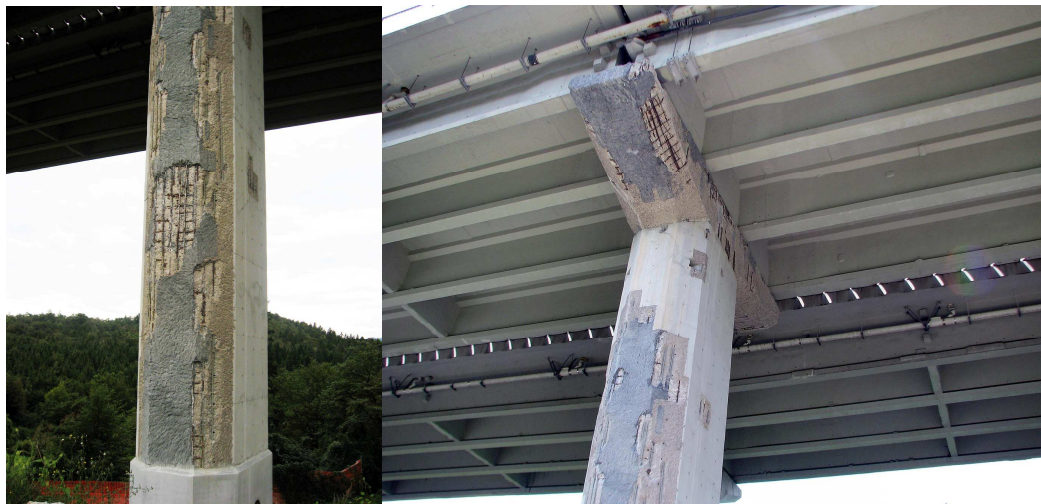
**Figure 5: Tall columns and hammerhead crossbeams during the repair work**

Because other columns had deteriorated outer concrete surface as well, it was recommended to add a new concrete layer on the outer surface of these columns, too. With new concrete layer the future durability of the columns would be much better with respect to conventional repair work with sprayed concrete or locally hand applied repair mortar. At the end, the owner decided that on other taller columns a new layer of the height of 4 m would be added only at the bottom of the columns. During the laboratory test at the bottom of the tall column model wide cracks appeared at the level of the reinforcement overlapping. In the figure 5 are shown columns during repair work in 2008.
