Investigation of Deteriorated RC Slabs on Steel Girder by Chloride Attack of Deicing Salt

Keywords. RC slab, Chloride attack, Deicing salt, Deterioration, Investigation

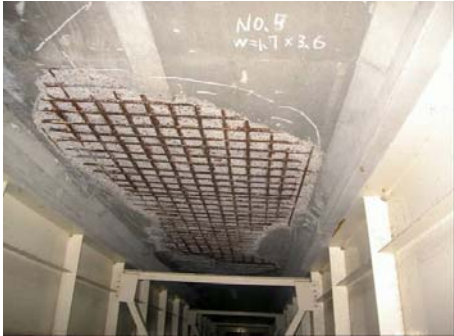
Typical deterioration in appearance of RC slabs on the steel girder in Chugoku region is slab delamination caused by corrosion of rebar in the slab (Refer to Fig 1 & 2.). It is noted that the slab delamination often appears on slabs on the steel girder located snowy mountainous area where deicing salt is spread over the road surface in winter period. Thus, it is considered that the slab delamination is caused by chloride attack of deicing salt(Honjo,2008).

Figure 1. Delamination around middle of slab

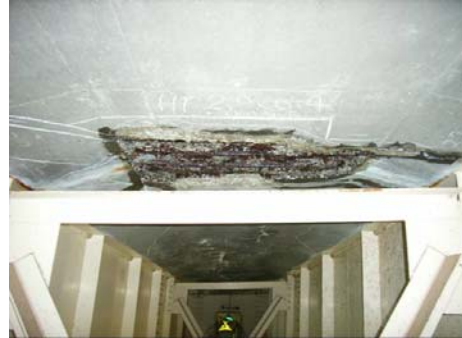
Figure 2. Delamination at the construction joint of slab

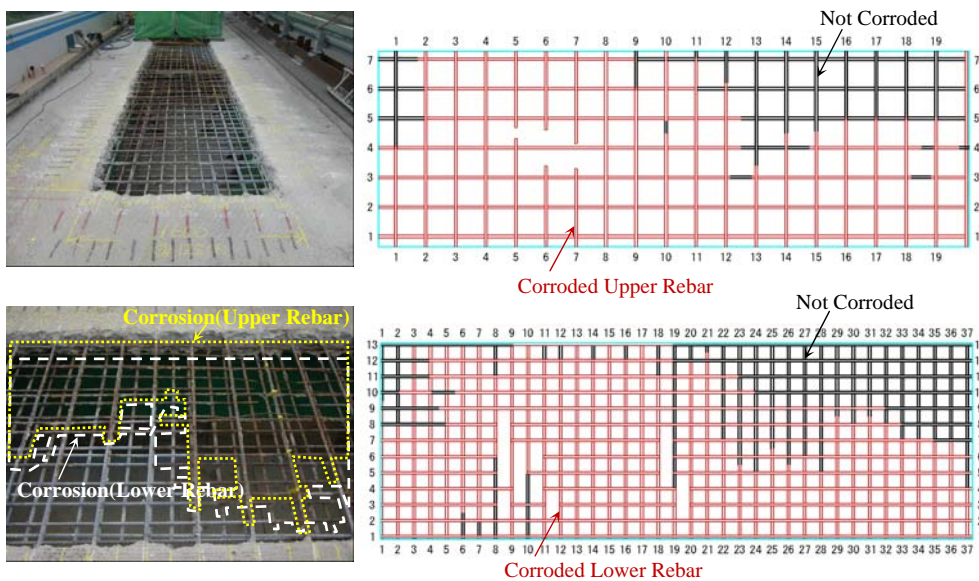
Slab delamination on the lower surface appears where water is leaking or leaked in the past. Detailed investigation at the time of repairing confirmed that the deteriorated area of upper rebar roughly coincided with the deteriorated area of the lower rebar (Refer to Fig 3). Few deterioration was observed separately on the lower slab surface except in the area where water was leaked through construction joints or drain pipes, whereas the deterioration often appears independently on the upper slab surface.

Figure 3. Corrosion area of upper and lower rebar of partially repaired slab

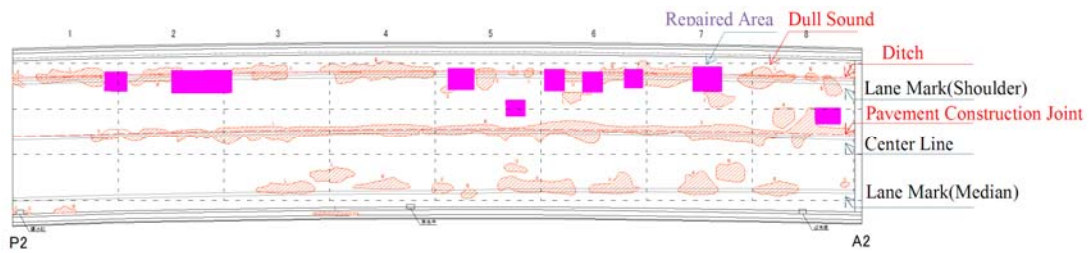
It should be noted that there is a V shape ditch for drainage of melted snow carved outside of the lane mark on the shoulder side. When hammering test was conducted on the pavement, dull sound was detected in the wide area around the ditch (Refer to Fig 5, 8 & 9).

Figure 5. Slab Surface of Bridge E (Pavement)

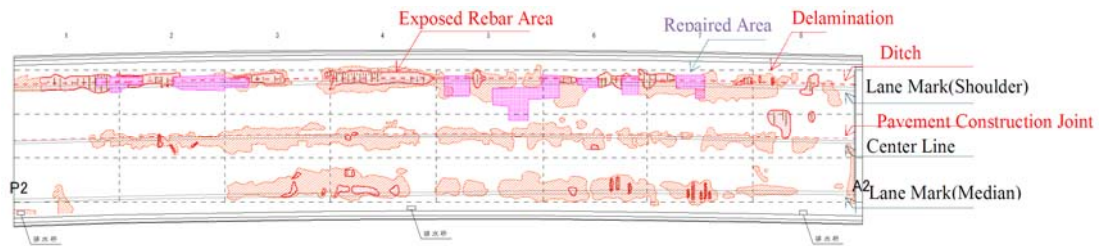
After the pavement was removed, upper slab surface was investigated. It was noted that there was slab delamination widely spread under the construction joint and ditch. It appeared to be true that the construction joint and ditch of pavement were the major water infiltration channels in the slab (Refer to Fig 6, 10 & 11).

Figure 6. Slab Surface of Bridge E (Upper slab surface after pavement removed)

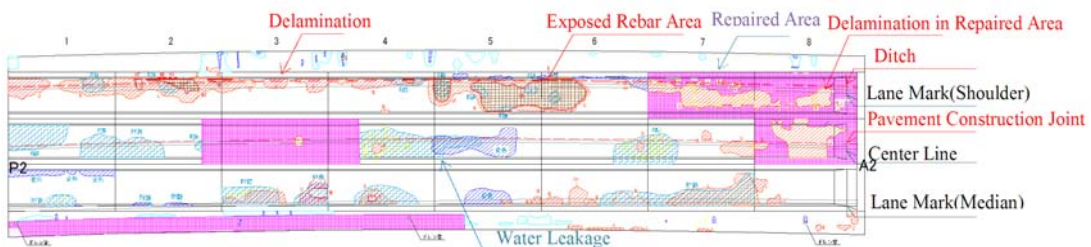
The deteriorated area of the lower slab surface almost conformed to that of the upper slab surface. It was noted that there was slab delamination widely spread under the ditch area and water leakage was mostly actualized along construction joint near the center line (Refer to Fig 7, 12 & 13).

Figure 7. Slab Surface of Bridge E (Lower slab surface)

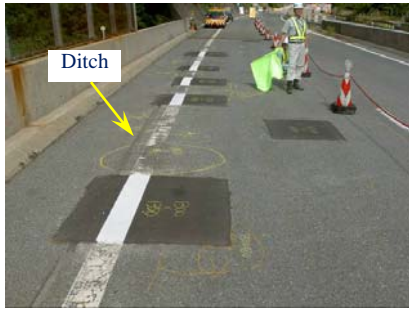
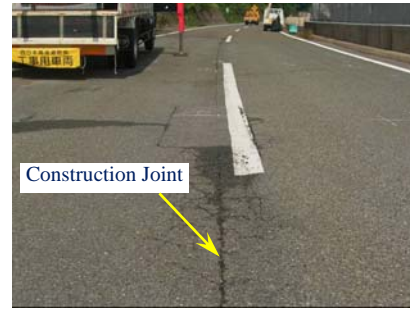
Figure 8. Pavement surface (Ditch) Figure 9. Pavement surface (Construction Joint)

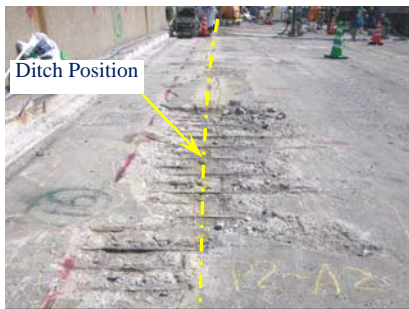
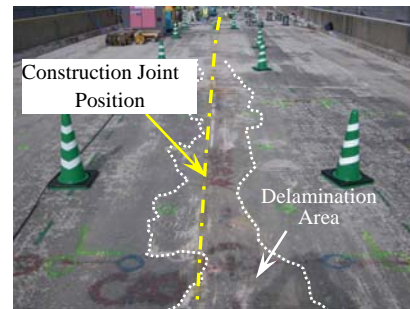
Figure 10. Upper slab surface (Under the ditch of the pavement) Figure 11. Upper slab surface (Under the construction joint of the pavement)

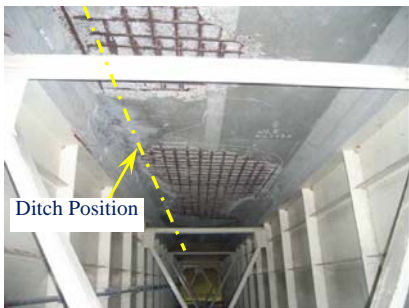
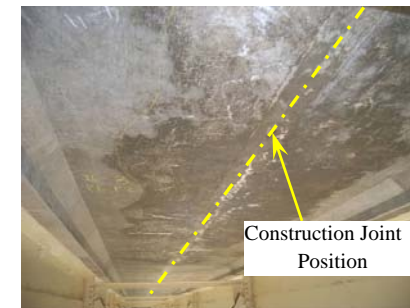
Figure 12. Lower slab surface (Under the ditch of the pavement) Figure 13. Lower slab surface (Under the ditch of the pavement)

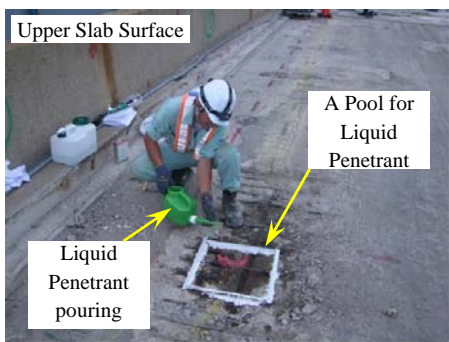
It is rather easily understood that the cold joint can cause leaked water channels in the slab, while a possibility of water channel caused by narrow cracks, which are mainly made by drying shrinkage, has not been quite confirmed. Thus, water leakage test was conducted by pouring water on the upper slab surface (Refer to Fig 14).

Figure 14. Liquid penetrant test on the upper slab surface

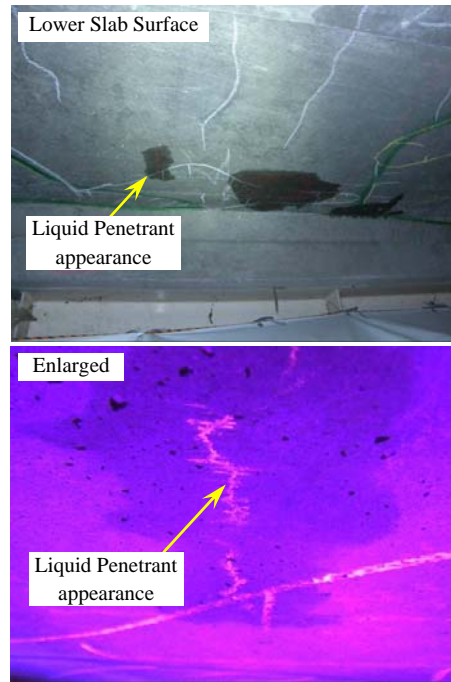
After pavement was removed, a water pooling device was prepared around deteriorated area on the upper slab surface. Then, liquid penetrant containing fluorescent pigment was poured in the pool. 3 hours afterward, liquid penetrant appeared through the cracks (less than 0.1mm width) on the lower slab surface (Refer to Fig 15).

Figure 15. Liquid penetrant appearance on the lower slab surface

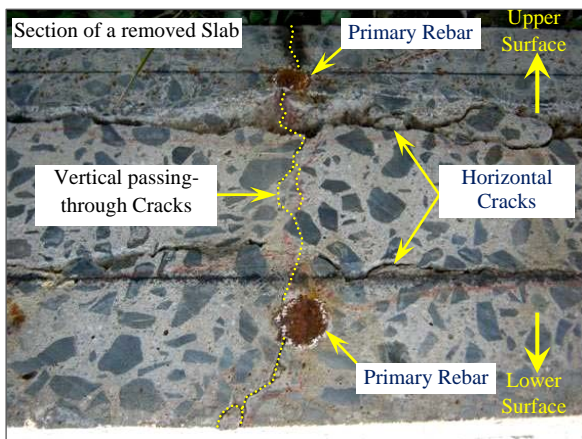
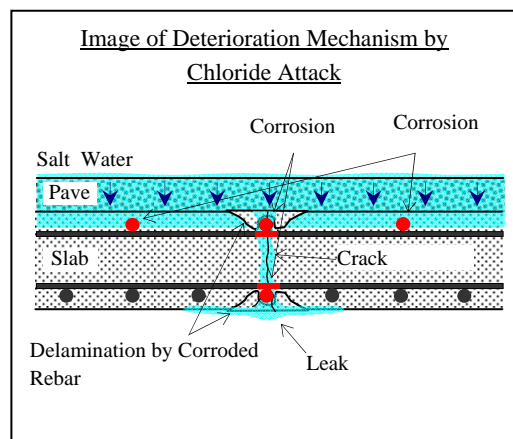
The section of the removed slab was investigated in detail. Then it was confirmed that the actual deterioration mechanism was very similar to the image that had been presumed (Refer to Fig 16).

Figure 16. Section of a removed slab similar to an image of deterioration mechanism

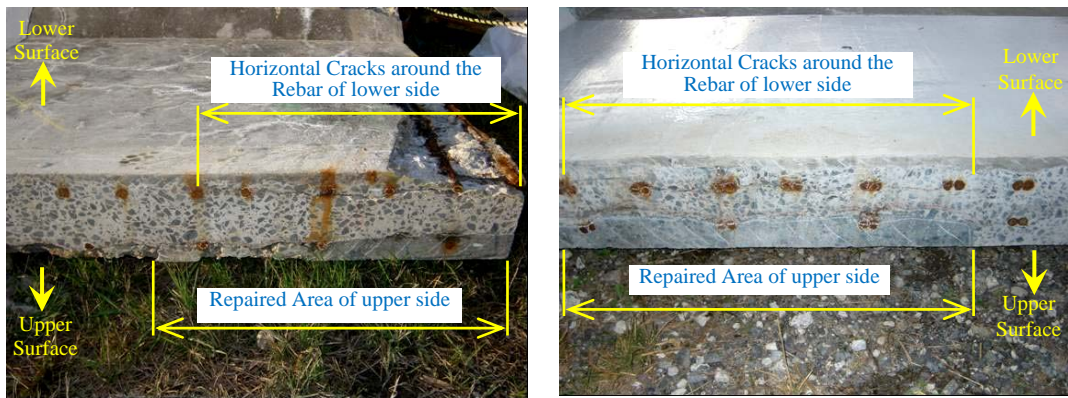
As mentioned before, it is considered that salt water on the upper slab surface infiltrates into a slab through construction joints or vertical passing-through cracks caused by drying shrinkage and temperature expansion/contraction. Detailed investigations on the section of the removed slab revealed that there were some cases to prove that the repaired area of upper slab surface roughly coincided with the deteriorated area of lower slab surface (Refer to Fig. 17).

Figure 17.A case of deterioration developed under the repaired area

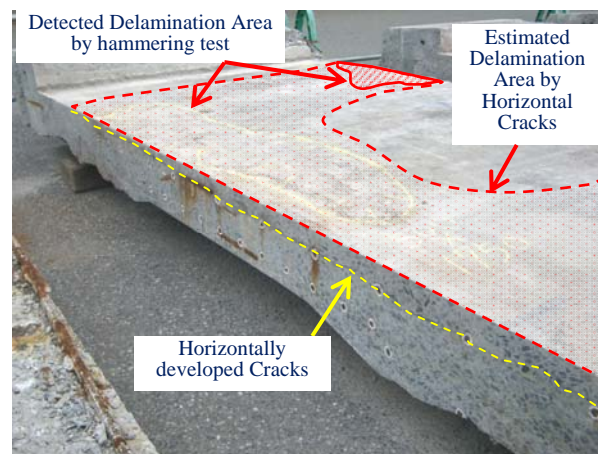
On the cross sections of the removed RC slab on which delaminations are widely spread, horizontally developed cracks (hereunder called horizontal cracks) can be seen along the delamination boundary. Such horizontal cracks were also observed on the removed slab sections of Bridge F. It should be noted however, some of these cracks could not be detected by hammering test (Refer to Fig. 19 & 20).

Figure 19. Comparison between the delamination area detected by hammering test and the delamination area estimated by horizontal cracks

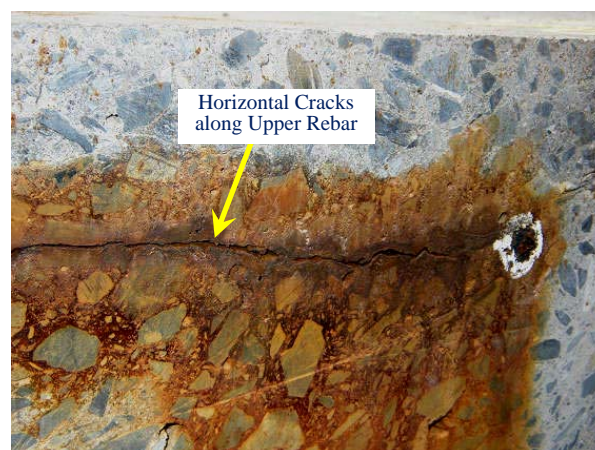
Figure 20. Horizontally developed cracks

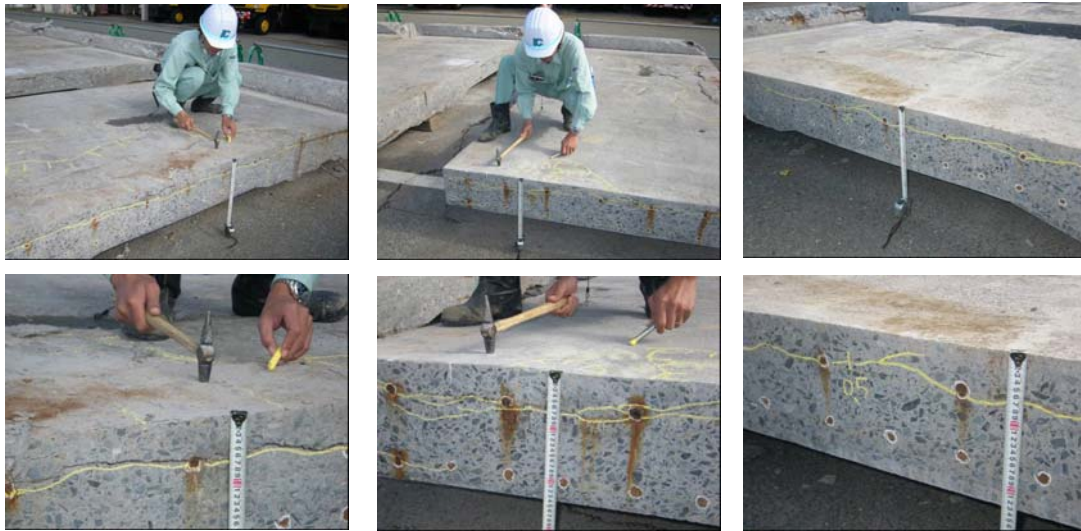
Detailed investigations shows that horizontal cracks located in a rather shallow area (approximately less than 40 mm in depth) or, cracks located in a deep area with a wide crack width can be detected by hammering test. However, horizontal cracks located in areas more than 50 mm in depth with a narrow crack width failed to be detected by hammering test even performed by a skilled inspector (Refer to Fig. 21).

Detectable in all area
(40~70mm in depth)

Detectable in partial area
(40~70mm in depth)

Not detectable
(50~70mm in depth)

Figure 21. Horizontal cracks detected by hammering test
