The University of Wisconsin Milwaukee Centre for By-products Utilization Second International Conference on Sustainable Construction Materials and Technologies June 28 - June 30, 2010, Università Politecnica delle Marche, Ancona, Italy. Proceedings of Honouree sessions ed. T Naik, F Canpolat, P Claisse, E Ganjian, ISBN 978-1-4507-1487-7 http://www.claisse.info/Proceedings.htm

Monitoring of a Very-High Performance Concrete Bridge

Luigi Biolzi¹, Sara Cattaneo¹, Gianpaolo Rosati¹, Gianluca Guerrini²

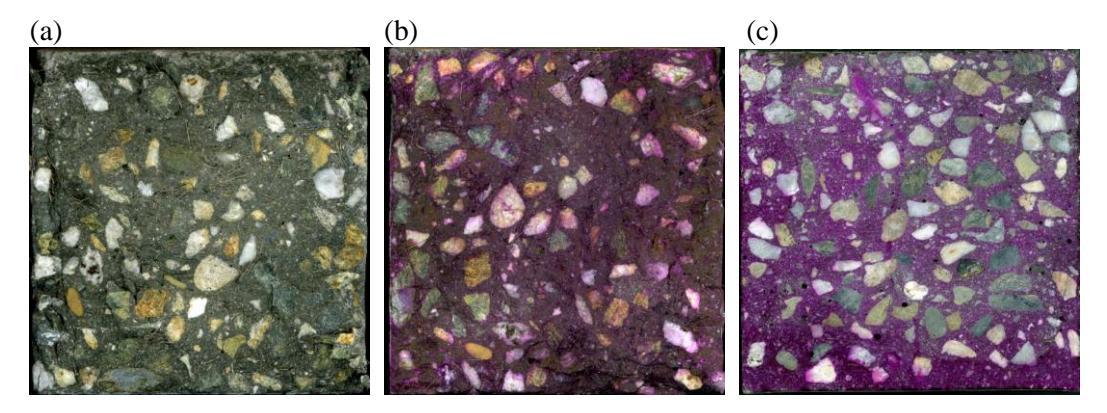
The tests showed that the carbonation process did not develop inside the specimens. Figure 5 shows specimens before (a) and after testing (b-c).

Figure 5. Carbonation tests: before (a) and after testing(b-c)

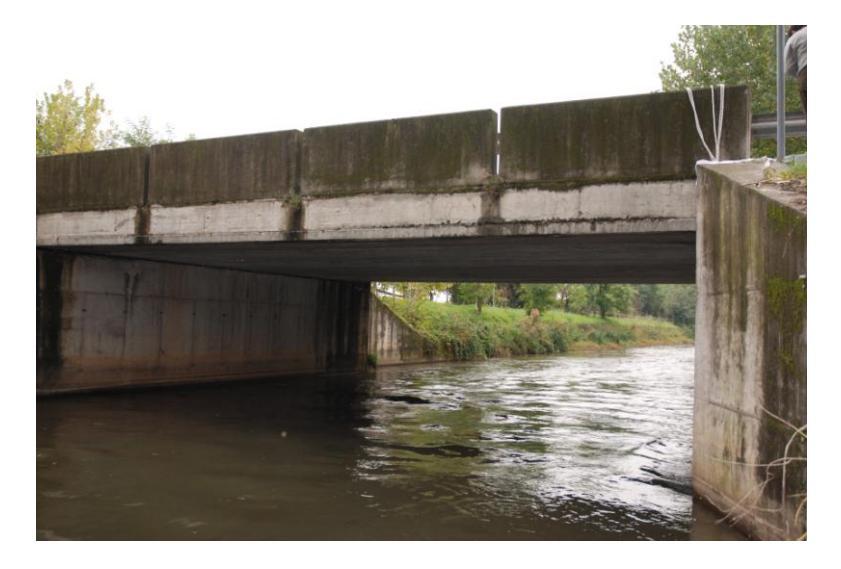
The in situ inspection involved visual survey, ultrasonic pulse velocity method and the carbonation tests. The visual inspection of the bottom of the bridge revealed the total absence of visible cracks, spalling, reinforcement corrosion or defects of the concrete surface. The bridge deck appears as it was placed (Fig.8).

Figure 8. Bridge

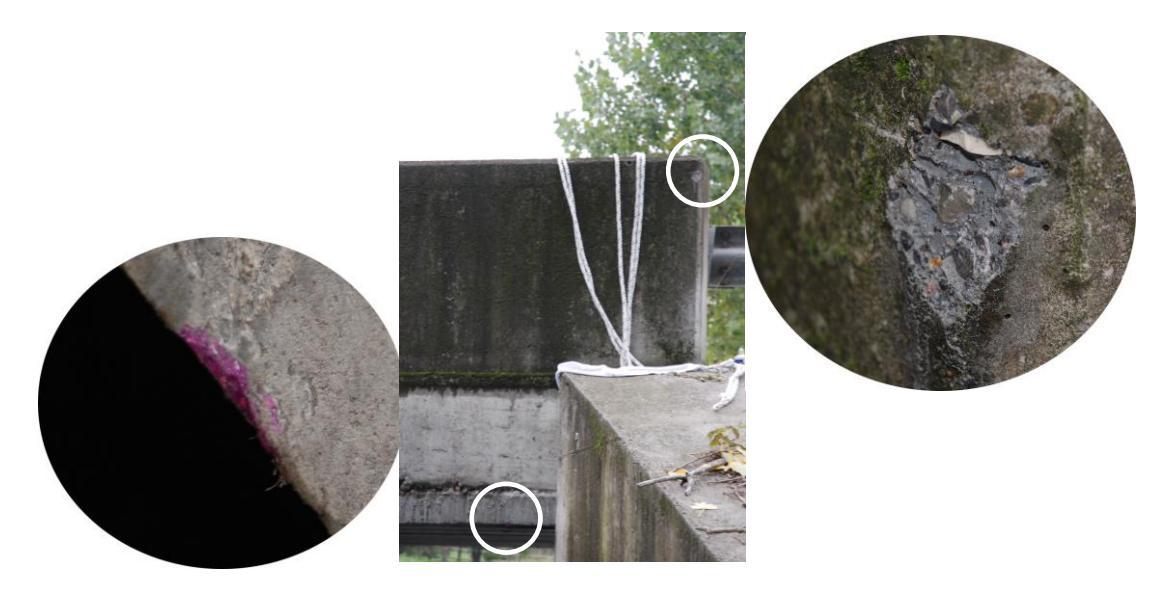
Since the laboratory tests on specimens did not show carbonation, the test was repeated on the bridge. A very small piece (thickness of about 2mm) of concrete was removed from a lateral member of the deck. In addition to this, a larger piece (thickness of about 5mm) of concrete was removed from the concrete jersey barrier (installed just after the bridge deck). Both parts were treated with a phenolphthalein indicator. The HPC bridge did not show any carbonation since a purple-red coloration appeared after few seconds (Fig.9 left), while the concrete jersey barrier (made with normal concrete) carbonated, since no coloration appeared (Fig. 9 right).

Figure 9. Carbonation tests
