Evaluation of maintenance methods for ASR-damaged structures in Hokuriku district, Japan

Masahiro Nomura¹, Akinori Komastubara², Kazunari Fujimoto³, Kazuyuki Torii⁴

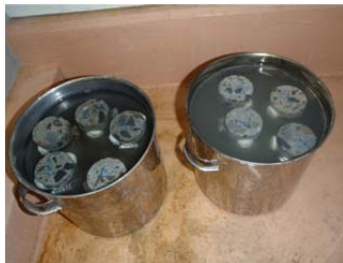
Figure 1 Cores immersed in a 1N-NaOH

The time-related changes in the expansion of drilled concrete cores (\varnothing =55mm, L=150mm, initial depth= 100mm) were measured in accordance with the accelerated mortar method (ASTM C1260-1994). The specimens were immersed in a 1N NaOH solution at 80°C. Referring to the evaluation criteria applied for the Hokuriku Expressway, cores with an expansion ratio exceeding 0.1% at 21 days were judged as having deleterious expansivity, as shown in Figure 1 and Figure 2.

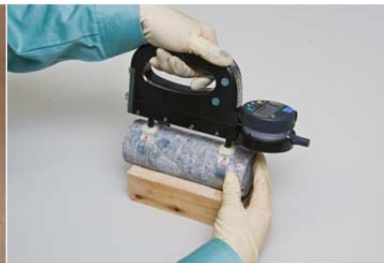
Figure 2 Measurement of the expansion of the core

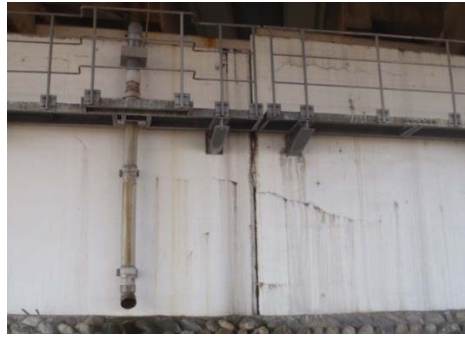
In structure C, the andesite ratio was high, but the alkali content was relatively low. In this case, it was considered that ASR would continue for prolonged periods. On the other hand, the residual expansion determined by Canadian method was as high as 0.5% in the repair period, but decreased to 0.25% in the course of 10 years after repair. Although there was no risk that structure C could be affected by water leaking from the backfill into the abutment, ASR showed a recession pattern, but it was difficult to apply the epoxy type of fiber sheet coating and cracks occurred in the cases where the residual expansion was more than 0.2%, as shown in Figure 8

Figure 8 Cracks occurred on the repaired in Structure C

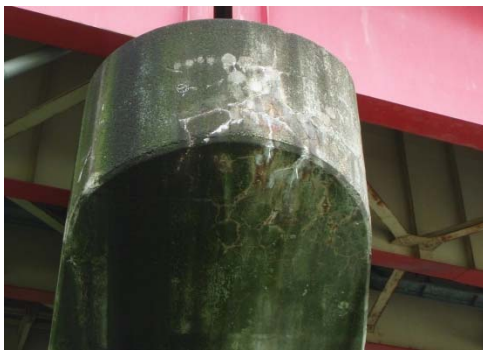
In structure E, surface treatment with sodium silicate was applied as ASR repair method in 1995, but cracks occurred after a few years, as shown in Figure 9. The characteristics of this material composed mainly of magnesium compound, suppress the ASR progress by densifying the concrete, while penetrating into the concrete depths and promoting the

Figure 9 Deterioration due to ASR in Structure E

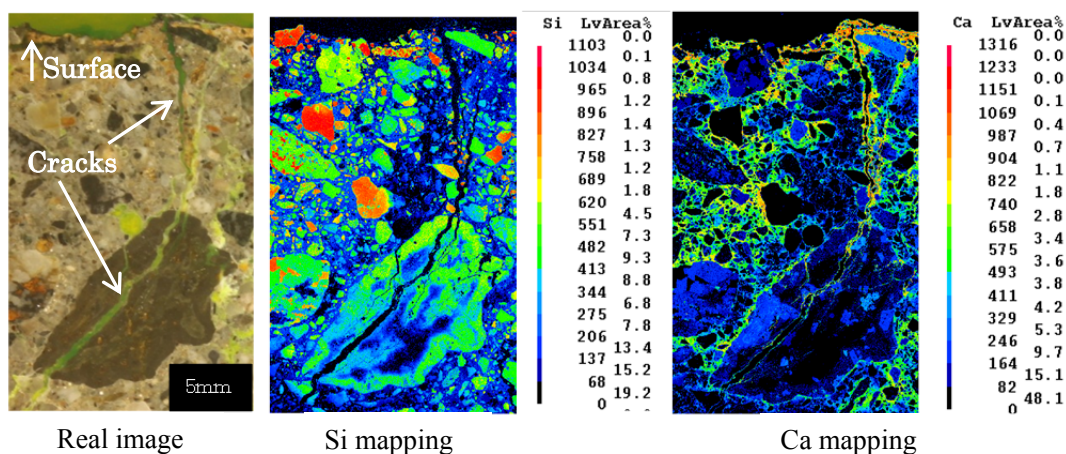
Figure 11 Results of EPMA(WDS) mapping at the cracks point

formation of new cement crystals that grow in the capillary pores, transition zone and microcracks. The Figure 10 shows the relationship between the andesite ratio and alkali content, and it is understandable that the ASR potential is very low. The concrete core was drilled from a cracked point of the structure and Figure 11 shows the results of element analysis distribution in concrete using EPMA. Crack width of approximately 0.5 mm that occurred through the coarse aggregate from the surface were observed. But these results could not confirm the presence of silica and calcium as the main cement crystals. This surface treatment has not been able to fill the cracks even 17 years after repair, so this method was not effective for suppressing ASR progress.

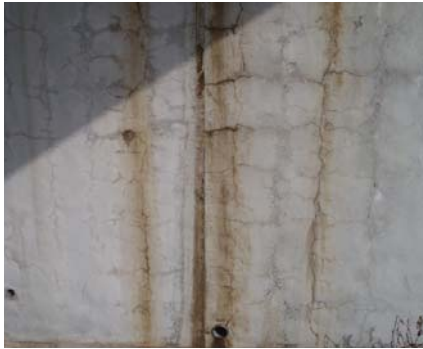
After removing the concrete cover, patch repair with polymer cement mortar was executed in Structures F and G. The polymer cement mortar used in both cases was a product of the same company. These mortars contain about 1.5 to 2% short fibers in order to prevent cracking in the material. However, ASR progress of the structure inside continued after repair, and cracks with less than 0.2 mm width have reoccurred, as show in Figures 12 and 13. Figure 14 shows the relationship between andesite ratio and alkali content of each structure. Figure 15 shows the comparison of expansion ratios at 21 days determined by Canadian method before repair and 10 years after repair. It can be understood that the andesite ratio and the alkali content of structure F are higher than those of structure G. In addition, the residual expansivity trended toward convergence in structure F, but it was clearly progressing in structure G. The changes in the extension and pattern of cracks that occurred in the patch repair have been better in structure G than F, and it became reflective of the potential of ASR. It is also important to note that, in the structures with patch repair where no residual expansivity was observed, the residual expansivity obtained by Canadian method was less than 0.1% at 21 days. From the economic rationality point of view, in the cases where a large number of cracks occurred, the possibility of re-damage was higher when patch repair was applied instead of crack injection. Therefore, the option of patch repair has to be carefully reviewed and judged in accordance with the results of the residual expansivity determined by Canadian method.

Figure 12 Cracks occurred on the patch repair in Structure F

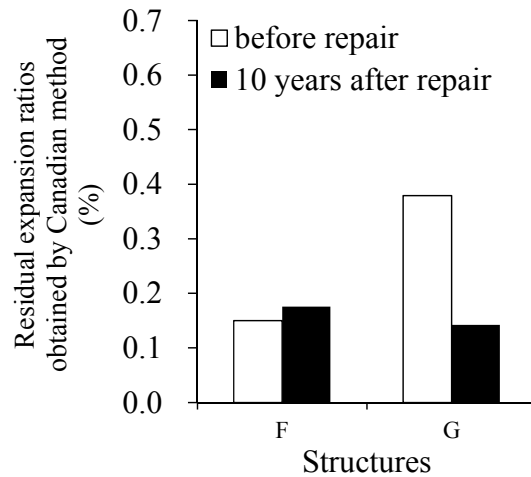
Figure 15 Comparison of expansion ratios determined by Canadian method

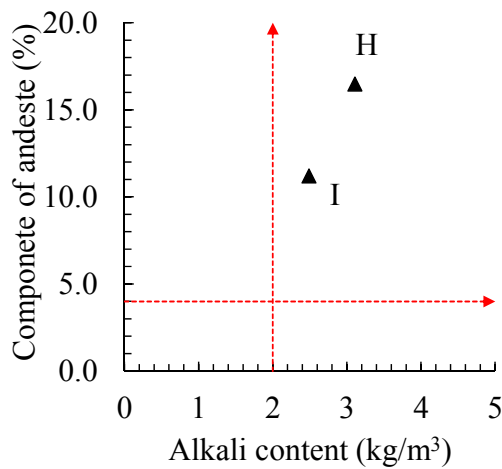
Figure 16 Relationship between the alkali content and component rate of andesite

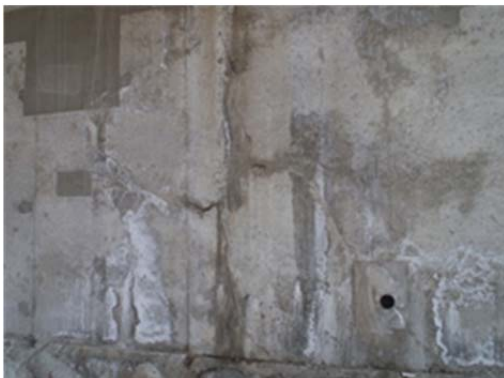
Concrete cover was removed and concrete jacketing was executed in Structures H and I, after placing the reinforcement steel. Table 4 shows mixing proportions of the concrete used. In addition, short fibers in the proportion of 0.5% of cement were included for crack prevention in the concrete, expansive agents and superplasticizer were added as admixtures. Figure 16 shows the relationship between the andesite ratio and the alkali content on each structure. Figure 17 shows the comparison between the expansion ratios at 21 days determined by Canadian method before repair and 10 years after repair. Both structures showed high potential trend of ASR. In addition, structure H had a high residual expansivity at the repair time, but the residual expansivity was less than half after 10 years period. It was suggested that ASR trend in structure H was towards convergence. On the other hand, the trend of residual expansivity has been constant in structure I, and it was suggested that ASR was not trending towards convergence. Figure 18 shows the cracks that

occurred in the structure I. Since ASR was not trending toward convergence, it was considered that concrete jacketing was not that effective in ASR suppression.

Figure 18 Cracks occurred on the patch repair Structure H

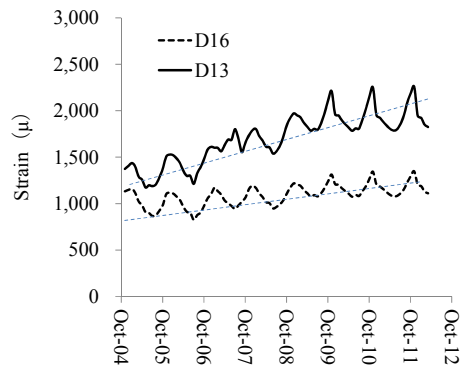
Furthermore, the reinforcement steel strains were measured at the repair time in the structure I, and they varied from 850μ to 1300μ . The reinforcement steel strains have been monitored by strain gauges after concrete jacketing was applied. Figure 19 shows the results of reinforcement steel strains. The expansion due to ASR has continued after repair, and the steel stresses have also increase. In particular, the strain of D13 reinforcement steel was more than 2000μ and reached the plastic area. Therefore, if concrete jacketing is applied to suppress ASR progress in the structure, the margin of reinforcement steel diameter has to be increased.

Figure 19 Strain of steel reinforcement due to ASR progress in Structure H

- (5) The repair with concrete jacketing was a good measure to suppress the residual expansion, despite high ASR potential of the structure. However, in the cases where the residual expansivity did not trend towards convergence, high stresses developed in the reinforcement steel. Therefore, when concrete jacketing is applied, the diameter of the reinforcement steel has to be considered with a margin.
