Construction of bridge slab ends repair system

ABSTRACT

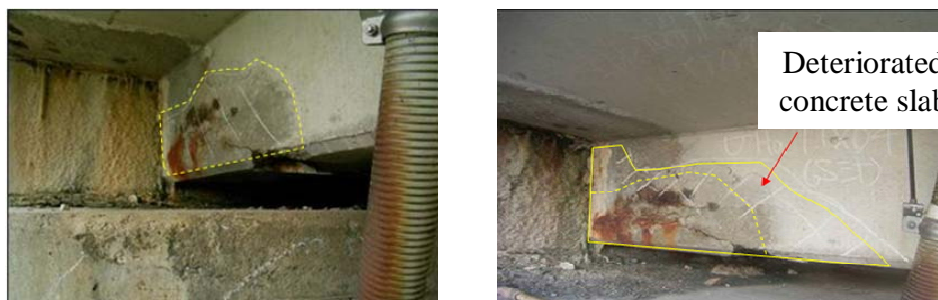
Photo 1. Deterioration at slab end of reinforced concrete hollow slab bridge

(a) Inspection in 2006

(b) Inspection in 2009

Deicing salt (NaCl) is provided to maintain road safety of a Japanese expressway. The steel rebar at the ends of the objective concrete hollow slab bridges are damaged by water leakage containing chloride, which flows through the expansion joints that lack water sealing. The cracking of the covering concrete due to corrosion of rebar affects the strength and durability of the slab ends. Photo 1 (a) and (b) show the deterioration at the slab end of the reinforced concrete hollow slab bridge in 2006 and 2009, respectively. These photos show that deterioration at the slab end is progressing prematurely, once the steel rebar begins to corrode due to chloride penetration.

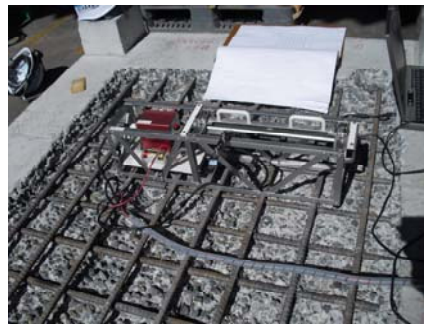
Photo 5. Laser light scattering device

Roughness of chipped concrete surface. The roughness of chipped concrete surface was measured using laser light scattering device as shown in Photo 5. Fig. 3 shows the roughness of the concrete surface, which was chipped using water jet by robot in two passes, followed by an additional hand gun water jet. The maximum roughness of concrete surface was 20-30mm, which was the same size as the maximum size of coarse aggregate. The concrete behind the rebar was completely removed.

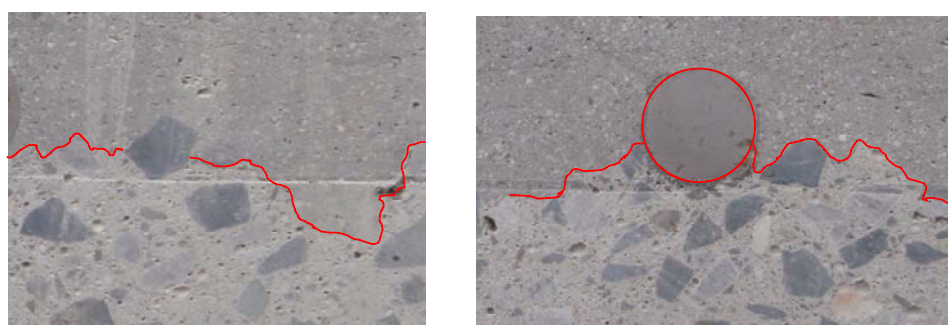
Photo 6. Filling of repair material

Estimation of filling performance. In order to estimate the performance of the filling between the surface of the chipped concrete and shotcrete sprayed repair material, the concrete test specimens were divided into four specimens on 28 ages after spraying. The performance of the filling was satisfied by confirming that repair materials fill in fully around the rebar and local cavity of concrete as shown in Photo 6.

(a) Local cavity of concrete

(b) Around rebar

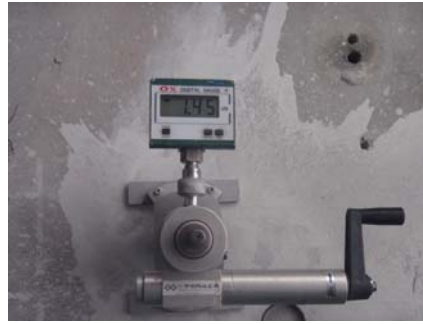
Photo 7. Pull-off adhesion tester

Influence of bond strength on concrete surface textures. An examination of bond strength was conducted to investigate the influence of bond strength on concrete surface texture between each sprayed layer. The bond strength was measured using pull off adhesion tester as shown in Photo 7. Specific parameters for each examination test case are shown in Table 3. In order to keep the wet or dry condition on the surface of chipped concrete, two cases (spraying water or spraying water proofing agent) are considered. Two types (trowel finishes or broom finishes) of concrete surface textures on each layer are also considered. This table shows that the case showing the highest bond strength employs a combination of spraying water and broom finishes. Therefore, this study maintained wetness on the surface of chipped concrete by spraying water, and made the concrete surface textures by broom finishes. Here, the ratio of rebounding sprayed material was 4%.

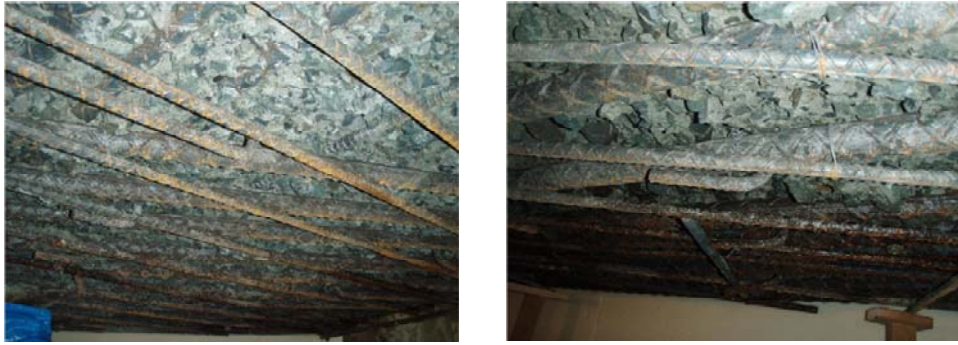
Photo 8. Slab and rebar after chipping deteriorated concrete by water jet

Removal of deterioration concrete by water jet. After consideration of the thickness of the covering concrete and congestion of the rebar at the slab ends of the bridge, the deteriorated concrete is removed by water jet robot in six passes, and by hand gun. Two water jets at a maximum hydraulic pressure of 240MPa, and a maximum flow rate of 38L/minute, were used. The capacity of two water jets is at a maximum hydraulic pressure of 220MPa, and a maximum flow rate of 68L/minute. The chipping depth is 80mm. Chipped concrete is shown in Photo 8. The deteriorated concrete and other concrete behind the rebar are removed completely.
