Evaluation of Strength and Maintenance Methods for Railway Reinforced Concrete Structures with Aged Deterioration

Ichiro Murata¹, Takahiro Yoshida², and Yoshihiko Watanabe³

¹²³West Japan Railway Company Co., Ltd., 2-4-24 Shibata, Kita-ku, Osaka, Japan

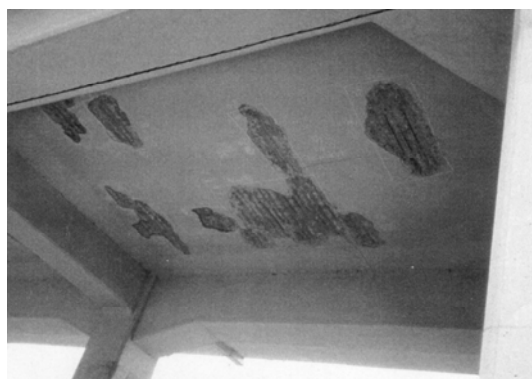
Photo 1. Deterioration of the slab

in the 1970s was completed within a short time period, overcoming difficulties such as inflation and a scarcity of building materials due to the oil crisis. However, within just 30 years of its completion, deformation such as flaking and falling of cover concrete on some viaducts had become apparent (Photo 1). Therefore, the Committee on Investigation for San-yo Shinkansen RC Structures (hereinafter, Committee on Investigation)

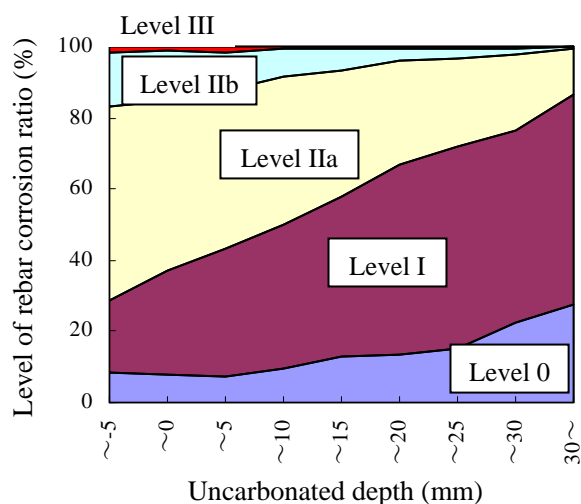
Figure 2. Relationship between the uncarbonated depth and the level of rebar corrosion

As an example of the results of the Comprehensive Inspection, a summary of the results concerning causes of rebar corrosion is given here. Figure 2 shows the results of examining the relationship between the uncarbonated depth (= cover minus depth of carbonation) and level of rebar corrosion in intermediate slabs. This relationship is that the smaller the uncarbonated depth, the greater the proportion of rebar corrosion of Level I (light corrosion is found in places) and above. Classifications for level of rebar corrosion established by West Japan Railway Company (JR-West) are listed in Table 1.

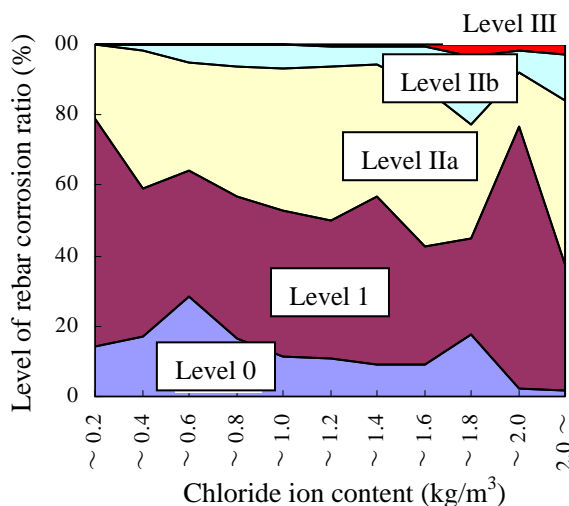
Figure 3. Relationship between chloride ion content and the level of rebar corrosion

In addition, the results of examining the relationship between amount of chloride ions and level of rebar corrosion are shown in Figure 3. The relationship is not as clear as that of the uncarbonated depth, but it was found that the greater the chloride ion content, the more advanced the rebar corrosion.

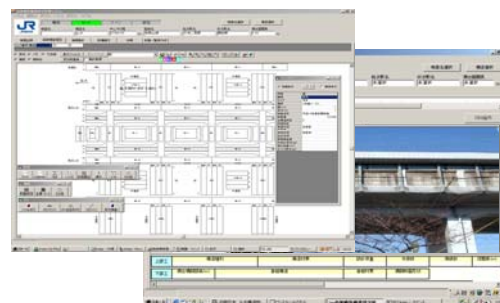
Figure 5. Bridge Analysis and Maintenance System(BRAMS)

3.1.3 Bridge Analysis and Maintenance System (BRAMS) (Figure 5). In order to conduct appropriate maintenance of RC structures, it is necessary to gather a wide variety of data and also to regularly update the data using the latest information. For this purpose, the Bridge Analysis and Maintenance System (BRAMS) was constructed in 2002. This system compiles a database of information such as bridge specifications, inspection data, and repair history with the aim of simplifying/accelerating processing and assisting in the planning of inspection and repair. Currently, information such as the history of sequential inspections/construction work is entered and updated using this system.

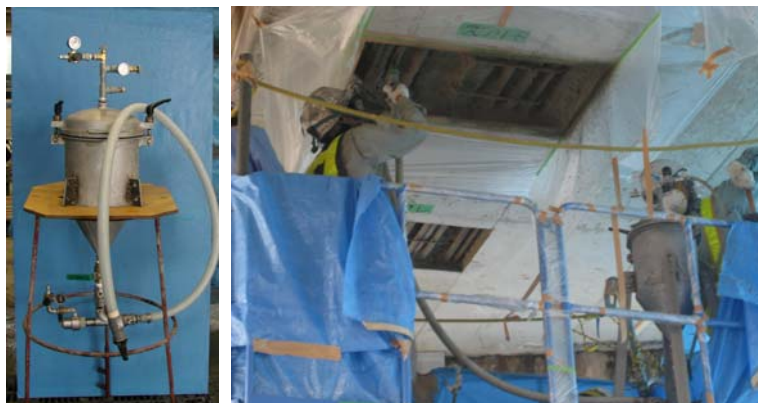
Figure 7. Small spray machine for partial patch repair

(2) Development of small spray machine for partial patch repair : Conventionally, a plastering method using a trowel was usually adopted for partial patch repair. However, ensuring the quality of, for example, repair material filling behind rebar and around rebar intersections was a challenge. The spraying method is considered to be suitable for ensuring a consistent construction quality, but the available spray machines were large and could not be applied to small repair areas. Therefore, a small spray machine for partial patch repair was developed, making it possible to apply the spray method even in places where it is not possible to bring in a large spray machine (Figure 7).
