Deterioration of Prestressed Concrete Beams Due to Combined Effects of Carbonation and Chloride Attack

ABSTRACT

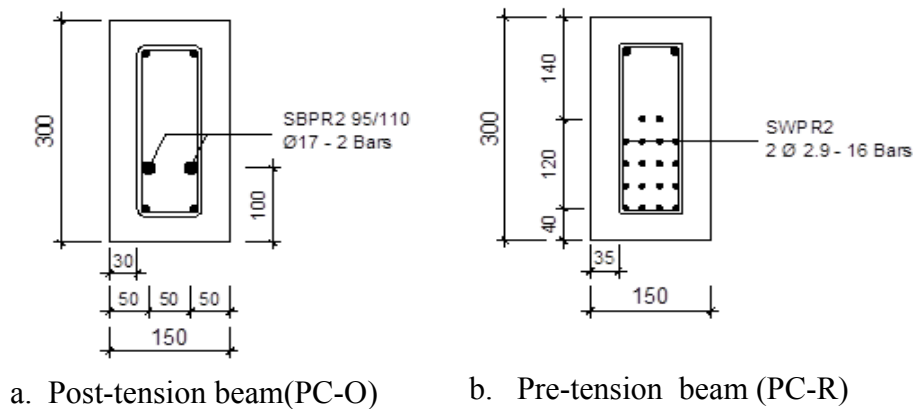
Figure 1. Cross-section of PC beams

Beam Details. A total of 4 prestressed concrete beams were taken out for tests, consisted of two beams of post-tension type (herein after abbreviated as PC-O) and two beams of pre-tension type (PC-R). All beams have the identical cross-section of 150 x 300 mm and length of 2400 mm, but bar arrangements and cover depth are varied according to the type of beam designated. Cover depth is 30 mm for PC-O beams and 35 mm for PC-R beams. Cross-section of the beams is described in Figure 1.

Prestressing tendons were round wires of $2\text{Ø}2.9$ mm in diameter for PC-R beams, and round bars of 17 mm in diameter for PC-O beams. Yield strengths were 1148 and 1795 MPa for the wire and bar respectively. Deformed bars of 10 mm diameter in the PC beams were embedded as stirrups with spacing of 100 mm.

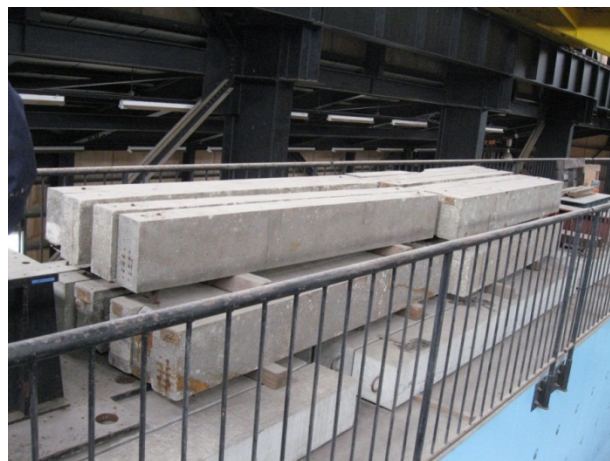
Photo 1. PC beam specimen

After 20 years of exposure, the beams were transferred to the laboratory and stored at a constant temperature over 15 years as shown in Photo 1. Then beams were taken out for laboratory tests. All tests were conducted in conformity with JIS, JSCE and ASTM.

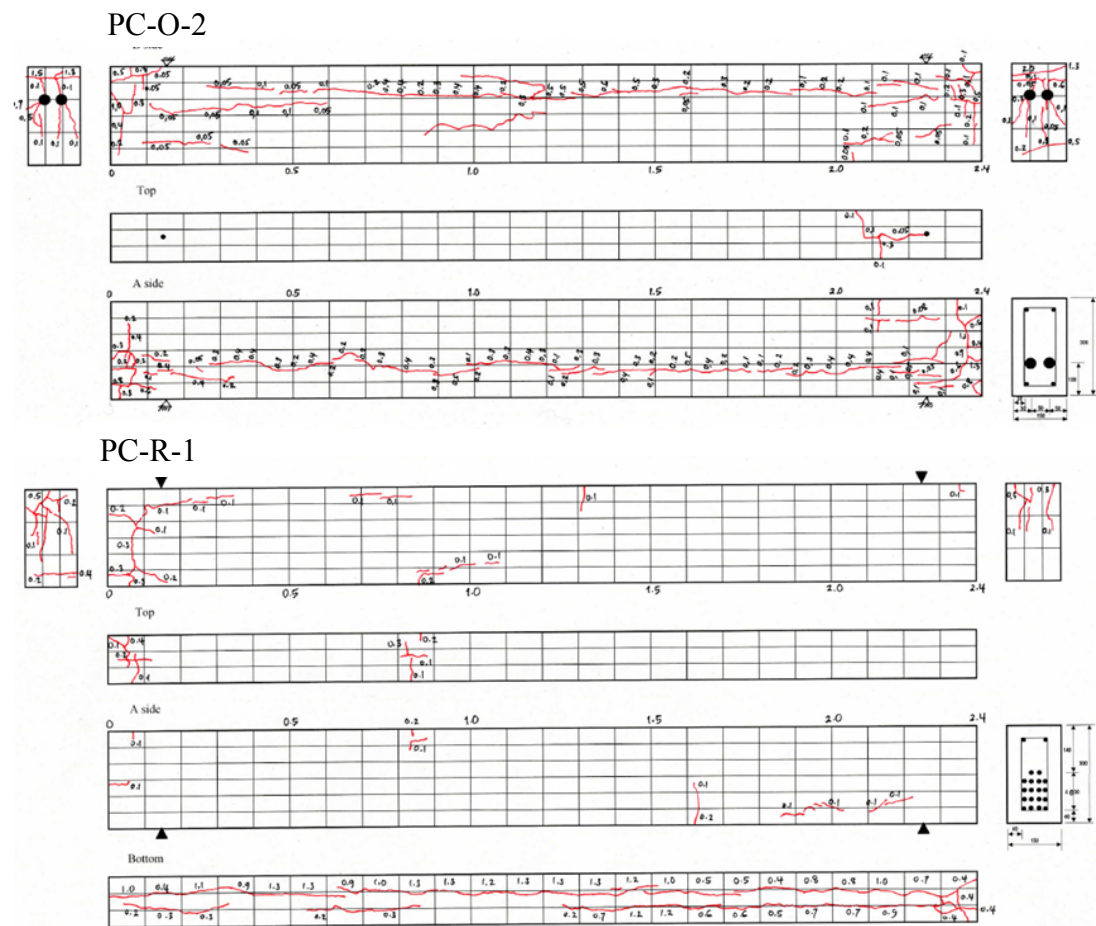
Figure 2. Appearance of beams over 35 years of exposure

Appearance of Beams. Figure 2 shows the cracking traces of beams. These figures show the side surfaces of the respective beams just after cleaned by steel brush. Uncovered aggregate were mostly found on the bottom side of beams due to seawater splashing, while rust stains commonly found at the ends of beams and in the vicinity of the cracks.

After exposed up to 35 years, all beam surfaces appeared rough surfaces, chips on the edges and a few spalling especially in PC-O beams. At the scale area, the maximum cracks width is about 1.5 mm for PC-O and 1.3 mm for PC-R. Air bubbles of 1-13 mm in diameter also appeared in each beam.

Deterioration of concrete is clearly observed from all PC beams, particularly the end parts damaged severely, and PC-O beams indicate extensive damage visually compared to PC-R beams. The result of the appearance at 20-year test, shows the maximum crack width was 0.2 mm and cracks concentrated in the ends of the beam. It seems that there was a large degradation over a period of 15 years in PC-O beams.

1. The large degradation appeared on the PC-O beams visually, with a maximum crack width of 1.5 mm, horizontal cracks along the side of beam parallel to the tendon and in the anchorage area, also spalling on the side surfaces of beams which showed that deterioration on the exterior is in progress.

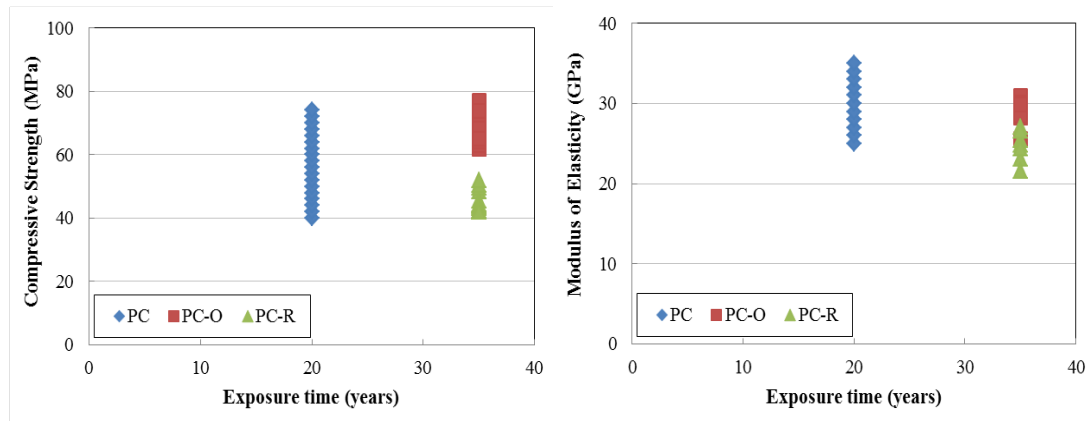
Figure 3. Compressive strength and elastic modulus

Mechanical Properties. The compressive strength and elastic modulus of concrete in 35-year test of PC beams is presented in Figure 3. Compressive strength values vary in a wide range from 42.10 to 77.03 MPa, with a coefficient of variation is 4.9. The mean value of strength is 67.8 MPa and 45.24 MPa for PC-O and PC-R, respectively. Modulus data was taken during the compression test, and their values vary from 21.6 to 30.9 GPa, with an average value of 29.1 GPa and 24.6 GPa for PC-O and PC-R, respectively. The elastic modulus losses up to 10% compared to the 20-years' data. On the other hand, the variation data for pulse velocity is low, which shall be equal to 4.30 and 4.13 km/s for PC-O and PC-R respectively, indicating good condition. The variation of the data is expected due to different shape and size of specimen test, that is in this 35 years test, small cores taken from beam were used, however, in 20 years test, Ø150 x 300 mm cylindrical specimens were used.

2. In view point of mechanical properties, test data of PC-R beams showed a sharp decrease in the compressive strength and modulus of elasticity. This is expected due to different shape and size of specimen test, in this 35 years test, small cores from beam were used, however, in 20 years test, $\text{Ø}150 \times 300$ mm cylindrical specimens were used.

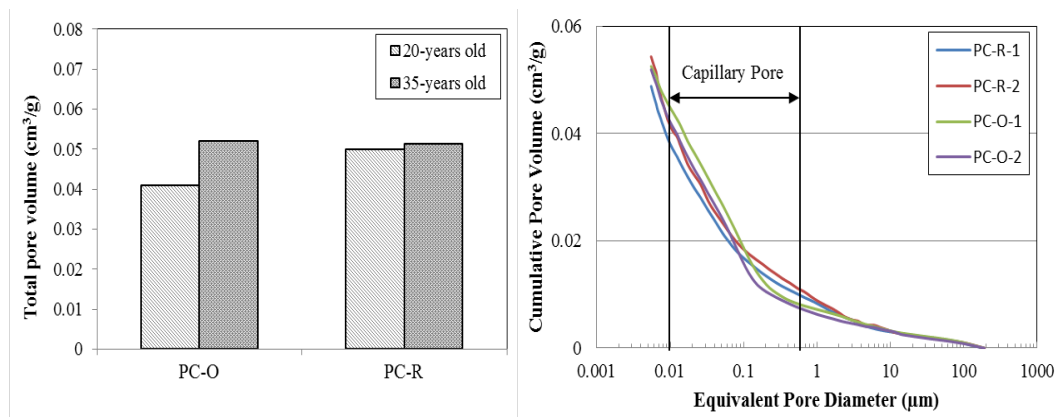
Figure 4. Total pore volume and pore size distribution

Porosity and Chloride Content. Total pore volume and pore size distributions of the mortar matrix collected at 10-20 mm depth of the specimens are shown in Figure 4. Pore size distribution in the capillary pore range exhibited the same trend for all specimens. From the view point of total pore volume, PC-R beam shows that total pore volume is similar between 20 and 35-year test, while pore volume of PC-O beams rose up 18% during 15 years. It indicates that deterioration on the exterior is in progress and may cause permanent damage to the surface of the beam.

3. The increase in total pore volume in the PC-O beams, caused chloride ions migrated easier and concentrated near the steel bar surface, and then reacted with the ferrous and hydroxyl ions to form various corrosion products.

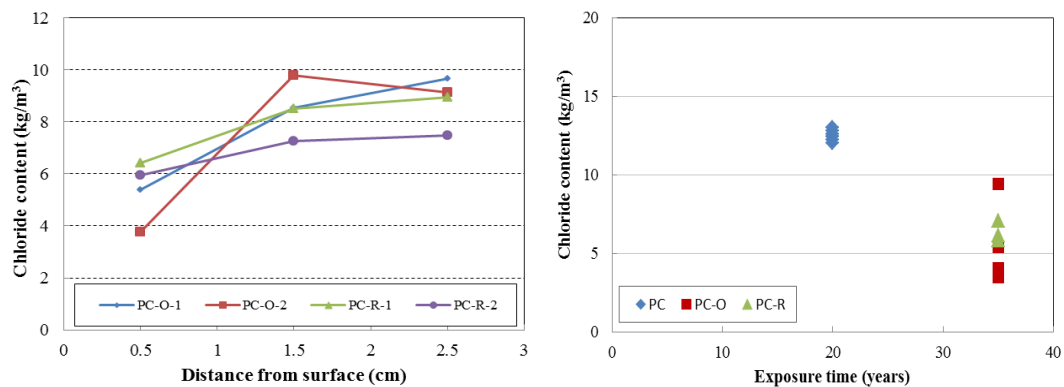
Figure 5. Chloride ion profile

Profile of chloride ion ingress into concrete for each beam was obtained from 35-year test of PC beams is shown in Figure 5. Total chloride content on the surface of concrete is lower than a certain depth from surface. It indicates that most of the chloride ions migrated and concentrated near the steel bar surface. Comparing chloride profiles of PC-O and PC-R, it is seen that the total chloride content in the surface of PC-O beams is lower than PC-R beams. Conversely, at a depth of 2.5 cm from the surface, the chloride content of PC-O beams is higher than PC-R beams. This is considered due to an increase in total pore volume, which makes chloride ions easier to migrate and reach the steel surface, thus lead to the onset of corrosion.

From 20 and 35 years' test results, chloride content in concrete of 35 years is smaller than that of 20 years. This is probably due to the effects of the size and shape of specimens. For 20 years test, $\text{Ø}150 \times 300$ mm cylinder specimens were used, however, in this 35 years test, small core of $\text{Ø}50 \times 100$ mm taken from beam were used, that is, the chloride content of cylinder specimens is much higher than beam specimens.

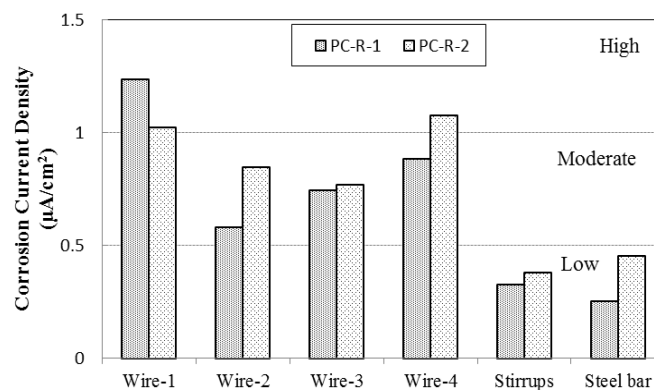
Figure 7. Interpretation of corrosion risk

The corrosion rate measured using polarization resistant represent the rate at the time of the test. The corrosion rate at a particular point in a specimen will depend on several factors, such as temperature, concrete resistivity and oxygen availability. Then corrosion rate is expressed as the corrosion current density, i_{corr} , is inversely related to the polarization resistance. Interpreting of corrosion rate measurements is described in Figure 7 based on the finding of Andrade, 1996. From this figure, it can be concluded that most of the prestressing wires and reinforcements are getting rusty with different levels of corrosion risk.

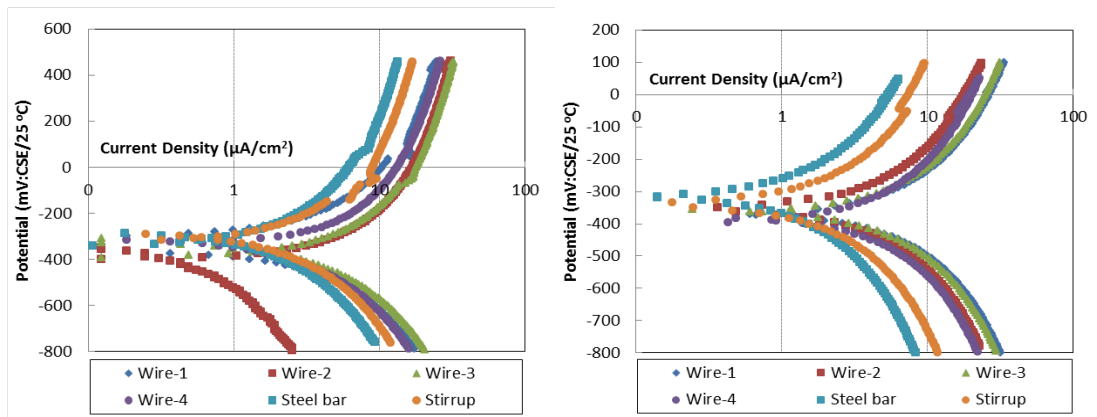
Figure 8. Anodic-cathodic polarization curve; PC-R-1 (left), PC-R-2 (right)

Polarization Curve. PC beams which were located in the tidal marine environments are a critical condition for corrosion initiation, where wetting and drying cycle favor the presence of both oxygen and chlorides. Polarization curve measurement was conducted on PC-R beams at 3 point and typical result is presented in Figure 8. This figure shows, all the reading were appropriated for extensive corrosion and they are categorized as Grade-1, except stirrups and steel bars in PC-R-2 as Grade-2. Most of the strands and stirrups had an i_{corr} value higher than $10\mu\text{A}/\text{cm}^2$ indicating that active corrosion is taking place. Only a few steel bars had an i_{corr} value less than $10\mu\text{A}/\text{cm}^2$, denoting that moderate corrosion was occurring. Corrosion initiation was accelerated by high oxygen availability. Increasing in the rate of corrosion likely occurred over the past 15 years, when beams were stored at constant

temperatures, where the presence of both chloride ions in the pores of concrete and oxygen supply was more than enough, and an ideal condition for corrosion process.

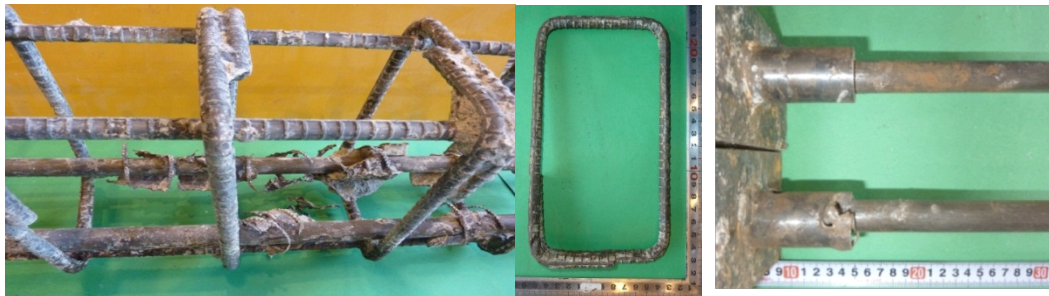
Photo 2. The state of reinforced bars of PC-O beam

Corrosion State of Pre-stressed Tendon/wire and Steel Bars. Photo 2 and 3 show corrosion state of longitudinal bars, stirrups, tendons/prestressing wire and anchorages. Most of the longitudinal bars on the tensile zone of beam suffered severe corrosion, instead, steel bars in the compressive zone show the better condition. The same pattern was also shown by stirrups, the bottom side mostly suffered quite severe corrosion while the top side remains in good condition.

The measurement of corrosion area was conducted on tendon, while for prestressing wire, length of wire corrosion was measured. Even though tendons were protected by sheath and

grouting mortar, however, corrosion area on tendon were large enough, i.e. 19.70% and 40.56% for PC-O-1 and PC-O-2 beams, respectively. This results show severe corrosion conditions for 35 years-test of posttension beams with 30 mm cover thickness. The same trend was also found in pretension beams, where the length of wire corrosion was 51.07% and 73.51% for PC-R-1 and PC-R-2, respectively. This value indicates that pre-cracked in PC-R-2 has accelerated the corrosion of reinforcing bars.
