Study on Durability and Corrosion Protection Performance of Concrete Cover Method for Port Steel Pipe Structures

Researching on corrosion protection technologies for steel pipe piles have been under operation by the exposure test using real pier in HASAKI since 1984. This paper is reporting the durability and corrosion protection performance of concrete cover method obtained from the exposure test. Deterioration of concrete cover was differed by materials and environments. Concrete cover in splash zone and marine atmospheric zone after 25 years was spalled off and fracture of reinforcing bar due to corrosion was occurred. On the other hand, concrete cover in tidal zone was sound. Despite the chloride ion concentration at steel surface in concrete was about 20 kg/m³, steel had not been corroded. It is considered that diffusion of oxygen into the concrete was limited to the level that could not generate the steel corrosion.

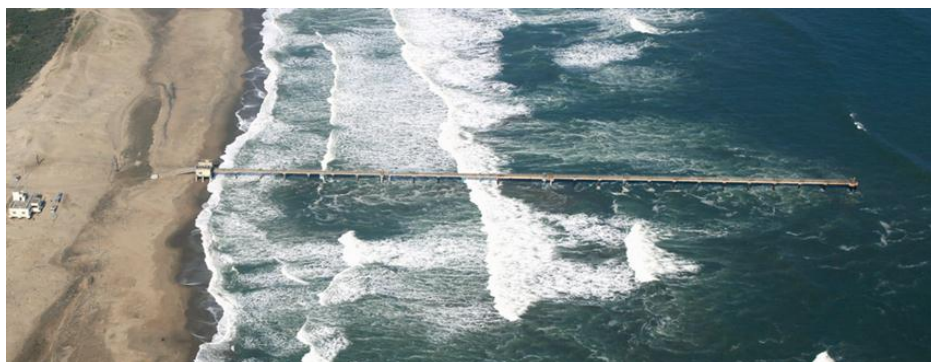
Figure 3. Bird-eye view of the HASAKI pier

HASAKI pier. HASAKI pier was built in 1985 as a research facility. This facility has been built to stick out in a direction perpendicular to the shoreline facing to the Pacific Ocean as shown in Figure 3. Total length of HASAKI pier is 427m, depth of the tip is about -5m. Exposure environment is very severe corrosive environment, prone to the action of intense waves and fast tidal current. Tide level difference is a 1.4m, and the significant wave height

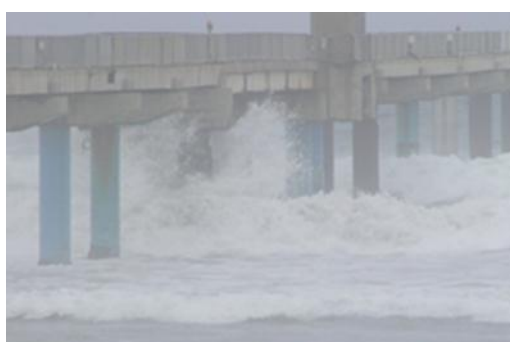
Figure 4. HASAKI pier at the time of stormy weather

is about 0 ~ 3m. At the time of stormy weather, the HASAKI pier receives the strong impact force by the wave as shown in Figure 4. And, the aerosol chloride ion concentration at the level of L.W.L.+7m is 88mg/m²/day. Therefore, it can be said HASAKI environment is very severe compared to the ordinary port environment.

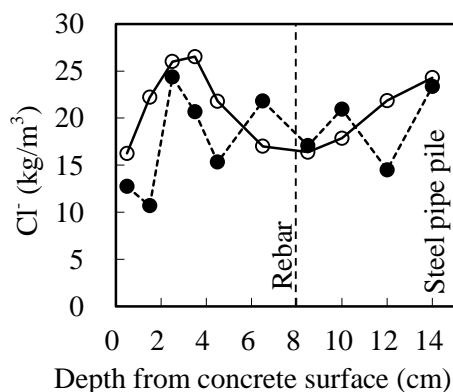
Figure 8. Chloride ion profiles (Type A, 21 years)

In Type A, a crack in the horizontal direction of 1~3mm in width was observed at a position of 20 cm from the upper side after 13 years exposure. This crack was caused by corrosion from the non-protection range of steel pipe pile, as shown in Figure 6. Therefore, in Type A, little erosion due to wave is observed, but it is considered that it has been maintained in a sound condition. However, it was suggested that in order to ensure the long-term durability, both end of the concrete cover should be surely protected. Figure 8 shows chloride ion

concentration profiles after 21 years exposure. Chloride ion concentration in concrete is very high. Therefore, it is considered that passive films of pile and rebar were already destroyed by the chloride ion. Figure 9 shows rebar in concrete of Type A after 14 years, and Figure 10 shows steel pile of Type A after 21 years. Despite high chloride ion concentration, corrosion of rebar and steel pile were not observed at all.

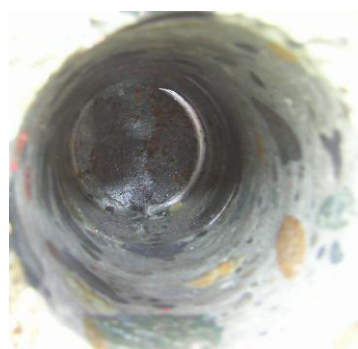
Figure 10. Steel pile of Type A after 21 years

Corrosion protection performance of concrete cover method. Steel pipe pile protected by type A was not corroded as shown in Figure 9 and Figure 10. Therefore, it is considered that steel pipe piles protected by concrete cover method in tidal zone have a high corrosion protection performance.

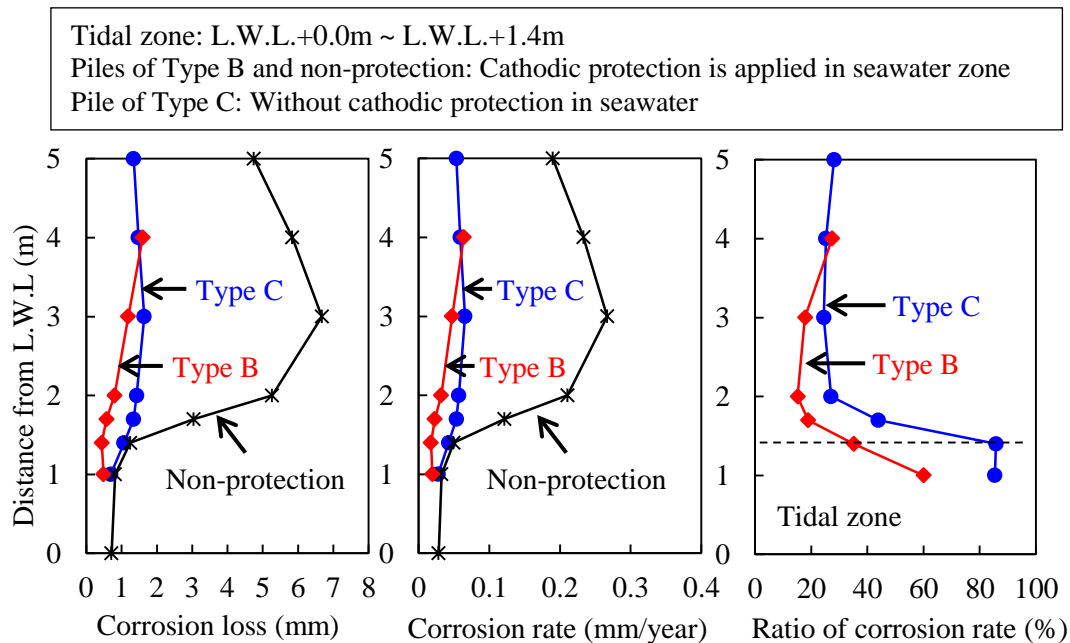
Figure 12. Corrosion loss and corrosion rate of steel pipe piles

Corrosion was observed in either case. However, corrosion loss of concrete covered pile is small compared to the non-protection piles. Corrosion of concrete covered piles in splash and atmosphere zone are decreased to 15~30%. This corrosion rate is estimated to be the same as the corrosion rate of steel in seawater protected by cathodic protection. Therefore, it is considered that concrete cover methods has a high corrosion protection performance.

The Type B showed a tendency to increase the corrosion rate with increasing the height from the sea level. On the other hand, corrosion rate of Type C was almost constant along the height from sea level. As shown in this Figure 12, corrosion rate of type B is smaller than that of Type C. This result coincides with deterioration condition of the appearance. In any case, the corrosion rates of 20~60 μ m/year is categorized as "high corrosion rate", referring to the corrosion rate of reinforced concrete. Therefore, it is estimated that high concentrations of chloride ions are accumulated on the steel surface in concrete. In future, the spalling and cracking of the concrete cover by the expansion of the corrosion products will be expected. Therefore, in order to construct the sustainable infrastructures, it is necessary to set a limit on the corrosion protection performance.
