Corrosion Monitoring of Steel Bars in Port Concrete Structures

Mitsuyasu IWANAMI^{1*}, Ema KATO², Yuichiro KAWABATA²,
Takahiro NISHIDA¹

¹ *Tokyo Institute of Technology, Japan*

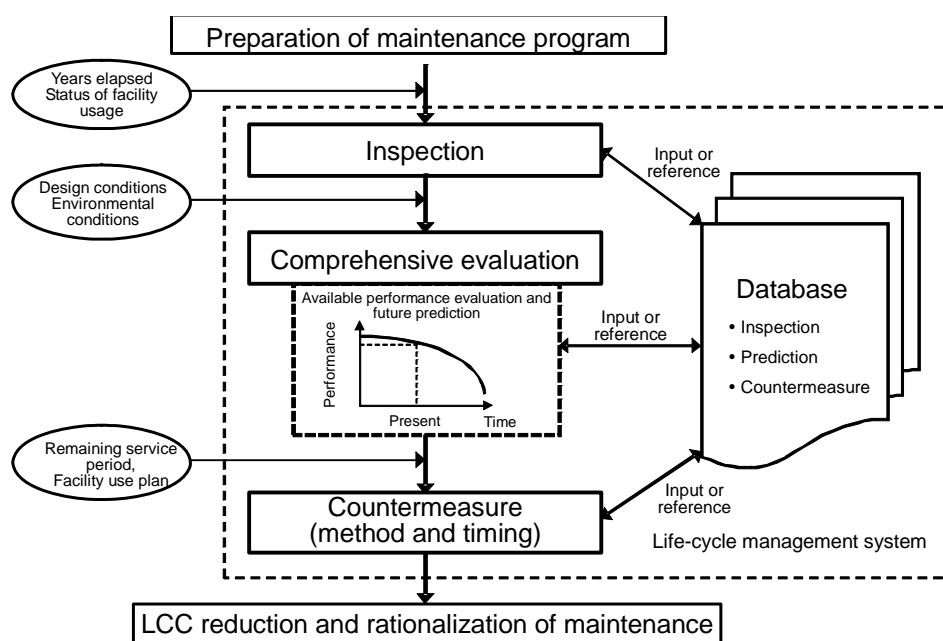
Figure 1. Flow of strategic maintenance of port facilities

For strategic maintenance of port structures, information about deterioration and deformation occurring in the structures shall be obtained from periodical inspection and real-time monitoring to assess the residual performance of the structures and also predict the future change in the performance. Based on the results of assessment and prediction, appropriate countermeasures shall be planned and executed if necessary. The flow of strategic maintenance of port structures is illustrated in Figure 1. At present, periodical inspection to port structures depends on visual observation to surface appearance of the structures. However, quantitative and reliable information is not always obtained from the periodical inspection. It is because the results of the visual observation are qualitative, and also differ inspector by inspector.

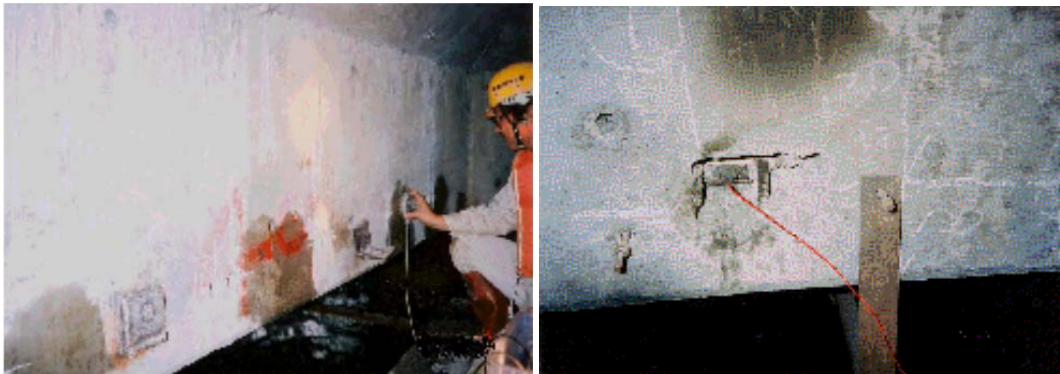
(a) Before installation

(b) Cable for electric short-circuit

(c) Pushing the sensor into the hole

(d) Completion of installation

Figure 5. Procedure of sensor installation

At 3 points on a side surface of the beam, drilling was made up to the vicinity of the measured steel bar. The diameter of drilled holes was 24mm. After fresh mortar was poured into the hole by the depth of about 20mm, the sensor was pushed into the fresh mortar so that the distance between the sensor and steel bar was about 10mm. Then, the rest of drilled hole was fulfilled with non-shrinkage mortar. Besides, a cable for electric short-circuit was directly connected with the measured steel bar after removing a part of concrete cover. Figure 5 illustrates a series of work for sensor installation.

As seen in Figure 5(b), it was confirmed that no corrosion was observed in the measured steel bar at the position of cable connection when removing the cover concrete. The cover depth of steel bar was about 130mm. The chloride ion concentration of concrete in the vicinity of the steel bar was 0.47kg/m^3 , which was measured by concrete powder obtained at drilling for the sensor installation. From this fact, it was estimated that corrosion of steel bars in this beam would be initiated in the near future, although the symptom of deterioration was not observed at the time.

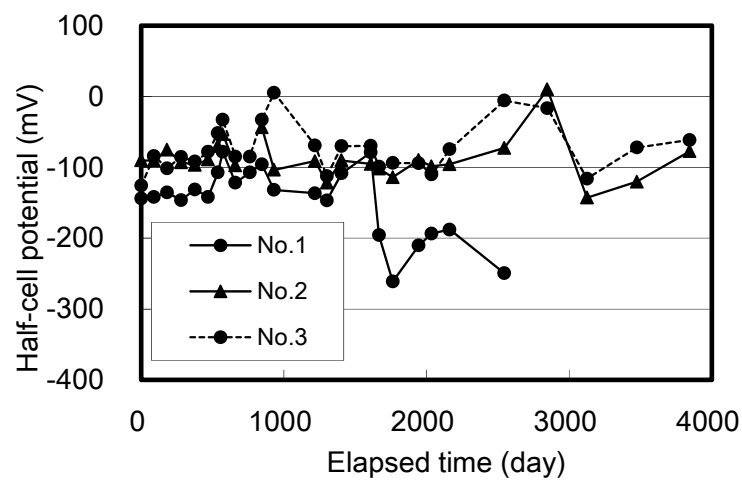
Change in Half-Cell Potential. Figure 6 shows the change in half-cell potentials measured for 10 years from the commencement of corrosion monitoring. The values of half-cell potentials in the figure were converted into the values against saturated copper sulphate electrode. No.1 to 3 in the figure indicate the positions of half-cell potential measurement; No.1 is sea-side, No.3 is land-side, and No.2 is in between. At the beginning of monitoring, half-cell potentials of the steel bar ranged between -150mV and -20mV , showing the possibility that no corrosion occurred in the steel bar according to the ASTM criteria (American Society for Testing and Materials, 1977). This agreed with the fact revealed at removal of the concrete cover, mentioned above.

However, about 5 years (about 1800 days) after the commencement of corrosion monitoring, half-cell potentials measured at No.1 shifted toward negative direction. According to the ASTM criteria, it was not clear if the corrosion started in the steel bar, while the trend of measured half-cell potentials was apparently different from those measured at other points, even considering scatters of measured half-cell potentials with time. It is well known that such a drop in measured potentials was observed in experiments where steel bar corrosion was artificially accelerated in room (Islam and Sugiyama, 2009).

Figure 6. Result of half-cell potential measurement

Scatter of Measured Values. As seen in Figure 6, it was found that measured values of half-cell potentials scattered more or less. One of the reasons for the scatter was considered

Furthermore, the range of half-cell potentials for the same temperature in air was about 50mV . It was considered that the range of 50mV was smaller than the scatter observed at the corrosion monitoring as shown in Figure 6. Therefore, it seemed that other factors than temperature existed, necessitating further researches on this matter to establish the corrosion monitoring by half-cell potential measurement.

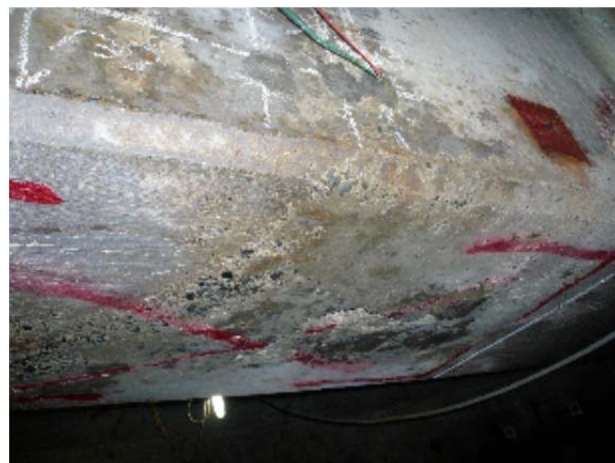
To investigate the reason for this change in the measured half-cell potentials at No.1, visual observation was carried out to the bottom surface of the beam. It was when about 2400 days passed after the corrosion monitoring started. For the visual observation, temporary scaffolds were placed under the superstructure. As a result, rust stain was observed at the bottom surface of the beam near the measuring point of No.1, as shown in Figure 7. It was considered that the change in half-cell potentials at No.1 was caused by steel bar corrosion, showing effectiveness of corrosion monitoring of steel bars in concrete by continuous measurement of half-cell potentials.

Figure 7. Bottom surface of beam near No.1

The visual observation revealed that the steel bars inside concrete of the target structure would be corroded to some extent, necessitating suitable repair to the superstructure. Consequently, the structure was repaired by cross-sectional restoration method after the contaminated concrete was removed. The concrete near the measuring position No.1 was removed for this repair, resulting in termination of corrosion monitoring at No.1. Corrosion monitoring at both No.2 and No.3 was continued even after the repair work. As seen in Figure 6, the half-cell potentials measured at No.2 and No.3 were consistent with the values before the repair work. This means that the repair work was done effectively without poor construction. It can be said that corrosion monitoring by measuring half-cell potentials of steel bars in concrete is also promising for one of construction control methods for repair work against steel bar corrosion.
