## Structural safety assessment with dynamic characteristics of prestressed concrete structures

Prestressed concrete (PC) structures are advantageous in terms of durability. However, even they deteriorate as they age. In order to enhance the assessment technology for PC bridges, affiliation of authors is jointly conducting research utilizing demolished PC bridges. This paper describes the result of dynamic measurement of an existing PC T-section girder bridge which had been used for more than 40 years. In addition, numerical analysis was conducted using FE model. In the test, ambient vibration and forced vibration induced by heavy truck or weight were measured. Comparing the higher modes, frequencies of damaged span were lower than those of fair span. In the FE analysis, dynamic characteristics were calculated with damaged span model. From the result, it was found that the effect of the fixation of supports because of deteriorated bridge shoes was much larger than that of deterioration of girders in lower modes.

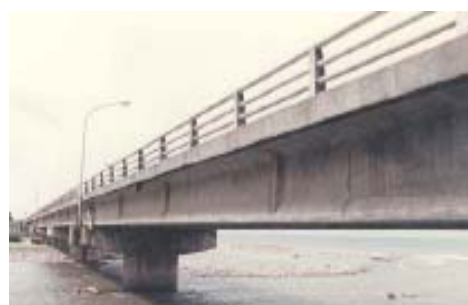
**Figure 1. PC bridge**

The structural type is a five-span simple PC T-section girder bridge. It was constructed in 1967 and served for 40 years or more. Since this PC bridge is constructed in the Sea of Japan shore, and the deterioration was severe due to the environment influenced by chloride, repairs had been performed more than once as damages of concrete or corrosion of steel were identified. However, because of confirmation of re-deterioration due to corrosion and breakage of PC wires as shown in **Figure 2**, rebuilding of the bridge was planned, and its service was terminated in September, 2010.

The outline of the PC bridge for which the vibration measurement was performed is shown in **Table 1**, and the photo is shown in **Figure 1**.

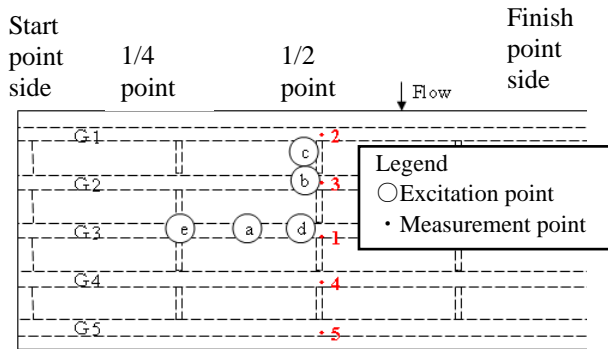
**Figure 3. Excitation point and the measurement point**

In the vibration measurement, the output signal obtained from servo-type accelerometer placed on the bridge surface was digitally converted with 1 kHz of sampling frequency after adjustment, then it was imported into a personal computer for a FFT analysis. Excitations were applied at 1/2 and 1/4 points of the span on the G3 girder, and measurements were performed at points that divide the G1 and G5 girders equally into 8 segments. (Shown in **Figure 3**) The measurement condition is shown in **Figure 4**.

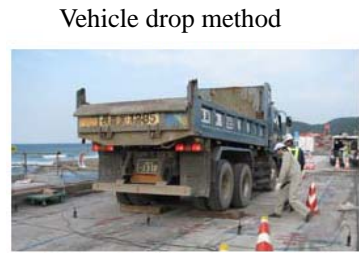
**Figure 4. Excitation methods**

**Vehicle drop method**

**Weight drop method**

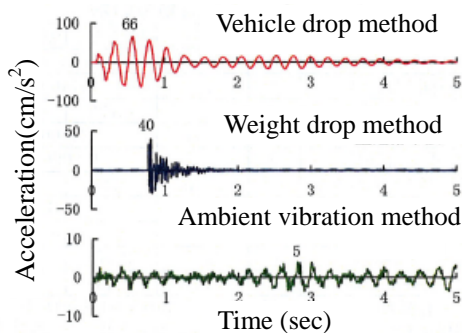
**Figure 5. Measured wave forms**

Examples of accelerograms obtained in the vibration test performed by using vehicle drop method, weight drop method, and ambient vibration method are shown in **Figure 5**. The Figure shows results obtained in the Span 1 with excitation point located at 1/4 point of the span and measurement at 1/2 point of the G3 girder span. The oscillatory waveform shown in **Figure 5** confirmed peaks 4 ~ 5 times in a second by the vehicle drop method and the ambient vibration method. Vibrations with shorter cycles were confirmed in the weight drop method.

In **Figure 5**, the maximum acceleration measured in the vehicle drop method indicated the largest value ( $66 \text{ cm/s}^2$ ), followed by those in the weight drop method ( $40 \text{ cm/s}^2$ ) and the ambient vibration method ( $5 \text{ cm/s}^2$ ), in descending order. The spectrum graph obtained by FFT analysis based on the waveform data in **Figure 5** is shown in **Figure 6**.

Note) The results of measurement performed with excitation point "e" and measurement point "1" in the 1st. span is shown. Numeric values in the figure indicate the maximum acceleration.

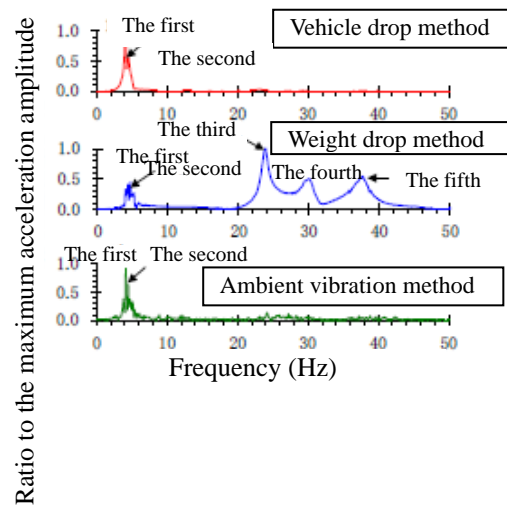
**Figure 6. Measured spectra**

As shown in **Figure 6**, dominant frequencies have been concentrated in the range of 4 Hz ~ 6 Hz in the vehicle drop method and the ambient vibration method. Additionally, dominant frequencies in the range of 20 Hz ~ 40 Hz were confirmed in the weight drop method. In **Figure 6**, the dominant first frequencies measured in the weight drop method indicated the largest value (4.3 Hz), followed by those in the vehicle drop method (4.2 Hz), and the ambient vibration method (3.8 Hz), in descending order.
