Study on Alumina cement based sulfuric-acid-resistant mortar

Ube Industries, Ltd. and the Japan Sewage Works Agency have jointly developed sulfuric-acid-resistant mortar, which eliminates corrosion and prevents coating with resin. The authors focused on alumina cement and special aggregate, which have superior sulfuric-acid resistance and promoted the development of sulfuric-acid-resistant mortar using such materials. They confirmed that such mortar has excellent basic properties in addition to sulfuric acid resistance. To confirm the workability and durability of sulfuric-acid-resistant mortar when used in an operating sewerage facility, the mortar was tested by repairing the wall of intermediate slab in a sewerage manhole under a corrosive environment. It was found that the mortar's workability (and its basic performances as mortar) was as good as that of general-purpose repairing mortar. It was also confirmed that the area where sulfuric-acid-resistant mortar was applied still maintains excellent durability even in a follow-up survey conducted eight years after the test construction.

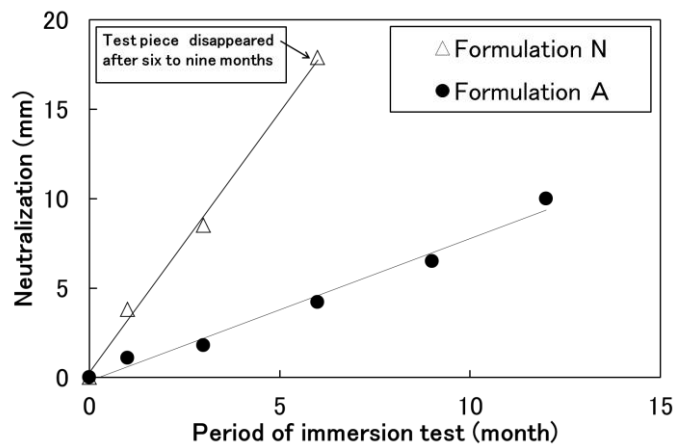
The sulfuric acid immersion test: The measurement results for neutralization after sulfuric acid immersion test are shown in Figure 1. For Formulation N, the specimen itself disappeared after six to nine months of immersion. In contrast, the neutralization of sulfuric-acid-resistant mortar after 12 months of immersion in Formulation A was 10.0mm, and that corrosion by sulfuric acid was suppressed. This was caused by calcium hydrate, a factor in the corrosion of hardened cement paste by sulfuric acids, not being generated when alumina cement is used and by it having higher acid neutralizing capacity than Portland cement.

Figure 1. Neutralization after sulfuric acid immersion test

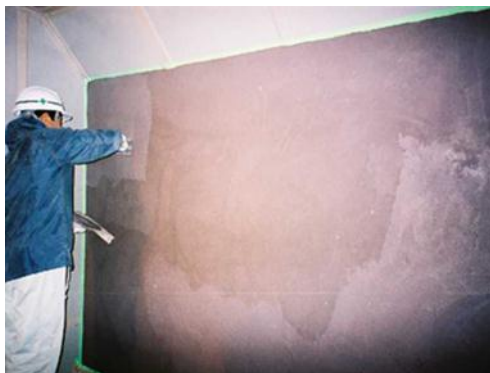
Situation of repairing. Photo 1 shows the application of sulfuric-acid-resistant mortar by trowel. We were able to complete the construction work from mixing to application without delays and without problems such as roughness, cracks, or peeling. As a result, we were able

to complete the construction on schedule as planned initially. Furthermore, the hardening was excellent condition and did not influence the construction work on the following day.

Photo 1. Application of sulfuric-acid-resistant mortar

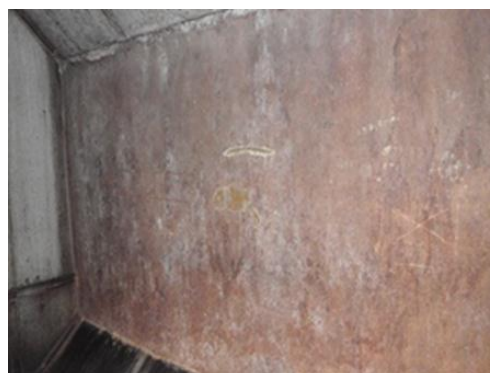
Visual inspection of the repaired parts: Photo 2 shows the repaired parts in eight years after the test construction. A visual inspection revealed discoloration of the wall surface (to brown) that changed properties of the surface of mortar. However, examination by touch and

Photo 2. Repaired parts in eight years after the construction

percussion with a test bar confirmed that the internal parts were strong, even though the surface was soft. Furthermore, no harmful cracks or peeling were detected in the repaired parts. In the photo, the trace of the sample collection and the trace of marking at the time of sample collection remain on the wall surface. Therefore the wall surface discolored because sulfuric acid generated on a resin sheet lining section of the ceiling concentrated and then dropped along the slant of the ceiling. Resin sheet lining has very high anti-corrosion performance. For this superior performance, it is considered that generated sulfuric acid is not neutralized and remains on the resin sheet lining. On the contrary, all of the mortar for Formulation N, placed at the field site for comparison, had changed into gypsum and disappeared by the second-year follow-up survey.

3. Based on a visual inspection of the repaired parts in 8 years after the construction, the inside was strong and no harmful cracks or peeling were detected, although the surface was discolored.

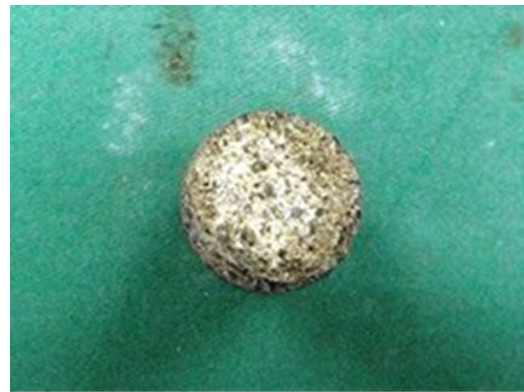
Visual inspection of core samples: Photo 3 shows a core specimen sprayed with phenolphthalein solution; Photo 4 shows the surface of the core specimen. As seen in Photo 3, the core specimen was approximately 40mm long in the depth direction. The sulfuric-acid-resistant mortar part was approximately 25mm long, and the original concrete part was approximately 15mm long. Sulfuric-acid-resistant mortar was initially applied with a thickness of 20 to 25mm depending on the unevenness of chipped original concrete surface. These facts suggest that the sulfuric-acid-resistant mortar was hardly affected by corrosion.

In confirming the neutralization with phenolphthalein, the whole side surface was colored purple-red by phenolphthalein, indicating that both the sulfuric-acid-resistant mortar and the original concrete were sound with no neutralization. The surface of the core specimen discolored and became whitish due to corrosion by sulfuric acid derived from microorganisms. However, the discoloration by phenolphthalein over the whole core suggests that only the surface layer was corroded by sulfuric acid.

Photo 4. Surface of the core sample
