Evaluation and Observation of Autogenous Healing Ability of Bond Crack along Rebar

Choonghyun KANG^{1*}, Minoru KUNIEDA², Takamasa KANO²,
Naoshi UEDA² and Hikaru NAKAMURA²

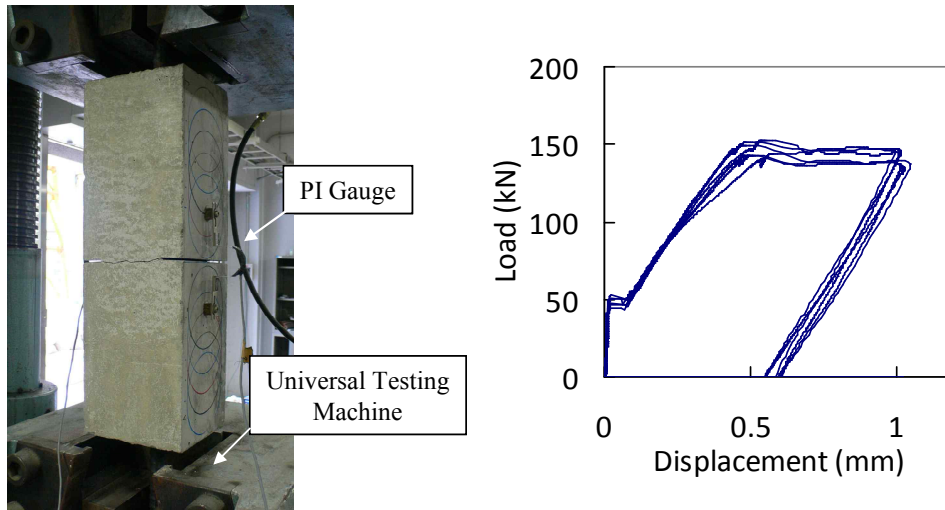
Figure 6. Experimental setup and load-displacement relationship

All specimens were demoulded at 24 hours after casting, and cured in 20°C water condition. The pre-cracking test was performed at 28 days of age, and recuring period was 28 days after the pre-cracking test. Loading was controlled by crack opening displacement, which was measured by two PI gauges attached on the specimen surface over the induced notches. Figure 6 shows the experimental setup and load-displacement relationship.

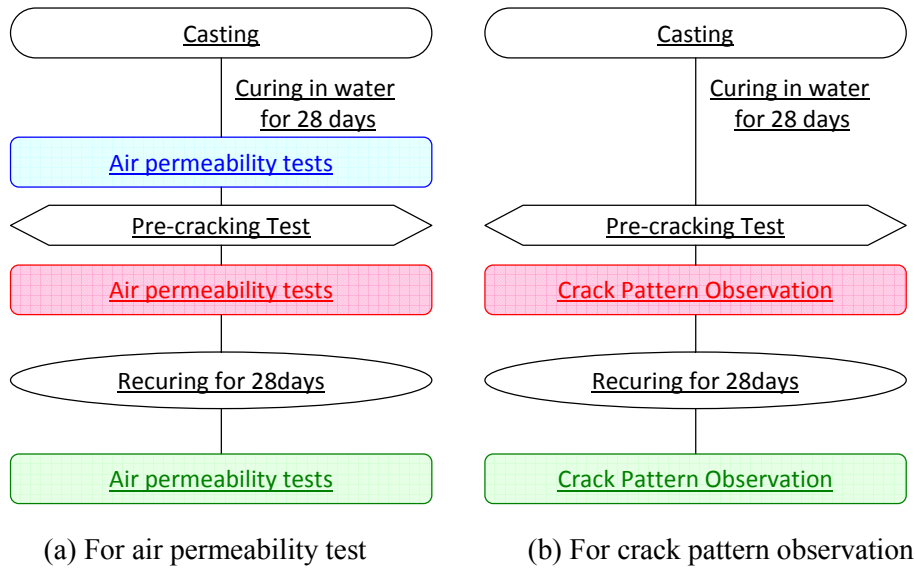
Figure 7. Experimental procedures

There were three specimens for air permeability test. After the pre-cracking test, one specimen was recured in air condition in curing room (20°C and RH 70~80%). Other two specimens were recured in water condition in 20°C. By comparison with air and water recuring condition, more appropriate circumstance for autogenous healing could be investigated.

Another three specimens were prepared for crack pattern observation. Crack pattern observation was performed just after the pre-cracking test, firstly. Other two specimens were recured after the pre-cracking test in air and water condition respectively. After the recuring, the effect of autogenous healing was investigated by each crack pattern observation.

Figure 7 illustrates the outline of the experimental procedures schematically.

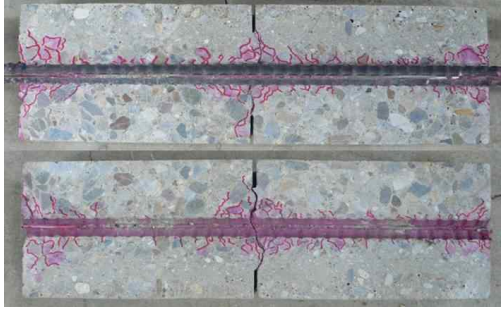
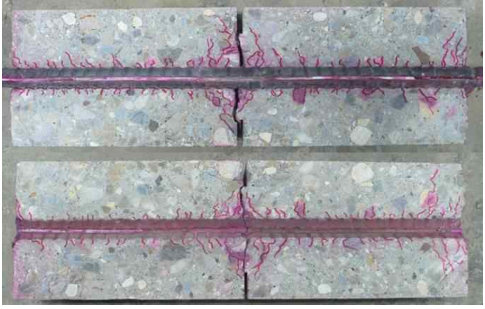
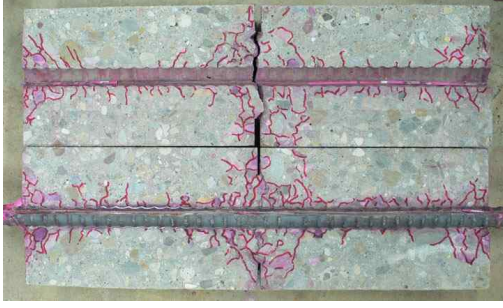
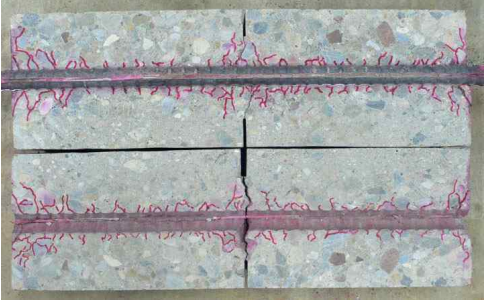
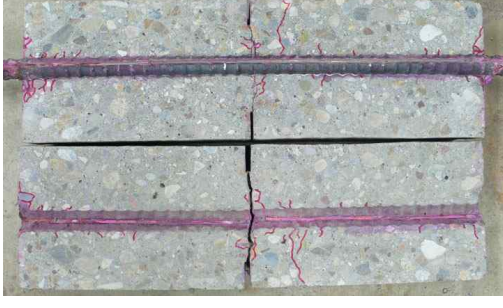
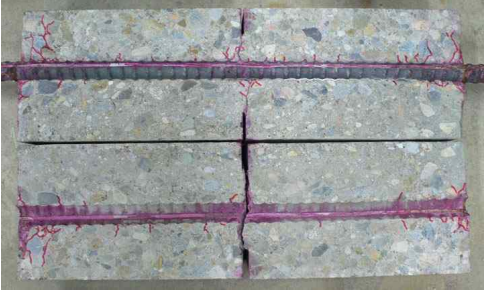
Table 2. Observed crack patterns

Recurring effect was more visually provided by crack pattern observation. Table 2 shows the dyed crack pattern of each specimen. After the pre-cracking test, small cracks with length of less than 2mm were observed near rebar. Regarding different concrete, a few cracks were observed after water recurring. It seems that generated products due to autogenous healing filled the micro cracks, and it also influenced air permeability coefficient. However, the observed crack pattern with specimens recurred in air condition was similar to that just after the pre-cracking test. It means that autogenous healing in air condition was less effective than water condition.

Although air permeability coefficients showed lower values with fly ash concrete than normal concrete, it is difficult to find significant different in crack patterns between normal concrete and fly ash concrete. It can be reason that air permeability coefficient is more sensitive than observation by the naked eye.

Normal concrete	Fly ash concrete
After pre-cracking

Recurring in air condition

Recurring in water condition

- 3) Crack pattern observation provides visually to reduce air permeability coefficient after recovery by autogenous healing. The deterioration degree of bond cracks was investigated by crack pattern observation just after the pre-cracking test, and recovery effect was also observed after the recuring. A little cracks was observed with recuring in water condition, on the other hand, crack patterns with recuring in air condition were almost the same with those just after the pre-cracking test. With results of air permeability test, it indicated that recuring in water condition is more appropriate circumstances for autogenous healing ability.
