Chemical Deterioration of Hardened Cement Pastes Immersed in Calcium Chloride Solution

Hiroaki Mori¹, Ryuichiro Kuga¹, Shoichi Ogawa¹ and Yoshimori Kubo²

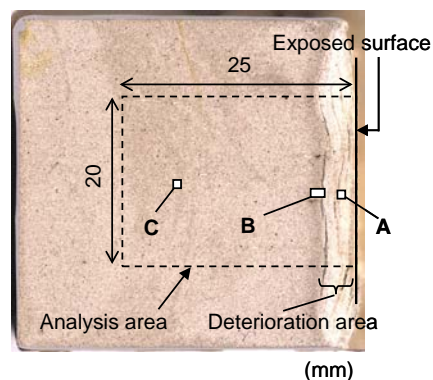
Figure 1. Analysis area by EPMA

immersed surface. The characteristic X-rays of Cl, Si, Ca and S were simultaneously measured by 5 wavelength-dispersive spectroscopy detector channels. Analytical conditions were 15 kV accelerating voltage, 50 nA beam current, and 50 μm pixel size. Also, three small areas (A, B, C) of the specimen were analysed precisely; A was the damaged area near the exposed surface, B was next to the damaged area and C was the area not penetrated by Cl. Analysis area was 0.4mm x 0.4 mm or 0.4 mm x 0.8 mm. Figure 1 shows the analysis areas by EPMA.

Figure 8 shows the back scattered electron image and four elements' concentration profiles on position A shown in Figure 1. There were several cracks which were parallel to the immersed surface and the cracks were filled with high luminance substances.

Figure 9 shows four elements' concentration profiles on position B and C shown in Figure 1. Cl concentration on B, which is nearly 7 ~9 mass%, is significantly larger than the amount of bound chlorides in hydrated cement pastes that is estimated at about 1.5 mass% in the case of immersion in high concentration of chloride solutions. It may be concluded that a large amount of chloride ions are concentrated in pore solutions of cement pastes.

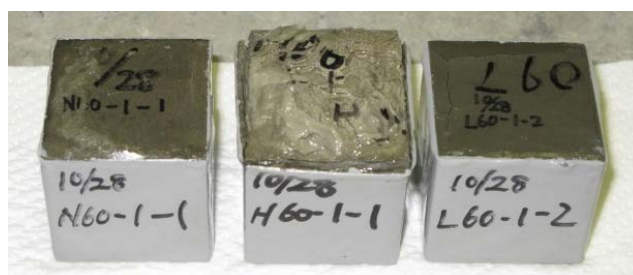
Photo 1. External appearances after 12 weeks (OPC60, HPC60 and LPC60)

Photo 1 shows the external appearances of OPC60, HPC60 and LPC60 immersed in CaCl_2 solutions at 5 °C for 12 weeks. Photo 2 shows their external appearances after continuous immersion for one year without exchanging the solution. HPC60 subjected to CaCl_2 exhibited the greatest degree of damage. After 12 weeks of immersion, the exposed surface swelled and spalled, and the deteriorated area consisted of a laminated structure composed of cement paste layers. For OPC60 comparable deterioration was observed with several millimetres spalling on the immersed surface after one year. LPC60 was the least damaged among three specimens and showed a little spalling and cracking on the exposed surface.

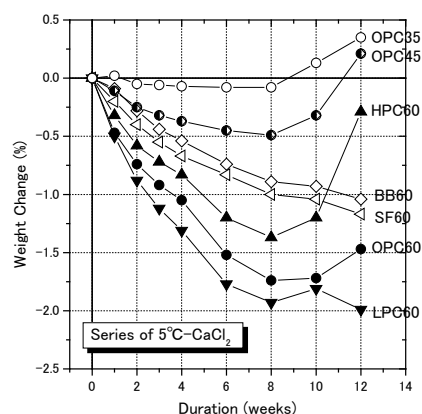
Figure 2. Weight change

Weight Changes. Figure 2 and Figure 3 illustrate weight changes of specimens during immersion tests. Figure 2 shows weight changes of all specimens immersed in CaCl_2 solutions at 5 °C and Figure 3 shows weight changes of OPC60 and BB60 subjected to different immersion conditions. The weight of specimens immersed in CaCl_2 decreases

gradually up to about 8 weeks, after which surface spalling and cracking are observed, as well as an abrupt increase in weight. BB60 and SF60 immersed in CaCl_2 and all specimens subjected to wet-dry cycles exhibited no weight gain throughout the immersion tests. On the other hand, all specimens immersed in saturated NaCl experienced a steady weight gain which became constant after 10 weeks.

The time at which weight gain begins corresponds exactly with occurrence of surface spalling and cracking. Therefore, it is considered that the weight gain in specimens immersed in CaCl_2 is mainly caused by the penetration of solutions into the surface deteriorated area. However, reasons for the weight loss of specimens immersed in CaCl_2 are not fully understood.

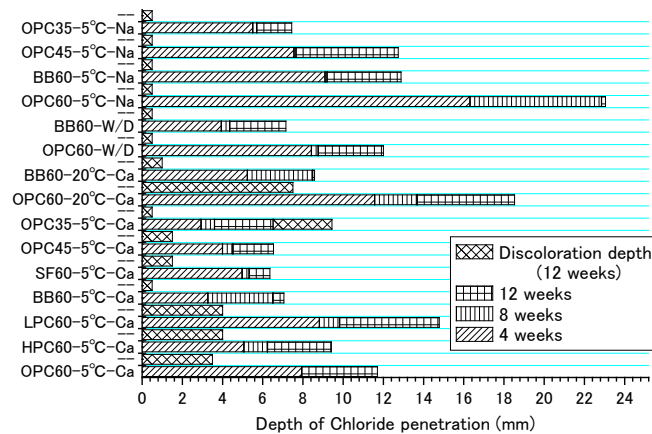
Figure 4. Depth of chloride penetration

Chloride Penetration Depth. Figure 4 shows chloride ion penetration depths of each specimen after immersion for 4 weeks, 8 weeks and 12 weeks and discoloration depths before spraying a 0.1 mol/L AgNO_3 solution. The chloride ion penetration depth of specimens immersed in 5 °C CaCl_2 increases in the order, HPC60, OPC60 and LPC60. The penetration depth at 12 weeks of blended cement pastes such as BB60 and SF60, and of lower W/B specimens such as OPC45 and OPC35 were lower than that of HPC60 or OPC60. In this study the penetration of the chloride ion at 20 °C are earlier than that at 5 °C and the rate of chemical deterioration due to CaCl_2 was accelerated. Discoloration depth does not necessarily correspond to the chloride penetration depth. It would appear that the final degradation degree of specimens depends on whether cracks occur on the exposure surface.

In immersed condition of W/D, discoloration or deterioration near the exposed surface was not observed while the chloride penetration depth was almost the same as that of continuously immersed specimens in 5 °C CaCl_2 solutions. There are several of interpretations of the effect of wet-dry cycles on deterioration of specimens. Some

In all specimens the chloride ion penetration depths in NaCl solutions were greater than in CaCl_2 solutions.

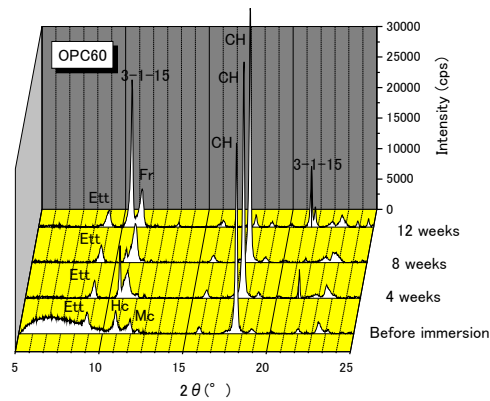
Figure 5. XRD patterns of OPC60

Reaction Products. Figure 5 shows the X-ray diffractograms of OPC60 immersed in CaCl_2 solutions at 5 °C while those of BB60 are shown in Figure 6. Each figure illustrates four diffraction patterns of pastes before immersion, after immersion for 4 weeks, 8 weeks and 12 weeks. Ettringite (Ett), Calcium aluminate mono carbonate hydrate (Mc), Calcium aluminate hemi carbonate hydrates (Hc) and Calcium hydroxide (CH) were observed in OPC pastes before immersion.

For OPC60 immersed in CaCl_2 solutions, the diffraction peaks of Mc and Hc disappeared and other diffraction peaks of Friedel's salt (Fr) and $3\text{CaO} \cdot \text{CaCl}_2 \cdot 15\text{H}_2\text{O}$ newly appeared. After immersion for 12 weeks, 3-1-15 phase's peaks became clear and the intensity peaks of CH decreased significantly. Friedel's salt generated from Mc or Hc by replacing CO_3^{2-} with Cl^- and CH was consumed with formation of $3\text{CaO} \cdot \text{CaCl}_2 \cdot 15\text{H}_2\text{O}$ phase. For BB60 the diffraction peaks of $3\text{CaO} \cdot \text{CaCl}_2 \cdot 15\text{H}_2\text{O}$ were not confirmed while the peaks of Friedel's salt appeared. In some literature 3-1-15 phase's peaks appeared in mortar with 40 % blast furnace slag. The amount of $\text{Ca}(\text{OH})_2$ in BB60 is lower than that of OPC60 and the depth of chloride penetration is also small. So the formation of 3-1-15 phase may be limited near the immersion surface.

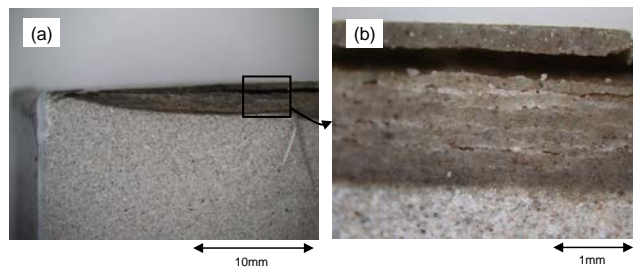
Photo 3. Damaged area near the surface

Analysis of Damaged Parts. Photo 3 (a) and (b) showed a cross section of OPC60 immersed in CaCl_2 at 20°C for 8 weeks and enlarged part of the damaged area. The area from the immersed surface to a depth of 5 mm discoloured into black. The damaged parts consisted of cement paste layers which were about 0.2 mm in width and were significantly softened as if the parts were easily ground down by hands.

For the above samples the XRD analysis was conducted and it was observed that the peaks of Friedel's salt (Fr) and $3\text{CaO} \cdot \text{CaCl}_2 \cdot 15\text{H}_2\text{O}$ phase appeared

distinctly and the peaks of CH decreased significantly. It would appear that the amount of $3\text{CaO} \cdot \text{CaCl}_2 \cdot 15\text{H}_2\text{O}$ is very large.

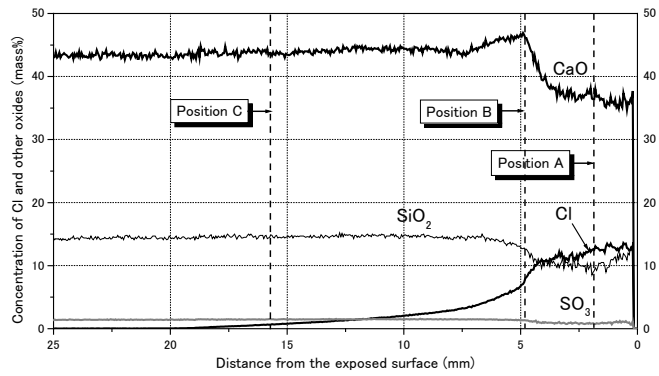
Figure 7. Concentration profile of 4 elements

Figure 7 shows the four elements' concentration profiles which are made from the results of wide spread area analysis by EPMA. At depths not greater than 5 mm Cl concentration is about 10 mass% and other oxide (CaO, SiO_2 and SO_3) concentrations are lower than those inside. However, only the CaO concentration at a depth of approximately 5 mm is higher than that inside.

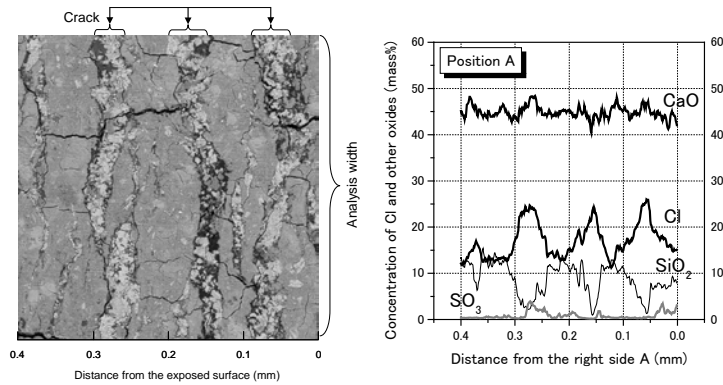
Figure 8. BSE image and concentration profile

According to the above results of XRD analysis the substances were considered to be $3\text{CaO} \cdot \text{CaCl}_2 \cdot 15\text{H}_2\text{O}$ phase. Cracks occurred at even intervals of 100 μm to 150 μm and the damaged parts seemed to be laminated structures consisting of cement paste layers and 3-1-15 layers alternately.

From Figure 8 it can be stated that inside a crack observed in the back scattered electron images Cl concentration is high and SiO₂ concentration is very low. The Cl/Ca mole ratio inside a crack is calculated to be 0.8. This result indicates that 3CaO · CaCl₂ · 15H₂O (Cl/Ca=0.5) coexist with chemical compositions of CaCl₂ solution (Cl/Ca=2.0).

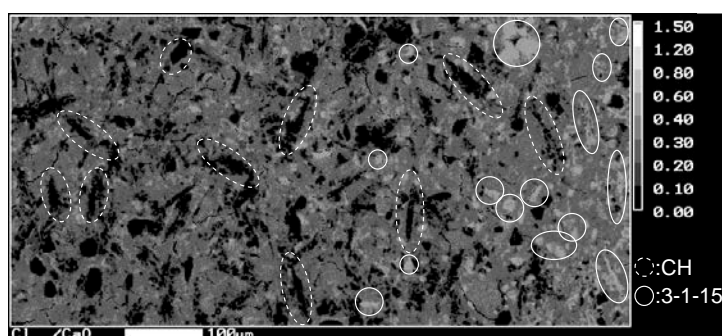
Figure 10. Mapping of Cl/Ca ratio (Analysis area B)

Figure 10 shows a mapping of Cl/Ca mole ratio on position B. Since there are cracks next to the analyzed area, the right side of position B was directly affected by the concentrated CaCl₂ solutions. At depths not greater than 100μm from the right side there exists several small parts with about 0.5 to 0.6 of Cl/Ca dispersedly. In view

of the Cl/Ca mole ratio it is likely that 3CaO · CaCl₂ · 15H₂O was formed in the small part. Because the shape of 3-1-15 phase's formation parts is similar to that of calcium hydroxide's precipitation, 3-1-15 seems to be formed substituting for Ca(OH)₂ in cement pastes.
