Life Cycle Cost of Road Bridges Affected by Salt Attack on the Sea of Japan Coast in Niigata Prefecture

Yasushi Tanaka^{1*} and Kyuichi Maruyama¹

¹*Nagaoka University of Technology, Japan*

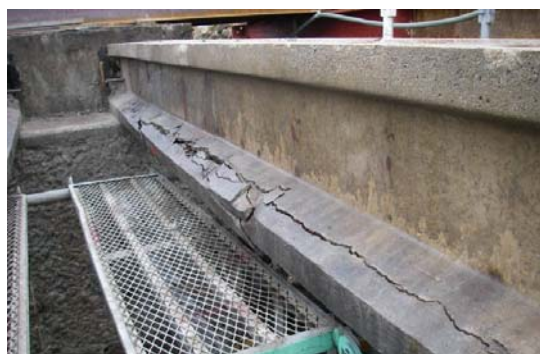
Figure 1. PC bridge beam affected by salt attack in Niigata Pref., Japan (constructed in 1975)

Concrete bridges constructed in coastal regions of Japan in the 1960s and 1970s have deteriorated as a result of salt attack as shown in Figure 1 (Tanaka, 2012). In this process, high concentrations of chloride ions accelerate the corrosion of reinforcing materials inside concrete structures.

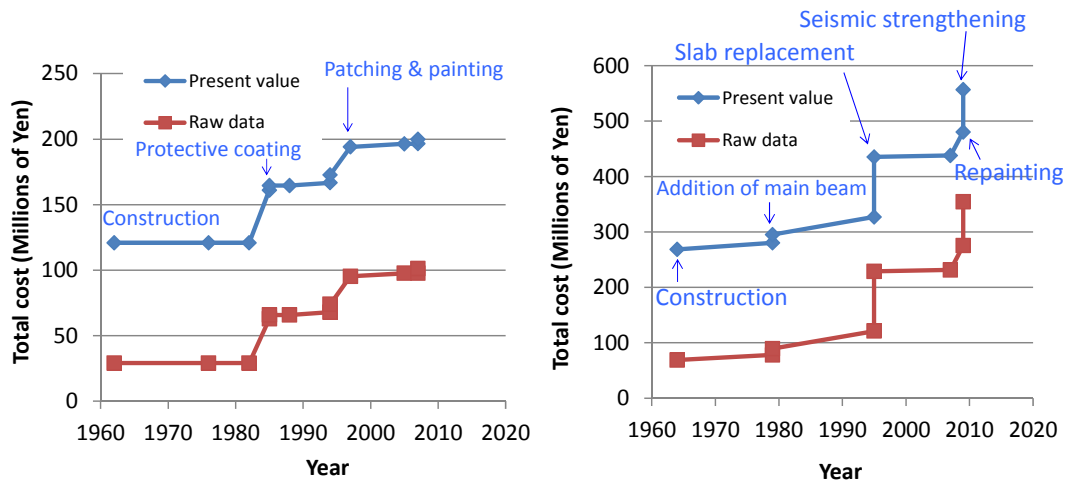
Figure 4. Examples of cumulative cost

Figure 4 shows examples of the total cost/time relationship. The red line indicates the cumulative raw cost, while the blue line represents the cumulative present value. Obviously, the initial cost is underestimated if the raw cost is cumulative. Bridge E located near the coast was first repaired about 20 years after construction due to salt attack. Patching and painting repair was conducted 10 years later due to re-deterioration, and as of 2012 the structure was again in a state of deterioration. The total cumulative repair cost stands at more than half the initial cost. The total cost for the inland Bridge P is about twice the initial cost, and no degradation was observed. This is because regulations on live and seismic loads were changed in the 1990s, and slab replacement and seismic strengthening were conducted as a result.

(a) Bridge E (a PCT girder bridge near the coast, Length = 76.8 m, width = 7.8 m, 3 spans)

(b) Bridge P (a steel girder bridge far from the coast, Length = 72.4 m, width = 10.2 m, 2 spans)

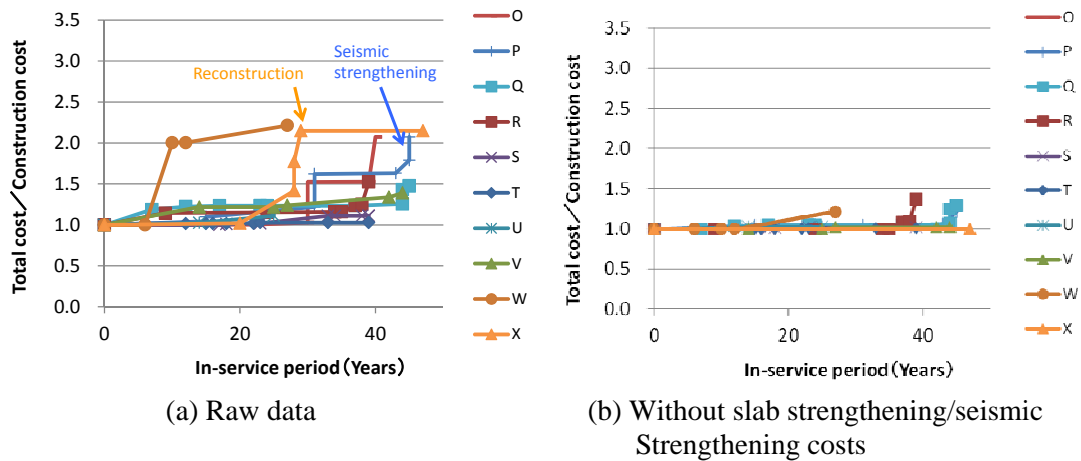
Figure 5 (a) shows changes in the total cost of steel girder bridges located more than 500 m from the coast. Here, the total cost is divided by the initial construction cost to allow intercomparison. As mentioned above, the total cost of steel girder bridges includes investment related to slab strengthening and seismic strengthening. In Figure 5 (b), the costs of these two types of strengthening to increase loading capacity are not included in the total because they are not related to chloride deterioration. As most bridges have not been repaired (except for periodical repainting), the total cost is low for all structures. It is clear that a distance of 500 m from the coast is enough to avoid salt attack in Niigata Prefecture.

Figure 5. Changes in total cost of steel girder bridges (more than 500 m from the coast)

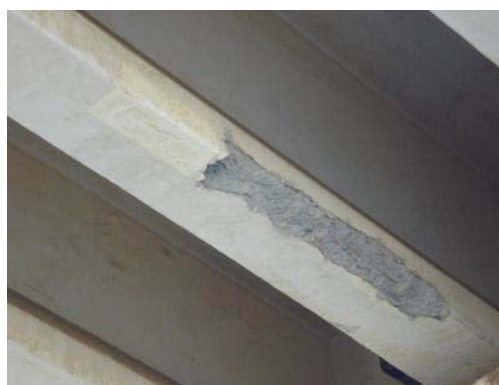
(a) Bridge C (7 years after last repair)

Figure 7. Re-deteriorated PC bridges in Niigata Pref.

Figure 7 shows re-deteriorated concrete bridges on the coast in Niigata Prefecture. These structures were repaired with patching and painting several years before the photos were taken, but the repair was clearly ineffective. As re-deterioration occurs periodically, the total cost continues to increase after patching repair as shown in Figure 6.

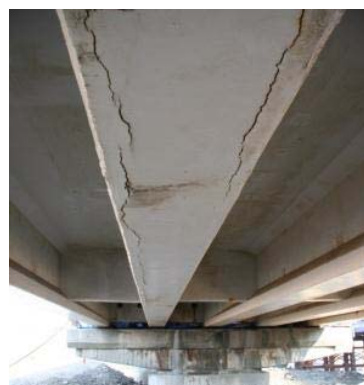
(b) Bridge G (2 years after last repair)

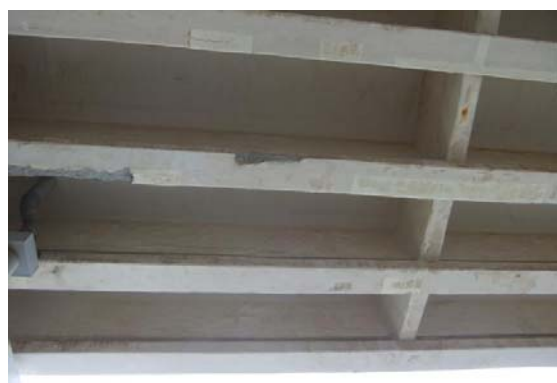
(a) Patching and painting work (7th span)

Figure 8. Repair methods for Bridge C

Two repair methods were used on Bridge C. As shown in Figure 8 (a), patching and painting were applied to all spans except the eighth one, which was repaired using cathodic protection. The total costs of each span are compared in Figure 9. Cathodic protection was applied 23 years after construction, and although this method costs more than patching and painting,

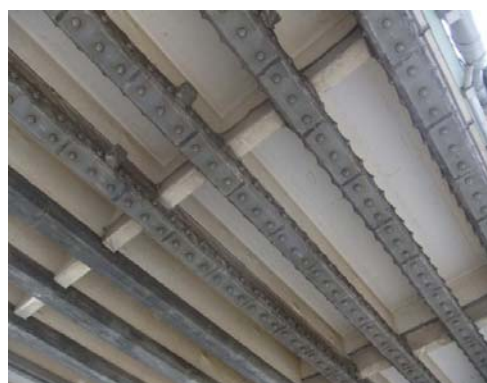
(b) Cathodic protection (8th span)

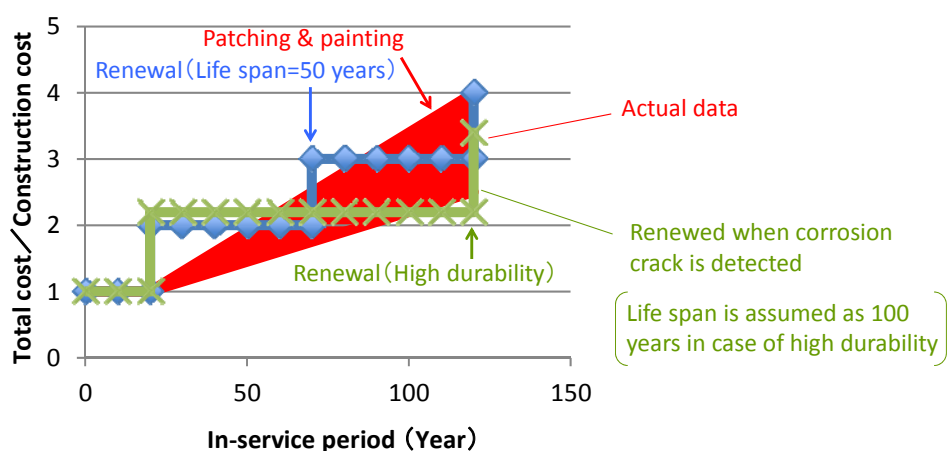
Figure 11 compares patching/painting and renewal in terms of LCC for a post-tensioned PC bridge. Based on actual data, chloride deterioration is assumed to start 20 years after construction. If the bridge is renewed when corrosion cracking is detected, the total cost becomes similar to that of patching repair. As residual strength is reduced if patching repair is repeated several times, the bridge should be renewed within several decades when such repair is applied. As a result, the total cost of patching and painting is higher than that of renewal. Replacement to create a highly durable bridge reduces LCC in the long run because this durability will account for only a small percentage of the construction cost. Ideally, post-tensioned PC bridges should be replaced as soon as possible. Although renewal places a heavy cost burden on the administrator, it should be implemented before residual strength is significantly reduced, i.e., within several decades.

Figure 11. Simplified LCC model for a post-tensioned PC bridge
