## A study of drying shrinkage for securing durability of PC bridges

Ryoichi KAWANAKA<sup>1\*</sup>, Hitoshi KOBAYASHI<sup>1</sup>, Tsutomu SAKIMOTO<sup>2</sup>

<sup>1</sup>*P.S.Mitsubishi Concstruction Co.,Ltd, Japan*

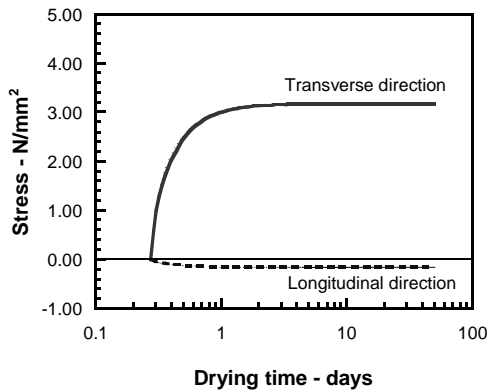
**Figure 1. Change with time of stress in damaged part (point A: standard analysis)**

Figures 1 and 2 show the results of analysis on the assumption that, as with the present design standards, the moisture distribution in the cross-section is uniform and the shrinkage strain in any element is also uniform. Figure 1 well depicts the high tensile stress in the transverse direction but shows little stress induced in the longitudinal direction. Hence cracking only in one direction is represented. The stress contours in Figure 2 also fail to show high stress in the existing sections before and after the post-cast section, giving results that are different from the actual damages.

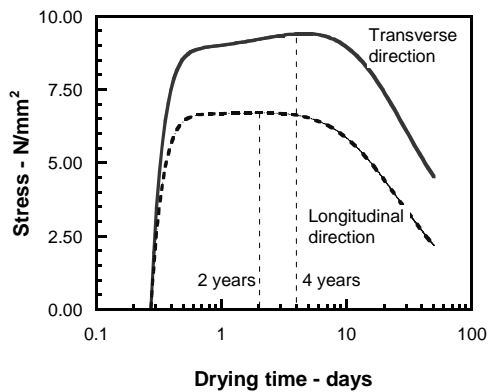
**Figure 3. Change with time of stress in damaged part (point A: analysis with focus on moisture diffusion)**

In contrast, Figures 3 and 4 show the results of analysis on the assumption of moisture diffusion in the concrete according to the diffusion theory and with the moisture distribution in the cross-section taken into account. Figure 3 indicates that high stress is induced in the longitudinal direction and in the transverse direction, successfully reproducing non-directional cracking. It also shows when the stress peaks and is capable of evaluating internal restraint stress, which changes over time unlike the external restraint stress. In addition, Figure 4 shows high stress in the existing sections before and after the post-cast section, which very closely represents actual damage.

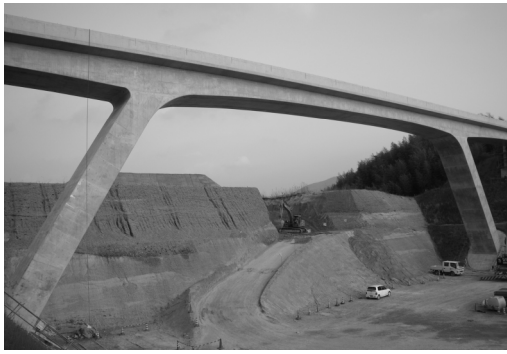
**Photo 3. PC strutted rigid frame bridge**

The bridge chosen as the subject of the test, which is an overbridge across an expressway, is a PC strutted rigid frame bridge with a box girder-shaped cross-section. For this bridge, the concrete available at the construction site was known to have a drying shrinkage strain close to  $1,000 \times 10^{-6}$  and a study was conducted in advance by a committee composed of experts. As a result, it was determined that test specimens of the same size as for the bridge should be built to take measurements of the drying shrinkage strain over an extended period of time in parallel with the construction of the bridge. Photo 3 shows an overall view of the completed bridge, Photo 4 an overview of specimens and Figure 5 the dimensions of the specimens. For the actual construction of the bridge, coarse aggregate was delivered from a distant location

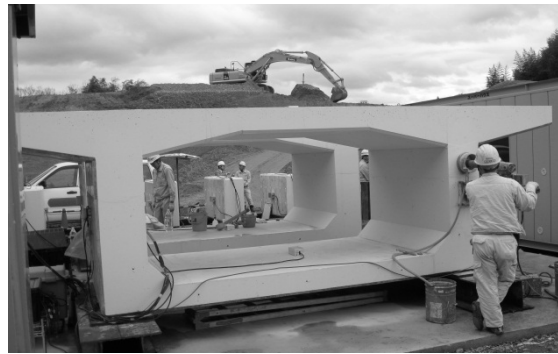
**Photo 4. Full-scale specimens**

A total of seven large test specimens were built with different concrete compositions and amounts of reinforcing bars for comparison. Two of those were box girder-shaped, of which one used a concrete containing coarse aggregate that causes a larger drying shrinkage strain (composition No. 1) and the other used a concrete containing coarse aggregate that causes a typical drying shrinkage strain (composition No. 2). Figure 6 shows the results of the length change test according to JIS A 1129 for the respective concretes. The shrinkage strain after 26 weeks turned out to be  $923 \times 10^{-6}$  for composition No. 1 and  $539 \times 10^{-6}$  for composition No. 2.

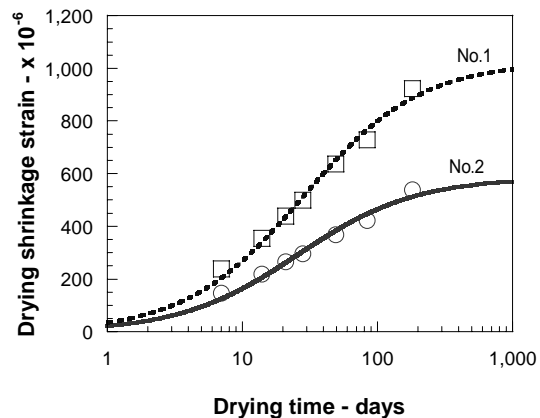
**Figure 6. Results of length change test according to JIS**

One cause of the large drying shrinkage strains of concrete is recent quality degradation of coarse aggregate. Length change tests according to a Japanese Industrial Standards (JIS) test method (JIS A 1129) using test specimens (100×100×400 mm) made of coarse aggregate of the same origins as those of the damaged PC bridges sometimes show a final measured strain exceeding  $1,000 \times 10^{-6}$ . Meanwhile, the Japanese design standards (such as the Standard Specifications for Concrete Structures and Specifications, and Specifications for Highway Bridges) specify that a drying shrinkage strain to be used for design of PC bridges is roughly  $150 \times 10^{-6}$  to  $200 \times 10^{-6}$ , which is considerably different from the result of the JIS test. There are four possible reasons for the difference:

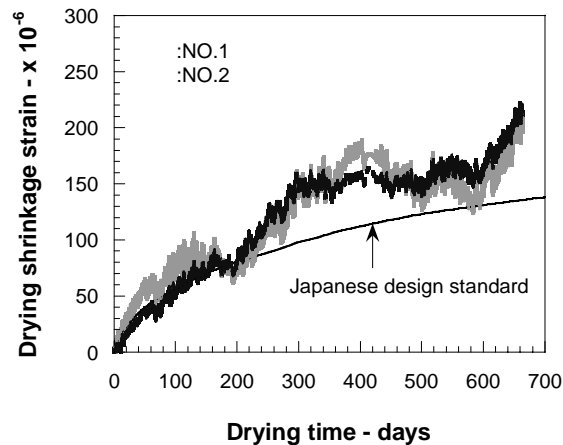
**Figure 8. Full-scale test specimen measurements**

Figure 8 shows the results of measurements in the longitudinal direction of full-scale specimens (perpendicular to the cross sectional plane in Figure 7). The measurement results were subjected to temperature correction by thermocouples. Twenty-two months have passed since the start of drying but not much difference was found between the drying shrinkage strains of the two test specimens at approximately  $200 \times 10^{-6}$ . The graph indicates that there is a time when the change switches from shrinkage to expansion, which coincides with early summer when rainy weather continues and ambient humidity increases in Japan.

To focus on specimen No. 1 with a larger drying shrinkage strain, the strain variation is larger than that of No. 2 not only while expansion continues but also when the change switches from shrinkage to expansion. This suggests that concrete No. 1 has a lower resistance to deformation than No. 2 and, as shown in Table 2, Young's modulus of concrete No. 1 is only about 70% of that of No. 2. In this way, the actual structures undergo repeated shrinkage and expansion because of the external environment and, for concrete with a lower

resistance to deformation due to the quality of coarse aggregate, both the expansion strain and the shrinkage strain are large. Accordingly, the average shrinkage strain is not much different from that of the standard concrete and the tendency is assumed to be different from the result of the JIS test, which is an indoor test where only shrinkage continues.

The curves in Figure 8 are change curves with time of drying shrinkage strains calculated based on the Japanese design standard. The average shrinkage strain is apparently slightly larger than the design standard for both No. 1 and No. 2. To focus on the peak value, however, the value for No. 1, for example, reaches 1.7 times the design standard at drying age of around 400 days, which may cause a risk of damage such as cracking depending on the structure. For that reason, to compare the drying shrinkage strain induced in the actual structures with the shrinkage strain for design and JIS test value, attention should be given to the peak value, which appears when drying progresses, rather than the long-term average shrinkage strain.

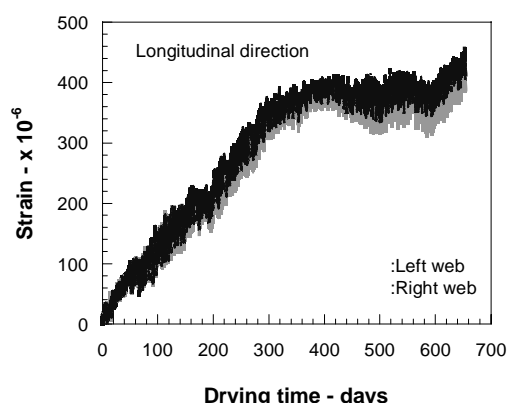
**Figure 9. Measurement results of actual bridge (longitudinal)**

Figures 9 and 10 show the measurements for the actual PC bridge. The shrinkage strain in the longitudinal direction shown in Figure 9 is about  $400 \times 10^{-6}$  at present, which includes a creep strain resulting from prestressing. The calculated value of the creep strain at drying age of 22 months is around  $200 \times 10^{-6}$  and, with this subtracted, the drying shrinkage strain is estimated to be around  $200 \times 10^{-6}$ , which coincides with the shrinkage strain in the vertical direction shown in Figure 10 (ignoring the effect of prestressing). Accordingly, the drying shrinkage strain in the actual bridge is estimated to be around  $200 \times 10^{-6}$ . This agrees with the measurements with full-scale specimens.

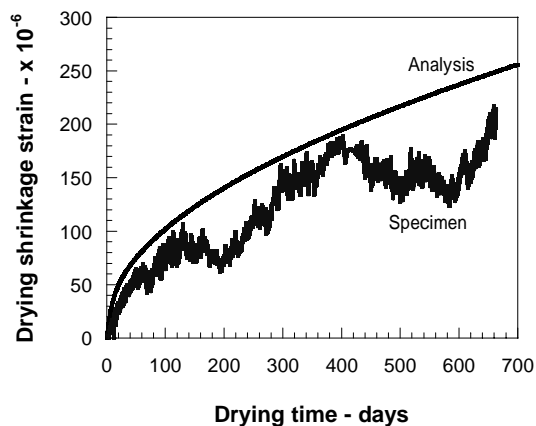
Figure 11. Results of analysis

**Result of analysis.** Figure 11 shows a comparison between measurements of drying shrinkage strain of specimen No. 1, which has a large drying shrinkage strain, and the drying shrinkage strain obtained by analysis with the focus on moisture diffusion in concrete. The relative humidity used for the analysis was 71.6%, the annual average. As shown by this

graph, the analytical values are slightly larger than the measured values but they are in close agreement with each other. The reason the analytical values are larger than measured values is apparently that the analysis does not take the impact of rainfall or restraint by reinforcing bars into consideration.
