Non-Traditional Pervious Concrete System to Manage Storm Water Run-off in Urban Neighborhoods: A Pilot Study

Rishi Gupta^{1*} and Amos Kim^{2*}

¹ Faculty and Program Coordinator, Department of Civil Engineering, British Columbia Institute of Technology, Canada

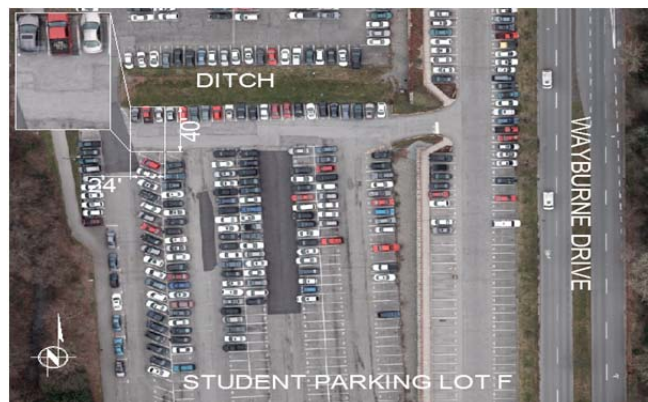
Figure 1: Site location at BCIT's Burnaby campus (with an insert- zoomed in view of the test slab)

The site is located at the northern area of Parking Lot F. The placement size is 24' x 40', and will cover three parking stalls and the roadway next to it. The specific stalls chosen for the placement are numbered 794, 795, and 796. Refer to Figure 1 for the exact site location at the Burnaby campus of BCIT, Burnaby, Canada.

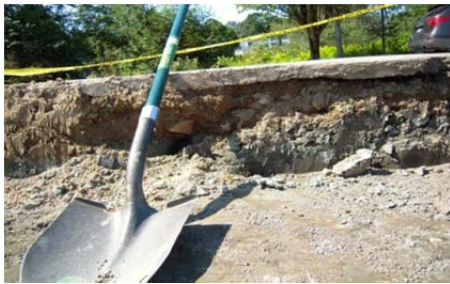
Photo 1: Pavement cross-section observed during excavation

In preparation for the excavation at the site, the existing asphalt was saw cut to form straight edges. The site was excavated 12" deep from the top of the asphalt surface. The soil below the pavement consisted of sandy soil for the top 6", and sandy clay in the lower 6". Soil samples were taken for further analysis. A small portion of the ditch north of the placement (outside the test slab) was also excavated to accommodate a water collection system to test the quality and measure the quantity of water percolating through the test slab. Sets of perforated pipes were placed below lanes 795 and 796 (west end of the test slab). One set was placed at the bottom of the clear crush and one at the bottom of the 6" thick pervious concrete slab. Separate pipes were used at each level under lot 795 and 796. The reason to do this is to study the reduction in percolation capacity (if any) of the slab by not maintaining (power washing) one of them. In this study, lot 795 will be maintained and lot 796 will be left unmaintained. These pipes were 3" in diameter, 7' in length, and made from PVC. Photo 2 shows the perforated pipes used.

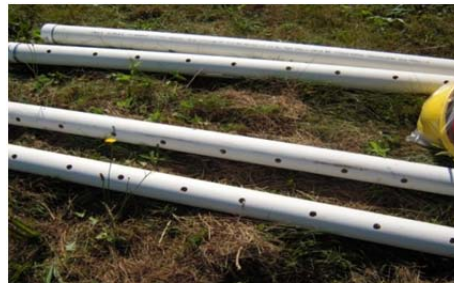
Photo 2: Perforated pipes used to collect infiltrated water

There were two rows of perforations for each of the pipes. The spacing of the perforations was 6" apart, and the perforations themselves were approximately 1/2" in diameter. Photo 3 shows the location of the perforated pipes above the excavated area. The perforated pipes were set approximately an inch above clear crush. This was done to prevent any deleterious material from clogging the perforations. The perforated pipes would lead through connections and more pipes to eventually reach a holding tank for the infiltrated water. The connections consisted of PVC elbows and ABS couplings to have 12' long ABS pipes extend downhill to the holding tank. Photo 4 shows a second set of pipes above the clear crush (at the bottom level of pervious concrete). The ABS pipes would then connect to reducers of one inch and a half. These reducers were then connected to ball valves and flexible pipes to control the flow of water to the holding tank. The flexible pipe was comprised of vinyl tubing with an inner diameter of one and a quarter inch.

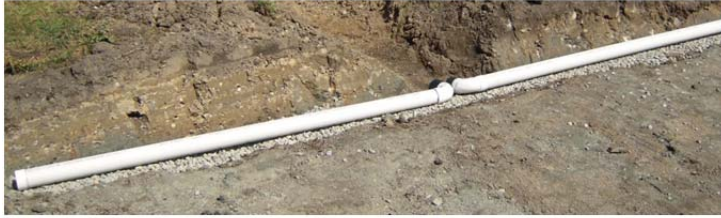
Photo 3: Perforated pipes above the subgrade

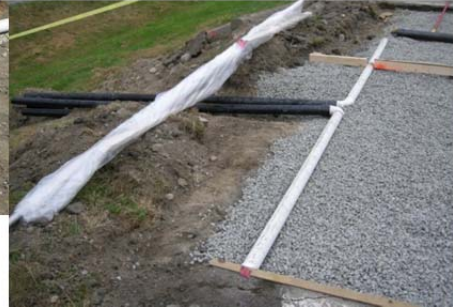
Photo 4: Perforated pipes on top of crush connecting to ABS pipes

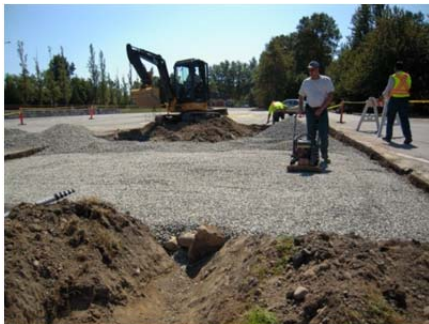
Photo 5: Compaction of clear crush and simultaneous excavation

Once the excavation was complete, 6" of fractured clear crush with a maximum aggregate size of $\frac{3}{4}$ " specified from the ready-mix supplier was deposited above the subgrade. The fill was then compacted using a vibratory roller and measured to gain a uniform depth of 6" throughout the placement. Photo 5 shows the clear crush being compacted by the vibratory compactor. The background of Photo 5 also showcases the simultaneous excavation of soil and the transportation of clear crush from a nearby deposited pile. The clear crush is necessary for pervious concrete as it acts as a storage medium and a filtration system for water passing through the pervious concrete. The crush also acts as a subbase for receiving the pervious concrete layer.

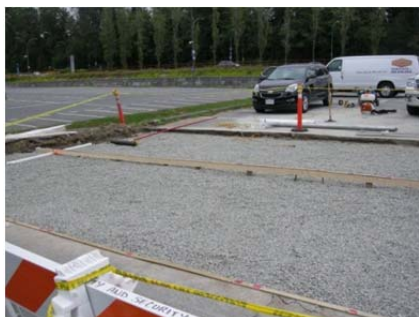
Photo 6: Site with formwork and compacted crush

A proprietary concrete mix was supplied by a local ready-mix supplier. The properties of the concrete mix reported by the supplier are given in Table 1. In addition to these properties, according to the supplier, this product has a unit weight up to 30% less than conventional concrete and is workable for up to 90minutes. The placement was split into two bays to accommodate the roller screed that was used for this project, as the roller screed length of 10' approximately matched the width of half the placement, or one bay. The site was prepared by adding minimal formwork to split the placement and to create straight edges along the sides, as cracks occurred in the existing asphalt surface during the excavation process. Photo 6 is a photo of the site prior to the concrete placement.

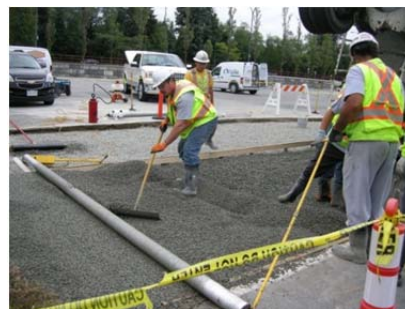
Photo 7: Roller screed and leveling

Concrete Placement and Finishing: Six inches of pervious concrete was placed on top of the compacted clear crush by a subcontractor that has experience working with this product. The pervious concrete was then immediately leveled using rakes and an aluminum roller screed for consolidation. Photo 7 shows a construction worker leveling the pervious concrete with the roller screed in the foreground. The roller screed is essentially a hollow tube that is filled with water for additional weight. The roller screed was approximately 50 pounds empty, and approximately 100 pounds when filled with water.

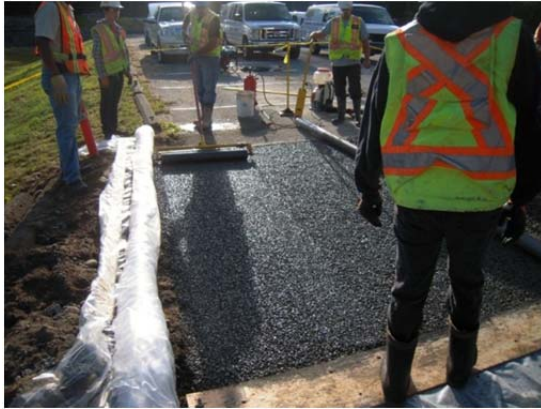
Photo 8: The second roller giving the desired finish of the concrete

The estimated speed of rotation of the screed was approximately 250 rpm. A smaller second roller was also used in the transverse direction to get the desired finish and compaction. Photo 8 shows the second roller in operation. The edges of the placement were further lightly compacted by using a flat metal plate. This was done to form a level surface between the existing asphalt and the pervious concrete. This process was also done to create level surfaces between the two placements of the concrete. Once the concrete was placed and consolidated, the concrete was sprayed with a minimal amount of water before being protected by a thick sheet of polyethylene. Photo 9 shows the finished placement with the polyethylene covering the pervious concrete. The

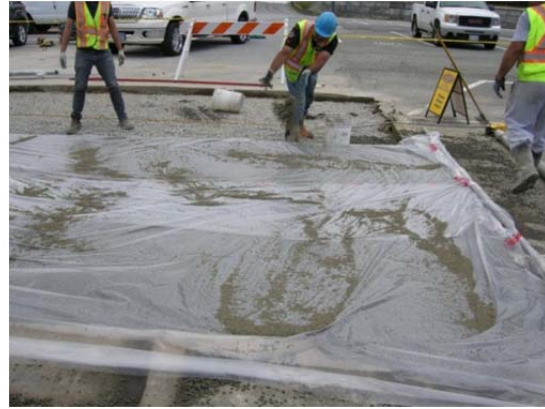
Photo 9: Finished concrete slab (Bay 1) covered with polyethylene sheet

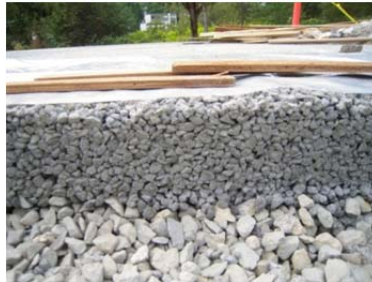
Photo 10: Pervious concrete cross-section after saw cut

polyethylene was held down using sand and smaller rocks to prevent removal of the cover. The second bay of the placement was placed seven days after the initial placement. The inside edge of the concrete was saw cut to provide a smooth edge prior to the second placement. Photo 10 shows the cured cross-section of the pervious concrete in Bay 1 (after 7 days of concrete placement). The second placement had identical procedures to the first placement.

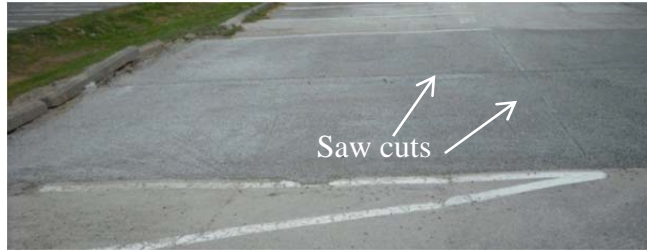
Photo 11: Cured concrete slab with saw cuts

Concrete curing: Once the first concrete placement was cured for 15 days and the second cured for 7 days, saw cuts were carried out. Photo 11 shows the cured slab with the saw cuts. One saw cut was made to reduce the length of the placement to half (20').

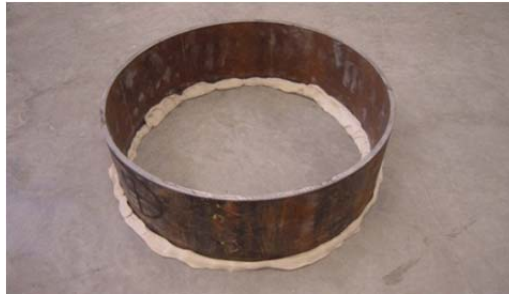
Photo 12: Ring used for the in-place percolation test

In-place filtration rates were measured according to ASTM C1701/C1701M, “Standard Test Method for Infiltration Rate of In Place Pervious Concrete”. This test method determines the field water infiltration rate of in-place pervious concrete. Maintenance of the pilot slab will also only be done on a specific side of the slab (40’ length of stall 796, West side of Bay 1), thus, filtration rate tests results will determine whether maintenance helps retain percolation capacity of the slab. Initial in-place filtration results are listed in Table 3 for the first half of the slab (Bay 1). The ring used for the percolation test along with the putty used during the test is shown in

Photo 12. The diameter of the steel ring is 300mm and a water head of 10-15mm was used during the test as specified by the ASTM standard.
