## The Latest Non-destructive Inspection Technologies for Evaluation of Grouting Condition of Tendon Ducts in Prestressed Concrete Beams

Toshiro KAMADA

*Osaka University, Japan*

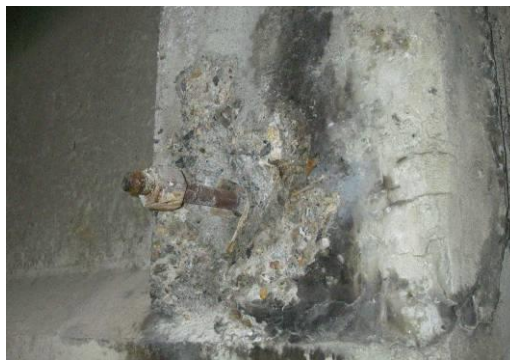
**Figure 1. Protrusion of PC steel bars from an anchorage area**

In prestressed concrete (PC) structures with a post-tensioned system, corrosion of PC steel components is prevented by employing PC grouting inside sheaths. Insufficient grouting causes corrosion of PC steel components, leading to their breakage. If a steel component breaks, it may protrude from an anchorage area as shown in Figure 1. and cause damage to third parties. Recently, there have been some reports on the breakage and protrusion of transverse prestressing steel bars in PC bridge girders (Yoshiyasu, 2009), and it is a pressing task to evaluate grouting condition properly. Moreover, the breakage of steel components

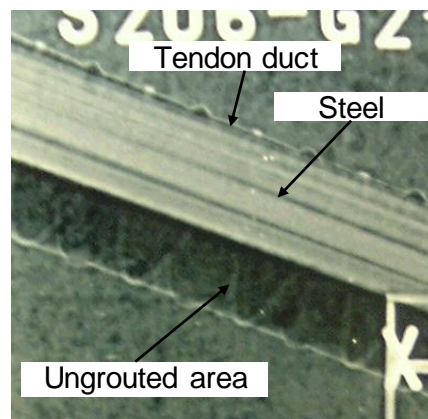
Figure 2. X-ray image

Against this backdrop, methods using electromagnetic waves (X-ray method (Maeda, Hasegawa, and Goami, 1988)) and elastic waves (ultrasonic method (Sakata, and Ohtsu, 1991), and impact elastic wave method (Kuroso, Yamada, and Nakai, 1995)) have been studied as non-destructive methods to evaluate PC grouting condition. Among them, the X-ray method can evaluate the existence of grout visually in terms of image contrast as shown in Figure 2. This method, however, has disadvantages such as a limitation in the applicable thickness of components, safety management restriction for radiation protection, costliness and low inspection efficiency. On the other hand, elastic wave methods, in particular the impact elastic wave method, are widely used because they are less restricted as regards inspection condition and can be performed efficiently. The elastic wave methods can be categorized into those in which elastic waves are propagated in the axial direction of PC steel members (Figure 3.) and those in which elastic waves are propagated in the direction perpendicular to PC steel components (Figure 4.). The former approach applies the velocity of elastic wave propagation deduced by the impact elastic wave method to roughly evaluate the average grouting condition inside sheaths. The latter approach applies frequency characteristics (impact echo method (Sansalone, and Streett, 1997)) or maximum amplitude (electromagnetic pulse method (Tsunoda et al, 2009)) and has the potential of a detailed inspection method to identify unfilled areas.

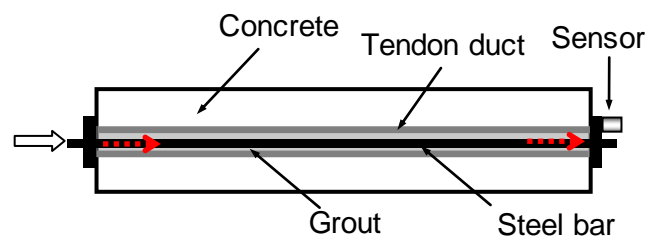
Figure 3. The method for propagating elastic wave to axial direction of PC steel bar (The method focused on elastic wave velocity)

In this paper, the author categorizes the impact elastic wave methods into (1) those that apply the velocity of elastic wave propagation, (2) those that apply frequency characteristics (impact echo method) and (3) those that apply maximum amplitude (electromagnetic pulse method). On the basis of this categorization, the author provides an overview of the latest non-destructive inspection technologies for broad and detailed inspection to evaluate PC grouting condition.

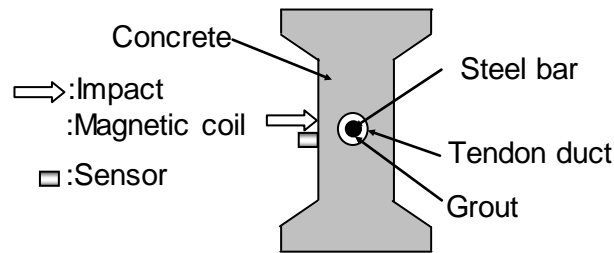
**Figure 4. The method for propagating elastic wave to vertical direction of PC steel bar (The method focused on frequency characteristic or maximum amplitude)**

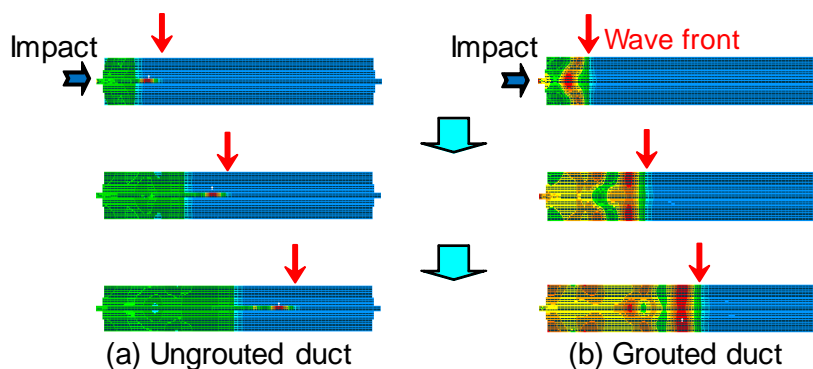
**Figure 5. Principle for evaluation of PC grouting condition focused on propagating velocity**

Figure 5. shows the principle of evaluation of PC grouting condition. If the sheath is not filled with grout, elastic waves propagate most rapidly through the steel bar. Therefore, the apparent elastic wave velocity becomes close to the propagation velocity in a steel bar as a single unit. If the sheath is filled with grout, elastic waves propagate through the composite member consisting of the steel bar and grout; propagation velocity therefore becomes smaller than that in the unfilled case.

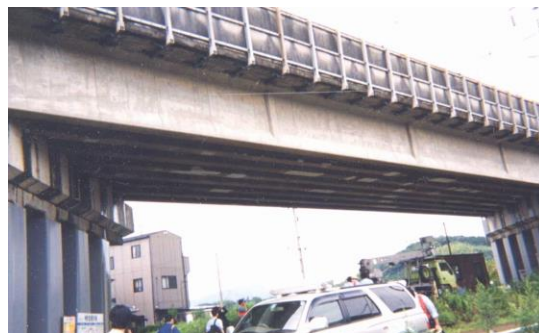
**Figure 6. PC girders**

**Example of inspection of actual PC bridge girders (Kamada et al, 2006)** For transverse prestressing steel bars in PC bridge girders in use (shown in Figure 6.), the results of evaluating PC grouting condition are outlined in this section. This bridge has separate girders for each of upbound and downbound lanes, and each lane consists of four main beams, a filling part and an extended part, which are integrated into one unit with transverse prestressing steel bars. The impacting device shown in Figure 7. was used for generating elastic waves. Impact was applied to a steel bar end in the extended part (see Figure 8. (a)). To record the time of elastic wave input, a sensor was installed near the point of impact (see Figure 8. (a)). The input elastic wave was detected with sensors installed on a concrete side surface situated between the upbound and downbound lanes (see Figure 8. (b)). Figure 9. shows an example of waveform detected by each sensor. The velocity of elastic wave propagation was obtained by dividing the distance between sensors by the difference in time of wave arrival between the sensors.

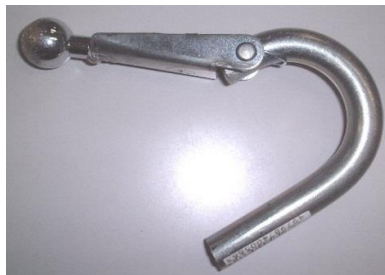
**Figure 7. Impact device**

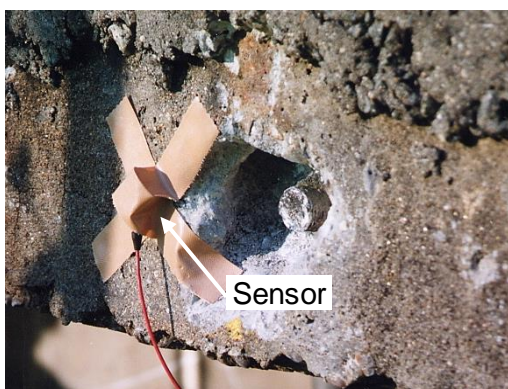
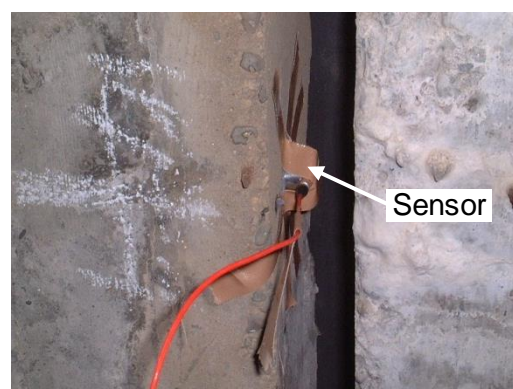
(a) Location of elastic wave input and sensor

(b) Location of sensor

**Figure 8. Location of elastic wave input and sensors**

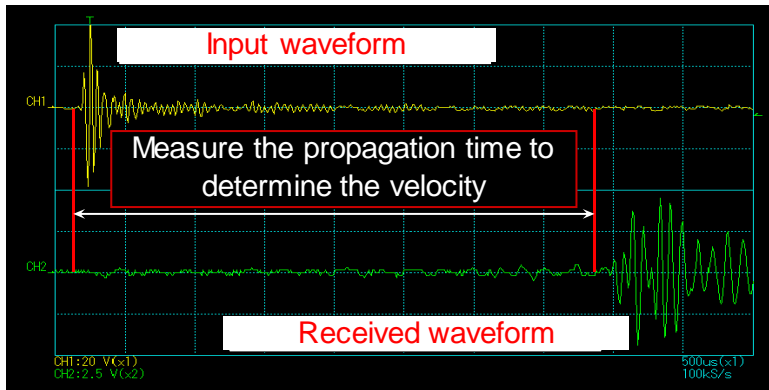
**Figure 9. Example of waveform with each sensor**

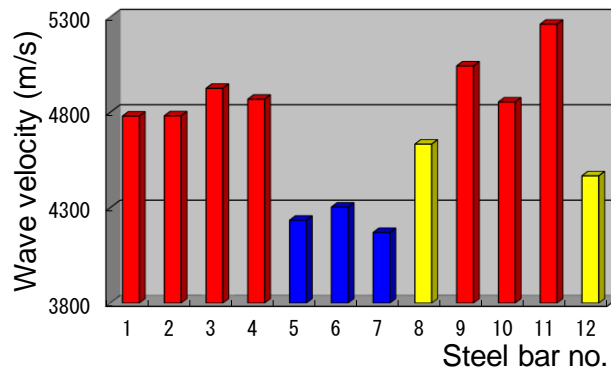
**Figure 10. Elastic wave velocity measurement results**

Figure 10. shows an example of results obtained. In the steel bars whose propagation velocity exceeded 4800 m/s (shown in red in the figure), areas unfilled with grout were observed at all the drilled locations as shown in Figure 11. In the steel bars whose propagation velocity was less than 4300 m/s (shown in blue in the figure), filling with grout was confirmed. In the steel bars whose propagation velocity was intermediate (shown in yellow in the figure), areas filled and unfilled with grout were mixed.

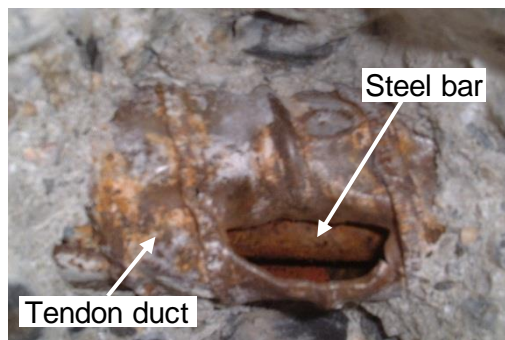
**Figure 11. Example of ungrouted duct**

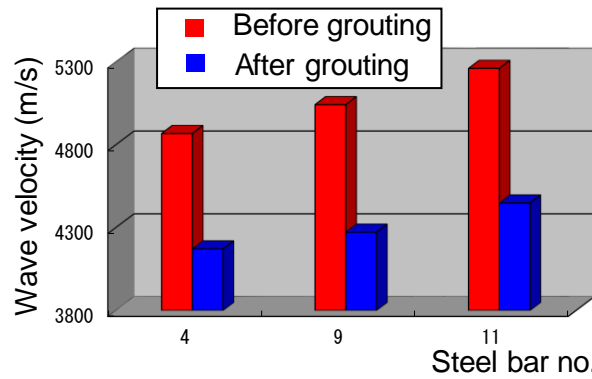
**Figure 12. Change of wave velocity due to grouting**

On the basis of the results of drilling investigation, grout was reintroduced to steel bars whose propagation velocity exceeded 4800 m/s, and then the velocity of wave propagation was measured again. Figure 12. compares propagation velocity before and after the re-grouting. In either case, propagation velocity became smaller after re-grouting. This indicates that the effectiveness of re-grouting can be evaluated by comparing propagation velocity before and after re-grouting.

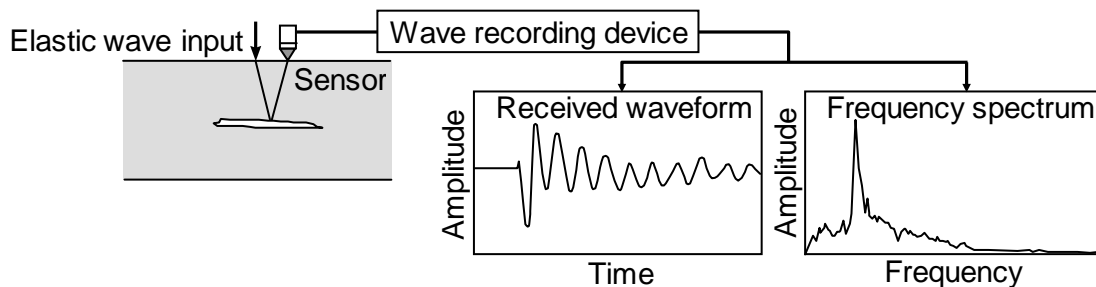
**Figure 13. Outline of the method focused on frequency characteristics (Impact-Echo Method)**

**Outline of the method and the principle of evaluation** In this method, as shown in Figure 13., a concrete surface is hit by a steel ball so that elastic waves are propagated through the concrete, a sensor installed on the side of the impact surface detects reflected waves from objects, and the thickness of components and the presence or absence of internal defects are evaluated from the observed frequency characteristics.

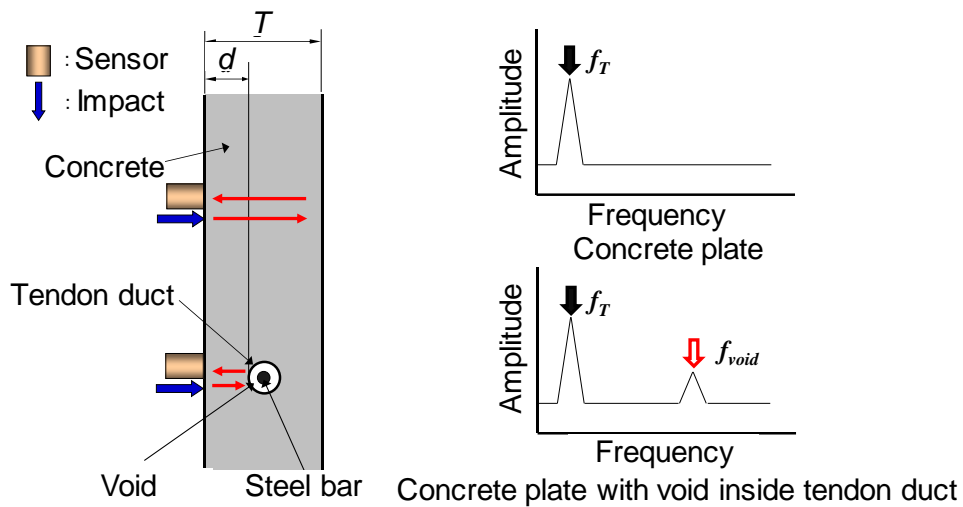
**Figure 14. Principle for evaluation of PC grouting condition focused on frequency characteristics**

Figure 14. shows the principle of evaluation of PC grouting condition. If a sheath is completely filled with grout, a peak corresponding to concrete slab thickness (defined as  $f_T$ ) appears on a frequency spectrum. If there is an area unfilled with grout, on the other hand, a peak corresponding to waves reflected from the unfilled area ( $f_{void}$ ) appears in addition to the  $f_T$  peak. The values of the two peaks of  $f_T$  and  $f_{void}$  are theoretically obtained by

$$f_T = C_p / 2T \tag{1}$$

$$f_{void} = C_p / 2d \tag{2}$$

When applying this method, the position and depth of a sheath is first investigated by the electromagnetic radar method. Substituting the estimated sheath depth into equation (2), we obtain a peak frequency value based on an assumption that there is an area unfilled with grout. Finally, a frequency spectrum is obtained by this measurement method, and if a peak appears at the theoretically predicted frequency, it is judged that there is an area unfilled with grout.

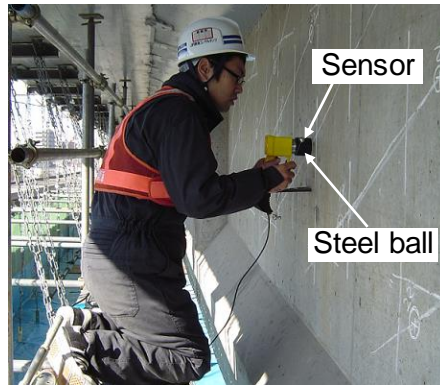
**Figure 16. Outline of measurement using the method focused on frequency characteristics**

**Example of inspection of actual PC bridge girders (Kamada et al, 2006)** For main cables in the PC bridge girders shown in Figure 6., PC grouting condition was evaluated by using the method that applies frequency characteristics, whose results are described here. Figure 15. shows the steel balls, sensor, amplifier and waveform collection system used in this method. Figure 16. shows measurement being conducted at the web part of a girder. Figure 17. shows an example of measurement results. The arrows in the figure indicate the theoretical  $f_T$  values deduced from equation (1), and the broken lines indicate the theoretical  $f_{void}$  values deduced from equation (2). The velocity of elastic wave propagation measured at the bridge is used in the figure. In either case of Figure 17. a peak appeared at the  $f_T$  location. In the case of Figure 17. (b), there is a peak at the  $f_{void}$  location in addition to the  $f_T$  location. This indicates that the sheath is filled with grout in the case of Figure 17. (a), and there is an unfilled area in the case of Figure 17. (b). The estimated results were in agreement with the results of drilling investigation.

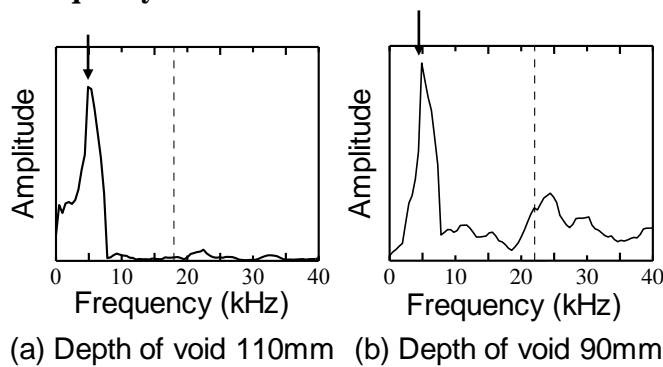
**Figure 17. Example of measurement results in the method focused on frequency characteristics**

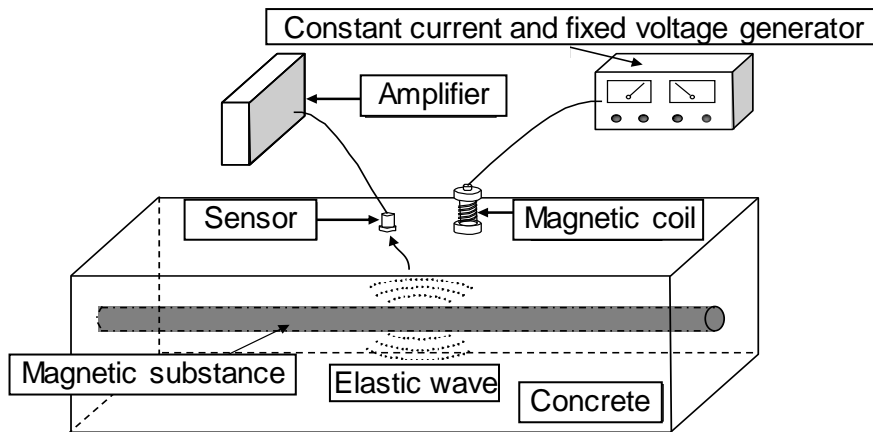
**Figure 18. Outline of the method focused on the maximum amplitude (electromagnetic pulse method)**

**Outline of the method and the principle of evaluation.** Unlike the methods that apply the velocity and frequency characteristics of input elastic waves, the method that applies maximum amplitude uses an exciting coil to impact PC steel components in a noncontact manner. This coil consists of magnet wire winding around an electromagnetic steel plate. An instantaneous magnetic field can be created by applying pulse current to the coil. The electromagnetic force created by the magnetic field induces vibration in the magnetic materials contained in concrete. Elastic waves created by the vibration of the magnetic materials are detected by a sensor placed on the concrete surface, and the state of the magnetic materials and their interfacial defects are evaluated non-destructively from the maximum amplitude of the receiving waves (see Figure 18.).

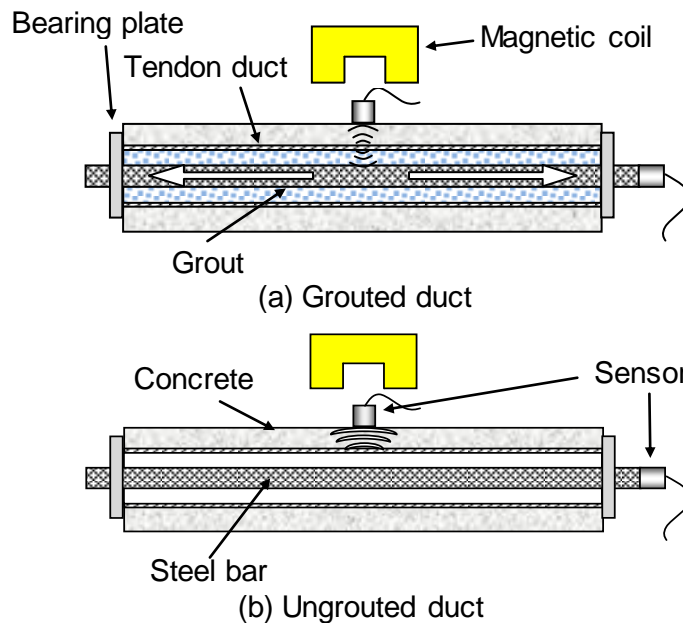
**Figure 19. Principle for evaluation of PC grouting condition focused on the maximum amplitude**

Figure 19. shows the principle of evaluation in this method. When a sheath is filled with PC grout (see Figure 19. (a)) and pulsed electromagnetic force is applied to a concrete surface in a noncontact manner, mainly the sheath beneath the exciting coil vibrates. Because the sheath is confined by the grout, the vibration of the sheath is more or less suppressed. In addition, the PC steel bar inside the sheath hardly vibrates because of the magnetic shielding effect. In the case the sheath is not filled with grout (see Figure 19. (b)), because the sheath is not confined by grout, the vibration of the sheath is apparently greater than that of the sheath filled with grout. By detecting vibration with a sensor placed on the concrete surface and comparing maximum amplitude values, it is possible to identify areas unfilled with PC grout.

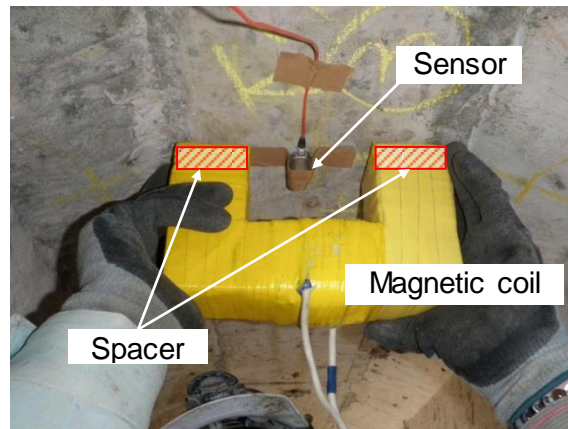
**Figure 20. Outline of measurement using the method focused on the maximum amplitude**

**Example of inspection of actual PC bridge girders** The PC bridge girders (transverse prestressing steel bars) investigated are of the same structural type as that shown in Photo 3. Measurements were performed at a filling part and an extended part as shown in Figure 20. An exciting coil was placed so that the lines of magnetic flux in the field become parallel to the longitudinal sheath direction. To keep a constant distance between the coil and concrete surface, a hard plastic spacer of 20 mm in thickness was attached to the coil end. Beneath the coil, a sensor to detect vibration from the sheath was placed on the concrete surface. Some results shown in Figure 21, indicate that the maximum amplitude in the extended part was smaller than that in the filling part. According to the principle of evaluation shown in Fig. 11, it is inferred that the extended part was filled with grout

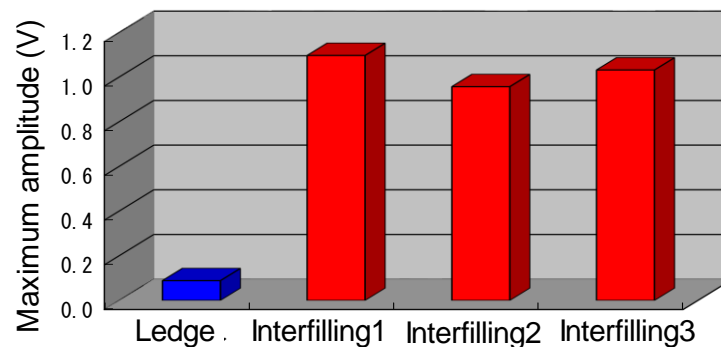
**Figure 21. Example of measurement results in the method focused on the maximum amplitude**

whereas the filling part was not filled with grout. The estimates given by this method were in agreement with the results of drilling investigation.
