**SCMT4**  
Las Vegas, USA, August 7-11, 2016

## **Experimental Study on Conservation and Preservation for Historical Architecture Using Plaster Finishing Material**

**Table 1. Outline of a target architecture**

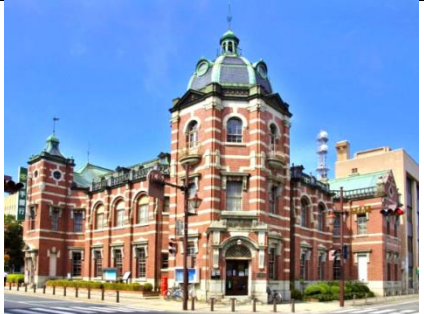
<p>The exterior of Morioka Bank</p>
Location	Nakayashikicho, Morioka-shi, Iwate, Japan	
Designer	Kingo TATSUNO, Manji KASAI	
Completion	AD 1911	
Structure	Wall : British-style Brick	
	Roof truss : Wooden Pratt truss	
Others	Lath Plaster Ceiling	
	(Surface of plaster finishing, Above wooden laths)

Table 1 shows the outline of the architecture. Morioka Bank was built at 1911 by a historical architect in Japan. The building is not currently being used as a bank, however, 100 years have passed since the building's construction, so it is a valuable part of Japanese architectural history. Therefore, it has been maintained from 2012 to 2016.

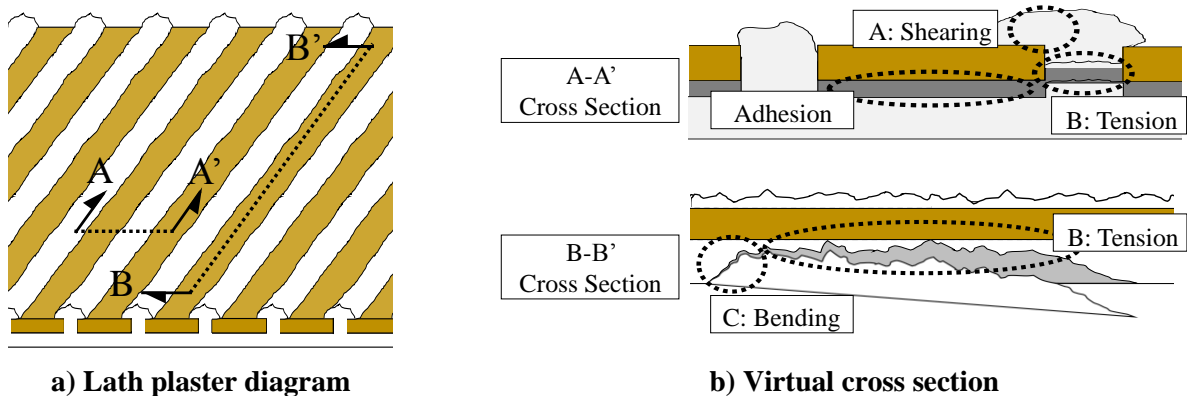
**Figure 1. Mechanical Systems of Wooden Lath Plaster**

Figure 1 shows the concept of the stress transmission lath and plaster. Table 3 shows the material used and strength experiment types.

The mark A is shear strength transmitting the plaster load to wooden lath. The mark B is tensile strength to support the plaster load. The mark C is bending strength to resist the flaking and cracking.

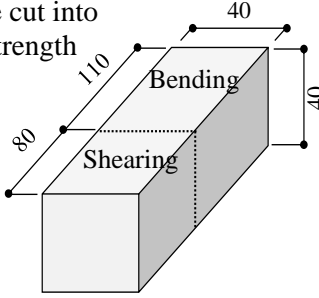
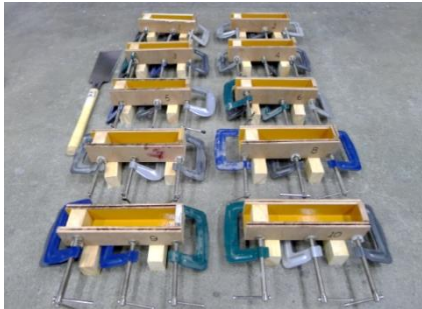
**Table 3. Mixture and specimens of the Experiment**

**b) Specimen size of the Experiment**

Specimens are cut into each type of strength experiments.

a) Specimen Size: W40×H40×D190(mm)      b) Form of Specimen

c) A: Shear strength      d) B: Tensile strength      e) C: Bending strength

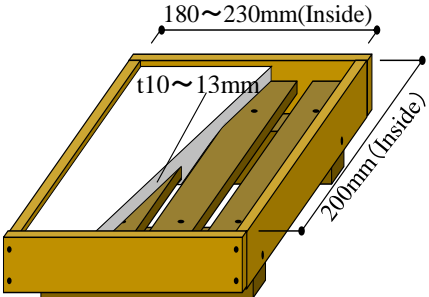
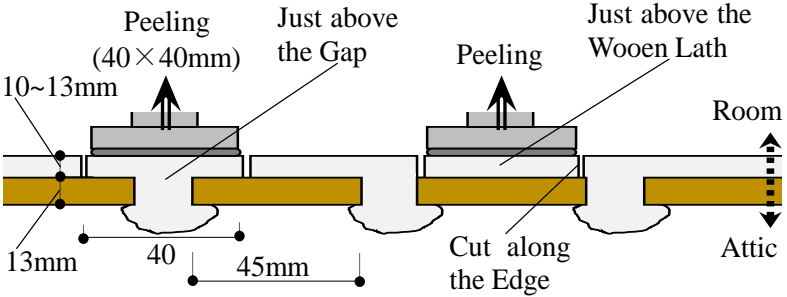
**Figure 2. Lath and Plaster specimen and Peeling strength Experiment**

**Peeling test of Plaster Layer.** Figure 2 shows the divided lath and plaster ceiling specimens. The specimens could be evaluated to measure the strength conditions of the ceiling member. This specimen was made in suspending conditions of same environment of the ceiling. These strength tests were enforced after 24 days after placing fresh plaster. A tensile testing instrument was attached to the surface of the finishing plaster after curing. The tensile strength test was enforced to pull plaster against the wood lath and record the peeling resistance in maximum load, the plaster deformation, and destruction pattern of plaster key.

a) Specimen image      b) Cross section of Peeling Experiment

**Peel test of Plaster Layer.** Figure 6 shows the relationship between breaking load and width of gap of the lath. This test was performed in the test body that we prepared (See figure 2). Therefore, traditional members of Morioka Bank is not used for destructive testing. Breaking load was correlated with the width of the wooden lath clearance. In addition, the plaster containing sand, the breaking strength would tend to be strengthened. This can be explained from the result that the drying shrinkage of the plaster containing lots of sand is smaller than that of no sand type. The closer the length between the wooden lath and plaster, the plaster key would expect strong mechanical interlocking conditions. However, if the amount of sand is too large, the positive effectiveness was eliminated, the strength would be decreased.

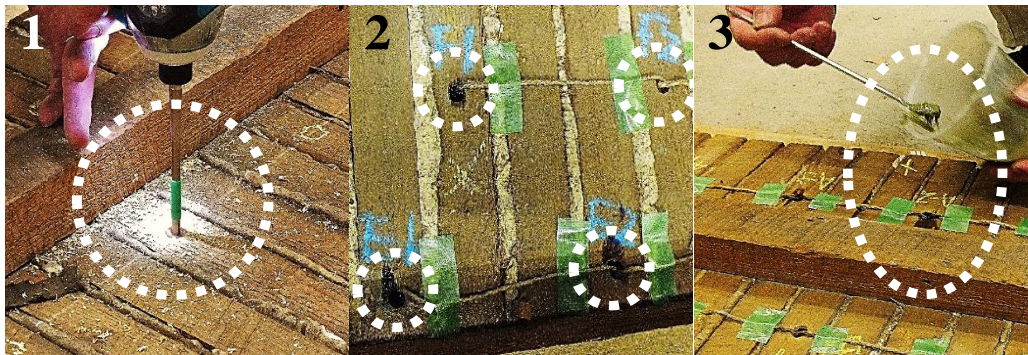
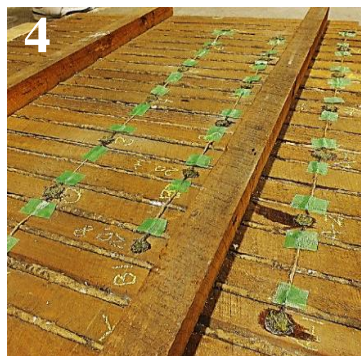
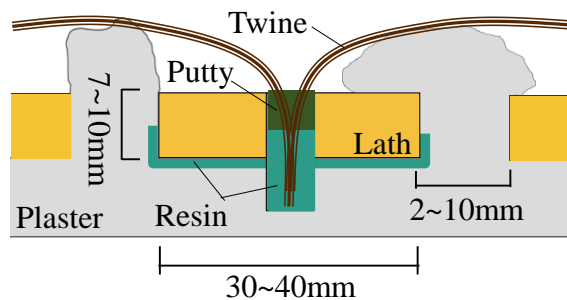
**Figure 3. Process of repairing lath plaster ceiling**

**Repairing Method of lath plaster ceiling.** Figure 3 shows the process of repairing lath plaster ceiling. From the standpoint of preserving cultural values in architectures and buildings, it is important to set the requirement to leave the original material and member if possible. In addition, it is also necessary to improve both design needs and safety. In the case of lath and plaster ceiling, it is better to improve the cracking of the surface plaster by acrylic resin. The method of repairing this type of ceiling is to make a hole to the wood lath (a) from the top of the ceiling, to inject acrylic resin and twine rope to the hole (b), to add the resin to the hole (c), and finally to connect the wooden lath and plaster. The repairing method prevents the peeling and falling of the lath and plaster ceiling.

a) Make holes in the Lath    b) Inject the acrylic resin and twine rope    c) Add the resin to the hole

d) Connecting the wood lath and plaster    e) Improved cross section of plaster ceiling

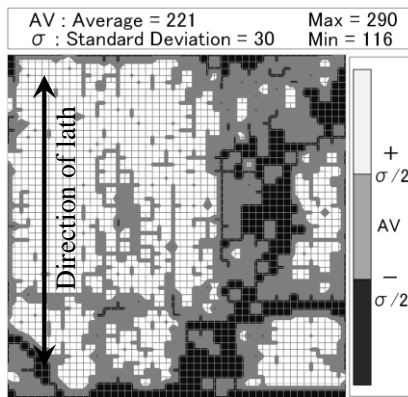
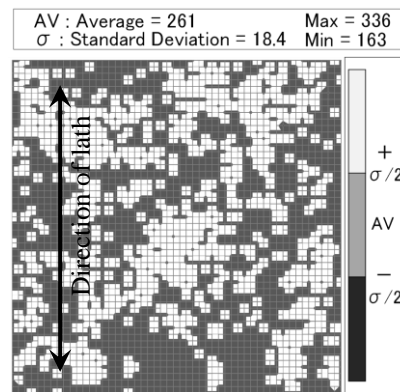
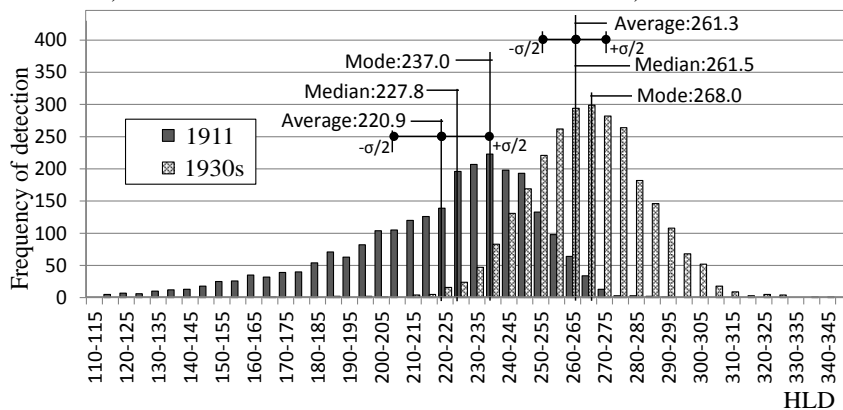
**Figure 4. Results of non-destructive hammering test**

a) 1911

b) 1930s

\*HLD = The mechanical impedance value by hammering test (non-destructive inspection)

c) Frequency detection of HLD

Figure 4 shows the results of the non-destructive hammering test. The color of figures a) and b) were classified by surface hardness of plaster ceiling. Figure c) shows a frequency distribution of surface hardness values of the two specimens. The strength of the ceiling at 1911 had a locally small part of plaster surfaces and was shown that the relative strength was smaller than average strength. The peak value of the strength of the 1911 was smaller than that of the 1930s. Thus, this means that the plaster of the ceiling had already been fragile, and when the peeling and falling of the plaster layer, the broken unit and particles were assumed to become small pieces. On the other hand, the hammering test results of the specimens from the 1930s were stable and small variability. The reason is that the thick plaster layer and high rigidity.

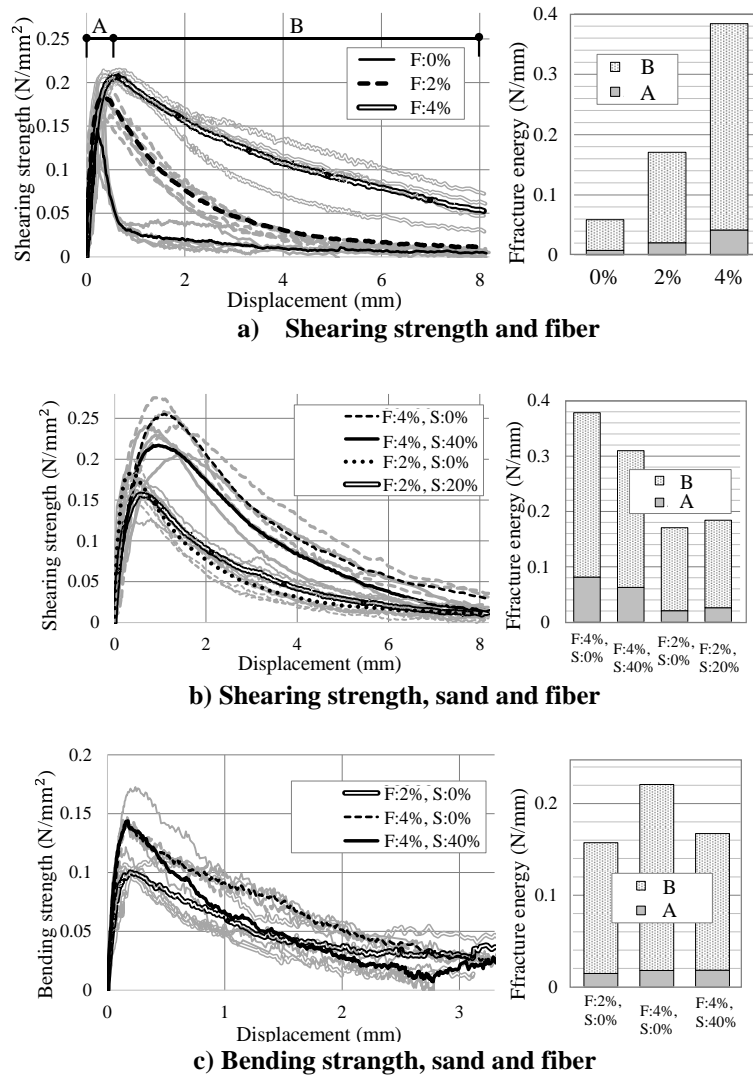
**Figure 5. Relationship between plaster strength and mixture proportion**

**Influence on the strength of plaster Formulation.** Figure 5 is shear strength of the plaster and fracture energy. Firstly, the maximum stress of the plaster was increased by about 20%, and the fracture energy was increased to 250%. The case of including small fibers was effective at increasing the shear stress, like a reinforced concrete rebar. Then, as for the plaster containing sand, the maximum stress was not increased, and the fracture energy was also reduced. As for the flexural strength, the plaster including the maximum amount of fiber was increased by 40% by increasing fiber contents, and the fracture energy of the sand was reduced by 27%.
