SCMT4  
Las Vegas, USA, August 7-11, 2016

## Long-Term Infrastructure Durability Enhancement of Hybrid Fiber-Reinforced Concrete Under Corrosive Environments

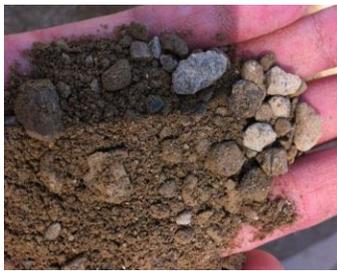
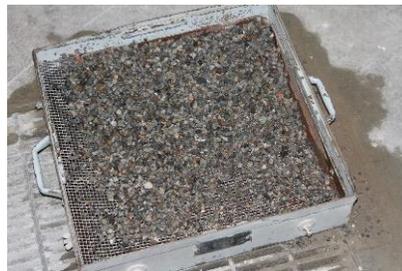
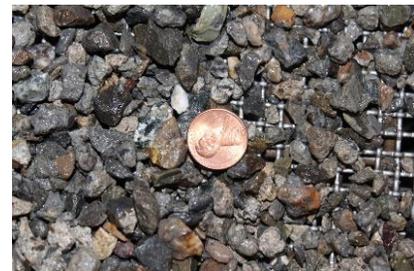
**Figure 1. Recycled concrete aggregate: (a) As-received at recycling center; (b) Sieved and washed; (c) Final product for casting, shown with scale reference.**

Berkeley campus (Figure 1a). The as-received product contained phases of mortar and larger aggregate from the original demolished structure, with the RCA having a maximum size of 9.5 mm. For proper use in concrete batching, particles less than 4.8 mm in size were removed and the remaining material was washed (Figure 1b, 1c).

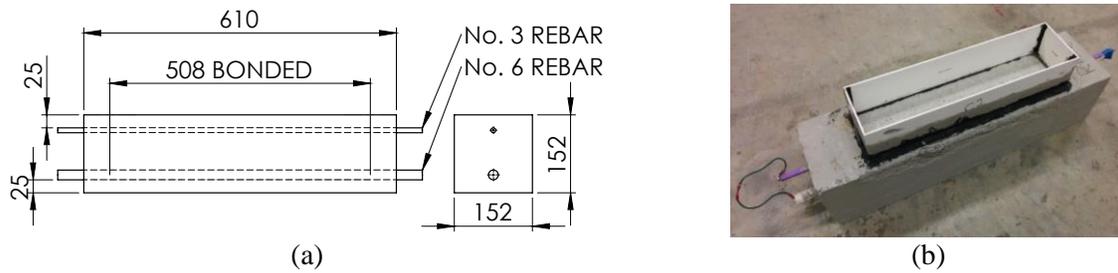
**Figure 2. Beam design: (a) Detailing (mm); (b) Finished specimen.**

Beam specimens with dimensions of 152 mm by 152 mm by 610 mm were flexurally preloaded to induce cracking prior to long-term saltwater penetration (Figure 2a). The beams were cast with HyFRC, G-HyFRC, C, or G-C. A No. 3 (9.5 mm diameter) and a No. 6 (19 mm diameter) A615 steel reinforcing bar were embedded longitudinally along the beam length, with the cover between the rebar to the nearest horizontal concrete surface being 25 mm. Prior to casting, the bars were sandblasted to remove the mill scale, such that variable corrosion effects caused by mill scale cracking would not be present (Ghods et al., 2011). A central length of 508 mm of both bars was allowed to bond directly to concrete and corrode under the experimental conditions. Surfaces of the rebar outside this region of interest were treated to prevent corrosion, first by coating with an electrically-insulating lacquer, followed by coating with electrical tape, and finished with a heat-shrunk polyolefin tubing. The two bars in each specimen were connected with an electrical wire to establish a galvanic cell. Because rebar in actual structures are in direct contact with other rebar in the concrete and corrode at varied times, the effects of macrocell corrosion were taken into account in the beam design.

The specimens were subjected to four-point flexural loading with a beam span of 457 mm and equidistant lengths between loading points (152 mm). Loading occurred such that concrete near the No. 3 rebar and No. 6 rebar was placed in tension and compression, respectively. After completion of loading, a polyvinyl chloride ponding dam was fixed to the horizontal surface of the beam nearest the No. 3 rebar (Figure 2b). The ponding dam allowed for continuous ingress of 3.5% sodium chloride solution (by mass) into the concrete matrix. Finally, a waterproofing sealant was applied to the surfaces of the specimens, except for the surface enclosed by the ponding dam footprint, and the entire horizontal surface opposite the ponding dam and nearest the No. 6 rebar. This surface established a directional flow of sodium chloride solution towards an evaporation surface during ponding.

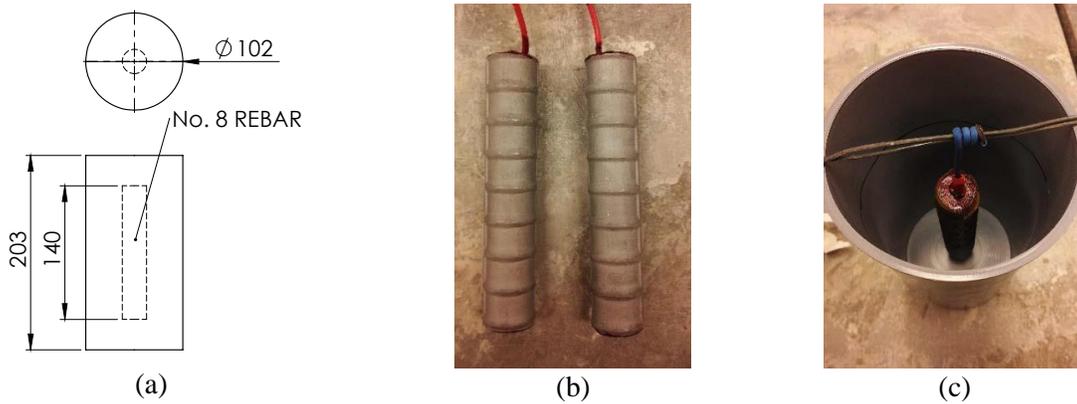
**Figure 3. Cylinder design: (a) Detailing (mm); (b) Sandblasted rebar; (c) Casting setup.**

as shown in Figure 3a, were selected instead to study the type of radial cracking that would be caused by hoop stresses derived from internal corrosion product expansion. The gross concrete dimensions were set to 102 mm diameter by 203 mm height, and a 140 mm-long No. 8 (25 mm diameter) rebar was centrally embedded along the cylinder's longitudinal axis. The bar was sandblasted and end surfaces of the bar were coated with an electrically-insulating lacquer (Figure 3b). During casting, the rebar was hung such that it was entirely embedded in the concrete, as shown in Figure 3c. An electrical wire was attached to the top end of the bar, and was allowed to extrude from the concrete.

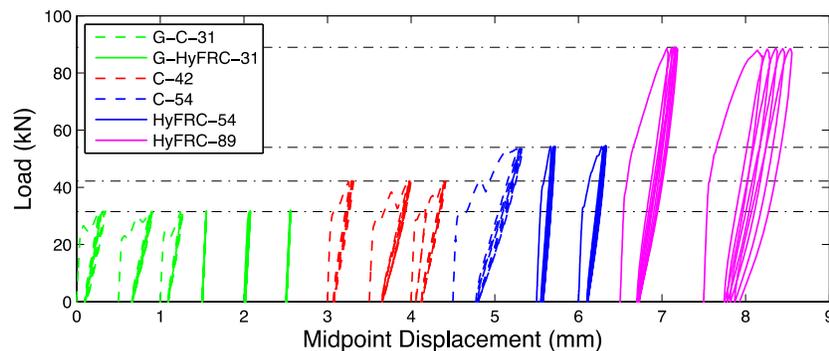
**Figure 4. Load-displacement response of preloaded beams. Responses are offset for clarity.**

Beam specimens prescribed for flexural preloading were subjected to a set load level in five consecutive loading cycles. Figure 4 shows the load-displacement response of all preloaded beams. Specimens are designated by material and peak load (in kN), though are not individually labeled. Green composite (G-HyFRC and G-C) specimens were loaded to 31 kN. The load level was selected as being sufficient to induce observable flexural and splitting (longitudinal) cracks in the G-C specimens. No observable cracking was found in G-HyFRC specimens, which had an elastic response during loading.

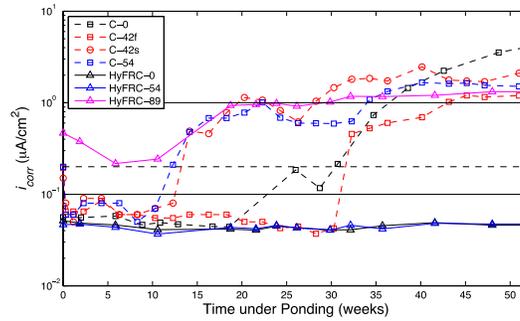
**Figure 5. Microcell corrosion current density of No. 3 rebar in C and HyFRC beams.**

Figure 5 plots the microcell corrosion current density ( $i_{corr}$ ) of the No. 3 rebar for plain concrete and HyFRC specimens over a duration of 52 weeks. The values were calculated assuming Stern-Geary coefficients based on measured corrosion potentials, and carry a maximum error factor of 2 using this method (Andrade and Alonso, 1996). Negligible corrosion is assumed for  $i_{corr}$  values less than 0.1  $\mu\text{A}/\text{cm}^2$ . Active corrosion may be possible for greater values, however due to the error factor, active corrosion is likely for  $i_{corr}$  measurements greater than 0.2  $\mu\text{A}/\text{cm}^2$ . Within the initial 10 weeks of monitoring, measurements suggested passive behavior in all specimens, excluding the results of HyFRC-89, which exhibited noticeably higher corrosion activity during the same period despite not forming splitting cracks and not having the greatest maximum flexural crack width among sample sets. While the behavior was not expected, internal cracking in HyFRC-89 specimens may have caused the early corrosion initiation.

The presence of splitting cracks was found to have a significant influence on the corrosion initiation time of specimens. Measurements for C-42s and C-54, which were the only specimens among C and HyFRC samples that formed splitting cracks as a result of preloading, sharply increased between the 12<sup>th</sup> and 14<sup>th</sup> week of experimentation, surpassing the active threshold value of 0.2  $\mu\text{A}/\text{cm}^2$ . After this time, the current density of C-42s was generally greater than that of C-54, which may be attributed to the longer splitting crack width of C-42s (191 mm versus 114 mm) providing expedited chloride migration to a greater surface area of the rebar. Because splitting cracks are formed at the rebar-matrix interface, where the deformed ribs of the rebar bear on the concrete and produce hoop stresses around the rebar (Goto, 1971), cracks observed on the surface of concrete specimens penetrate to the depth of rebar embedment, providing chloride solution a direct path to the rebar. Remaining plain concrete specimens (C-0 and C-42f) reached the active corrosion threshold after 31 to 33 weeks. The C-0 specimens, despite not having cracks as a result of preloading, may have achieved a similar corrosion initiation time as the C-42f specimens due to a higher matrix permeability, as suggested by its lower measured compressive strength (45 MPa versus 53 MPa). When comparing the corrosion initiation times of the C-42f and C-42s specimens, C-42f likely exhibited a delay in activity due to the absence of splitting cracks reaching the surface of the concrete specimen, as the maximum flexural crack width between C-42f and C-42s were similar.

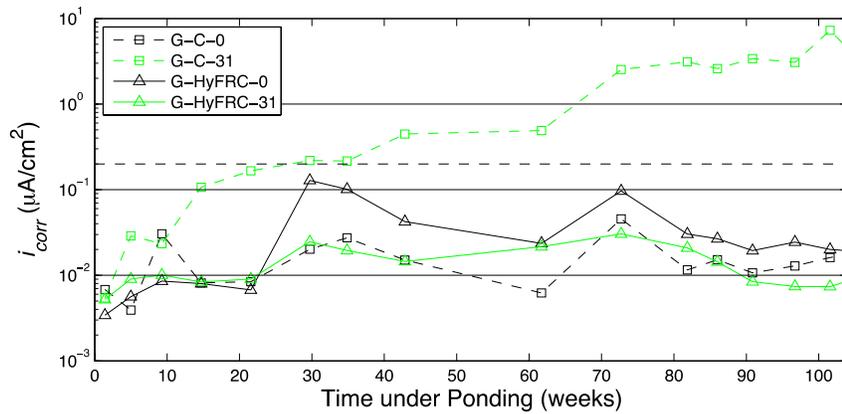
**Figure 6. Microcell corrosion current density of No. 3 rebar in G-C and G-HyFRC beams.**

Measurements of the microcell corrosion current density for G-C and G-HyFRC beams are presented in Figure 6 for 104 weeks of experimentation. Unlike the C and HyFRC specimens,  $i_{corr}$  in these samples was based on Tafel scan tests that directly provided Stern-Geary coefficients, resulting in measurement values without an inherent error factor. Using the lower bound of assumed corrosion activity, G-C-31 specimens may have been actively corroding as early as 14 weeks under ponding, based on  $i_{corr}$  exceeding 0.1  $\mu\text{A}/\text{cm}^2$ . Because these specimens exhibited surface splitting cracks, it is not surprising that the corrosion initiation time was similar to C-42s and C-54, which also had such cracks. For the presented two years of testing, the average corrosion current density of the other specimens (G-C-0, G-HyFRC-0, and G-HyFRC-31) generally remained under 0.1  $\mu\text{A}/\text{cm}^2$ , while G-C-31 reached a peak  $i_{corr}$  of 7.3  $\mu\text{A}/\text{cm}^2$ .

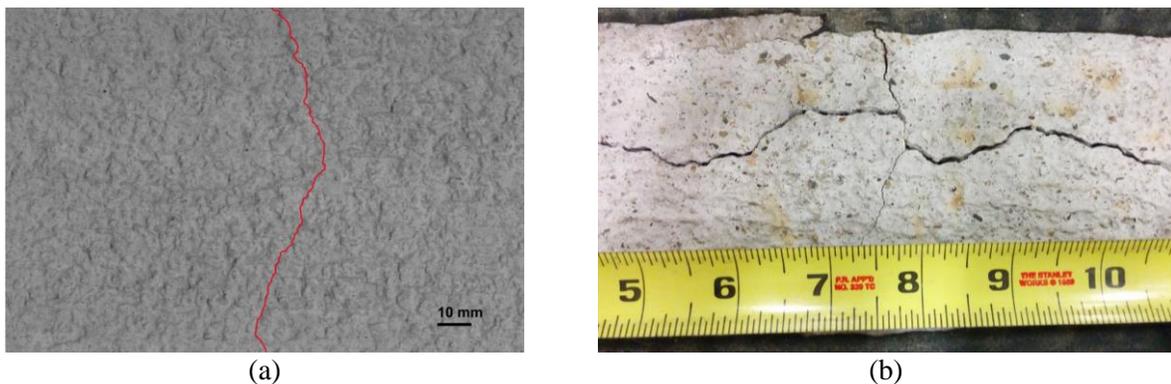
**Figure 7. Ponding surface of a G-C-31 beam: (a) After preloading, with flexural crack highlighted; (b) After 105 weeks of corrosion testing.**

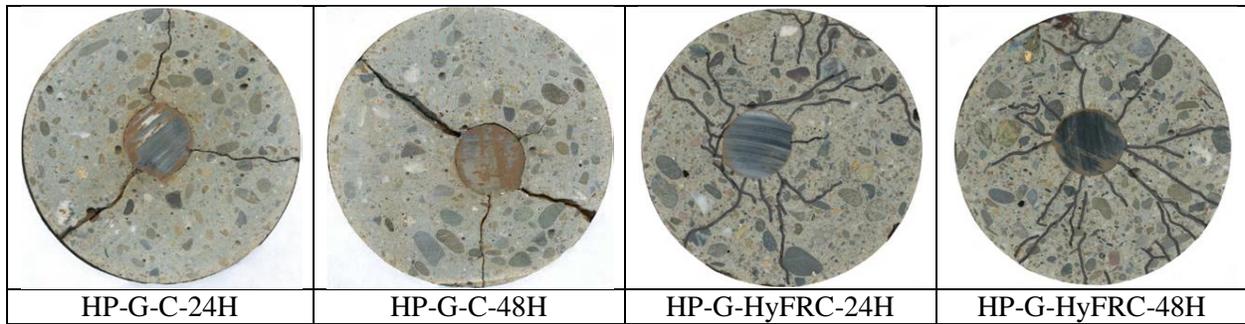
**Figure 8. Cross sectional images of HP-G-C and HP-G-HyFRC after corrosion testing. Cracks are marked for improved visibility.**

Figure 8 shows cross-sectional images of cut specimens after the conclusion of corrosion testing. To improve visibility, cracks were outlined with a black pen. Cracking in the HP-G-C matrix was characterized by a few, dominant cracks. These cracks would manifest as splitting cracks in structural elements, similar to the type previously observed in Figure 7. In contrast, addition of fiber hybridization resulted in more numerous, though finer, cracks. The large crack width in the HP-G-C specimens allowed for a greater ingress of sodium chloride solution and outward migration of corrosion products, resulting in greater corrosion activity. In contrast, as corrosion products formed and produced cracks in HP-G-HyFRC, fibers restricted crack propagation, initiating microcracks elsewhere in the matrix.

Due to this mechanical confinement, corrosion products collected at the steel-matrix interface, locally densifying there. This densification of the corrosion products at the interface is thought to reduce the oxidation rate of iron by the impressed current. When comparing the percentage of mass loss between the specimens, HP-G-HyFRC-24H lost 0.59% of its rebar mass for 24 total hours of impressed current, while HP-G-HyFRC-48H lost proportionally less rebar mass (approximately 0.36%) from 24 h to 48 h despite increasing in  $i_{corr}$ , assuming similar corrosion behavior within the initial 24 h between the two HP-G-HyFRC specimens. The nonlinear rebar mass loss was proposed by Liu and Weyers (1998), who suggested the rate of corrosion product growth decreased in proportion to the amount of product. HP-G-C, lacking confinement effects provided by hybrid fiber reinforcement, was not as effective in reducing the rebar mass loss from 24 h to 48 h, losing approximately 0.54% of rebar mass compared to 0.36% lost in HP-G-HyFRC-48H during the same time period.
