SCMT4
Las Vegas, USA, August 7-11, 2016

Damage Estimation of Buckle Plate Slab Under Fatigue Test by Elastic Wave Method

Kentaro Ohno^{1a}, Kimitaka Uji^{1b}, Atsushi Ueno^{1c}, and Mikio Sekiguchi²

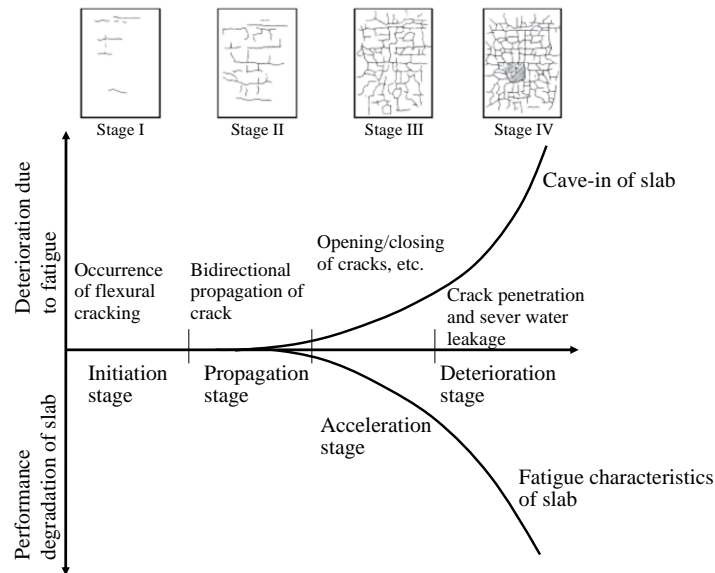
Figure 1. Deterioration process due to fatigue of concrete slab

The number of civil infrastructures built more than 50 years ago has been increasing not only in Japan but also the other developed countries. Especially, since reinforced concrete (RC) slabs are subjected to a variety of environmental conditions such as traffic loads, temperature and humidity, it is important to estimate current state of RC slabs. According to Standard Specification for Concrete Structures in Japan, damage degree in RC slab can be estimated based on crack density on the bottom surface of the slab as shown in Figure 1 [JSCE 2010]. In Japan, the Bridge Inspection Manual is notified by Ministry of Land,

Infrastructure, Transport and Tourism (MLIT) in 2004. The inspection of existing bridge is conducted to each bridge element by visual inspection every five years. Damage degree in RC slab is classified by result of comparing visual inspection with Figure 1. It is important to predict damage in RC slab to draw up the maintenance plan for all bridges before critical damage occurs in bridges.

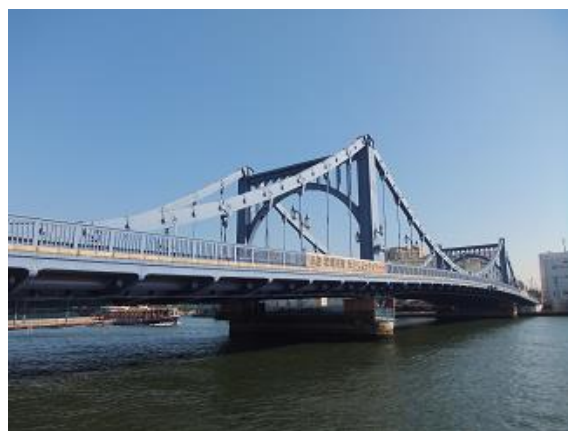
Figure 2. Kiyosu Bridge

Tokyo Metropolitan Government has drawn up a long-term bridge strategy for extending of life in old bridges. Especially, Kiyosu bridge in Tokyo as shown in Figure 2 has been designated as the nationally important cultural properties, thus the maintenance of this bridge is particularly necessary. Buckle plate (BP) slabs have been applied to this bridge. The BP slab consists of steel plate (buckle plate) and concrete, these materials are not connected structurally. Because the amount of information on the fatigue durability of the BP slab is little, fatigue test of BP slab is important for determination of the maintenance plan. In addition, since repair work would be conducted based on inspection result, demand for quantitative estimation method of the current state in a structure is increasing. Besides a regular inspection (visual inspection), nondestructive techniques (NDT) are encouraged to apply to concrete structures. Here, it is well known that acoustic emission (AE) method and impact elastic wave method are powerful tools for defect and crack detection methods by NDT.

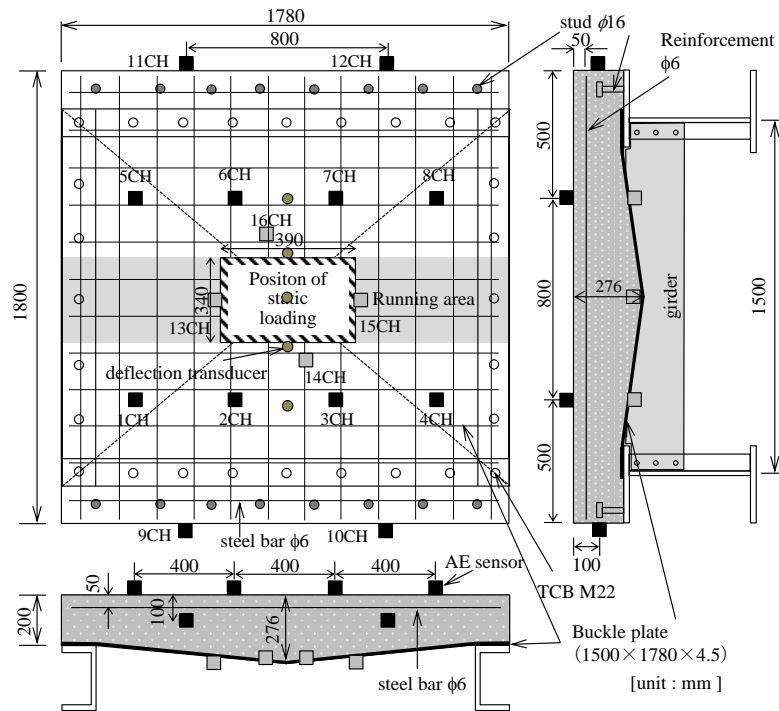
Specimen and Wheel Load Running Test. The specimen was a real size model of Kiyosu bridge’s BP slab. This specimen was made to simulate repair work in the future. Figure 3 illustrates specimen geometry, the dimensions of specimen are 1,780 mm long, 1,800 mm wide and the thickness is changed from 200 mm at the edge to 276 mm at the center. Concrete mixture proportions are given in Table 1. The aggregate used specimen was type II lightweight aggregate, the compressive strength of concrete was 47.5 N/mm², and elastic modulus was 17.0 kN/mm² at 28 days. The SS400 (tensile strength of rolled steels for general structure is 400 N/mm²) was adopted for BP in the slab specimen. The thickness of the BP was 4.5 mm. The studs ($\phi 16 \times 100$ mm) were applied to prevent uplift of concrete from BP.

Figure 3. Specimen details

AE Monitoring and Impact Elastic Wave Method. 12 AE sensors were attached to the concrete surface and 4 AE sensors were mounted on the BP as shown in Figure 3. The resonance frequency of all AE sensors was 60 kHz. AE signals were amplified with 40 dB gain by pre-amplifier, and then they were recorded by AE measurement system. In AE monitoring, sampling rate was 1 MHz, the threshold level was set to 75 dB to avoid noise from testing machine during wheel load running test, and 40 dB of the threshold level was adopted for static loading.

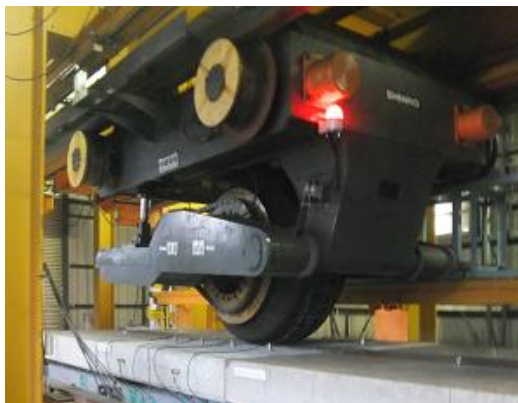
Fatigue test by the wheel load running machine with a rubber tire was conducted at a laboratory as shown in Figure 4. The specimen was simply supported on two shorter edges. Figure 5 shows the loading program for specimen in the test. The experiment was continued until 700 thousands cycles. The experiment was consisted by three steps, 1) wheel load running with AE monitoring, 2) static loading test

Figure 4. The wheel load running machine

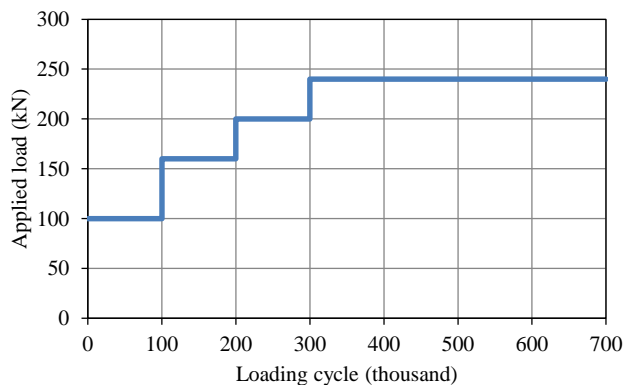
Figure 5. Loading Program

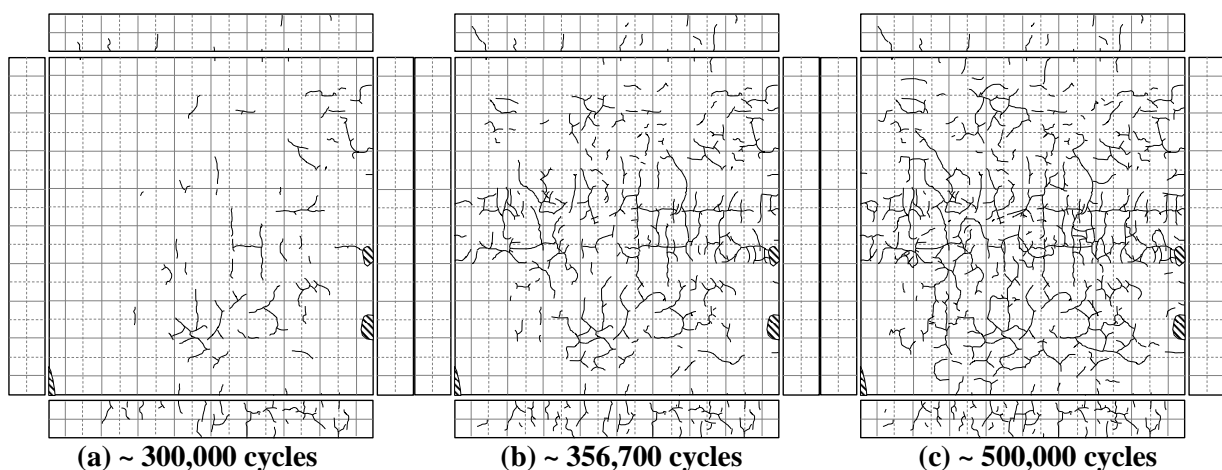
Figure 7. Observed cracks at upper surface of concrete

Results of Wheel Load Running Test with AE Monitoring. Figure 6 shows the delamination area between concrete and BP at the bottom of the specimen. The delamination area was determined by hammering test at bottom of the specimen. The delamination started to occur at edges of the specimen at initial loading within 10 thousands cycles. After that, the delamination area increased with increasing load cycle. Finally, BP completely separated from concrete at 500 thousands cycles. Figure 7 illustrates observed cracks at upper surface of concrete. The visual inspection is usually conducted at bottom of the RC slab, while the surface concrete at the bottom in this specimen could not see because the concrete surface at the bottom was covered by BP. Therefore, status of the concrete was observed from top of the specimen. Surface cracks were observed from 300 thousands cycles, crack density increased with increasing loading cycle. Here, the upper surface of the concrete kept flat plane, aggregate did not appear at the upper surface until 700 thousands cycles corresponding to end of the experiment.

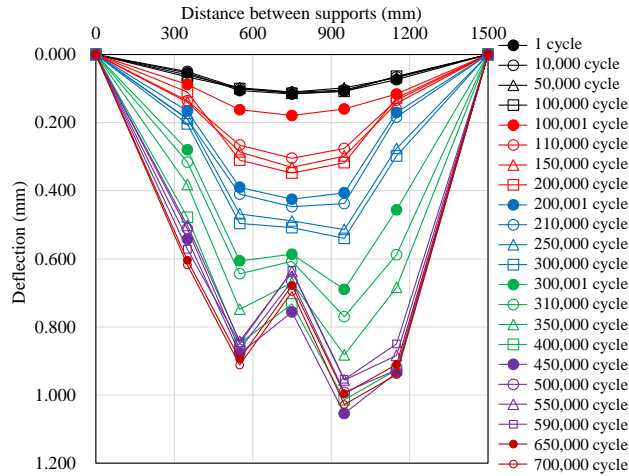
Figure 8 shows the deflection of the specimen. The deflection of the specimen became constant value until 100 thousands cycles, this phenomena shows elastic behavior of the specimen. After increasing of the load level from 100,001 cycles, the deflection gradually increased as increasing loading cycles. The form of the deflection indicated “W shape” observed after 300 thousands cycles. This shape suggests that cracks related with punching shear failure generate in concrete. The biggest deflection occurred at 450 thousand cycles, after that deflection did not change despite increasing of loading cycle.

Figure 8. The deflection of the specimen

AE monitoring was conducted during wheel load running test, the numbers of AE hits per 10 thousands cycles are summarized in Figure 9. The numbers of AE hits increased after 450 thousands cycles at sensors attached to both concrete and BP. Focusing on AE signals larger than 85 dB, the numbers of AE hits detected at BP were large at 10 and 50 thousand loading cycles. These signals were associated with delamination between concrete and BP as shown in Figure 6. At 210 and 250 thousands cycles, AE hits had high amplitude obtained from both sensors attached concrete and BP again. Then, the numbers of AE hits decreased at next cycles. After that, a large number of AE hits were detected at 450 thousands cycles. In this time, since the biggest deflection occurred as shown in Figure 8, it is suggested that AE generation behavior corresponds to failure process in the specimen.

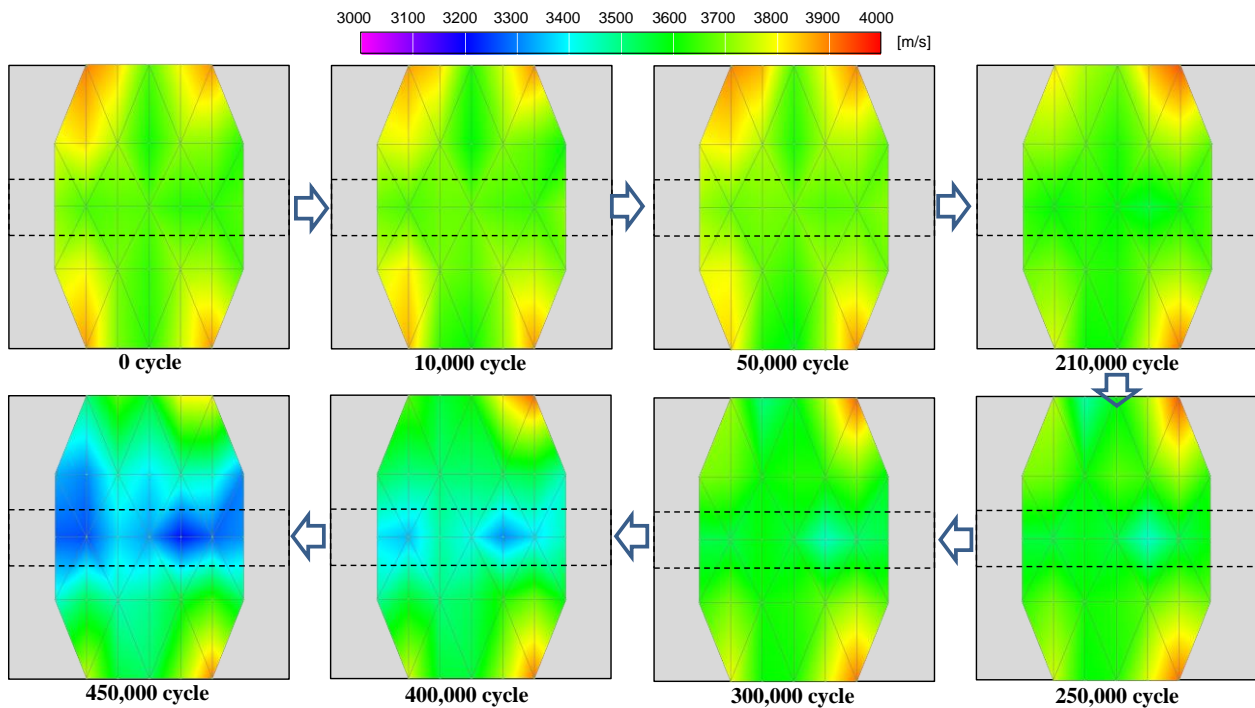
Figure 12 summarizes the results of the travel time tomography. Wave velocity in concrete did not change from initial to 210 thousands cycles. And then, wave velocity at loading area of the specimen decreased at 250 thousands cycles. At this moment, the deflection of the specimen started to slightly form W shape, it is thought that fatigue damage of concrete would be accumulated. After that, cracks were observed at upper surface of the concrete at 300 thousands cycles. Therefore, deterioration of concrete due to fatigue could be estimated by impact elastic wave method before cracks occur at concrete surface. The wave velocity gradually decreased from 400 to 450 cycles, lower velocity area spread from loading area to sides of the specimen.

Figure 12. Results of the travel time tomography

- The state of concrete in BP slab can be estimated by the travel time tomography. The damage area is visualized by changing of wave velocity in concrete of the specimen.
