SCMT4
Las Vegas, USA, August 7-11, 2016

Out of Plane Experimental Behavior of T-Shaped Full Scale Masonry Orthogonal Walls Strengthened with Innovative Composite Systems

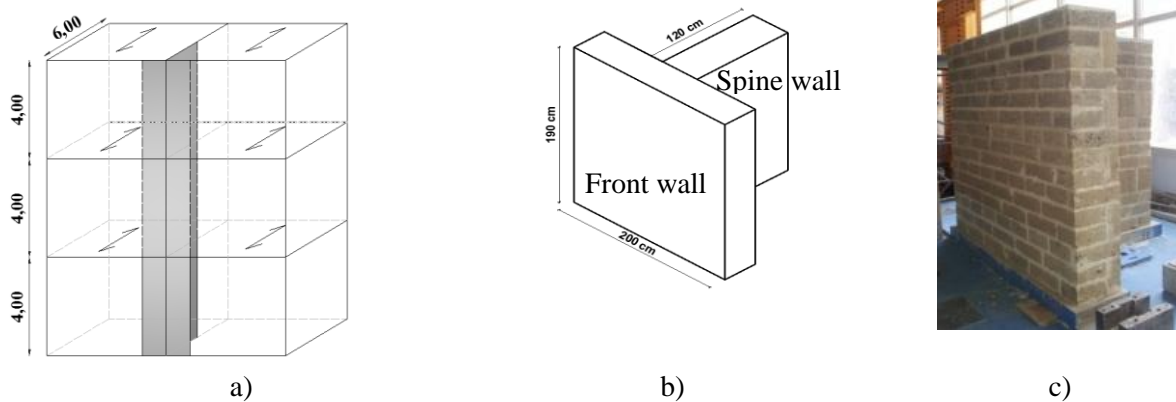
Figure 1. Designed specimen: a) Building scheme; b) Specimen dimensions; c) As-Built specimen.

A full scale T-shaped masonry wall has been designed in order to reproduce common orthogonal bearing walls of existing masonry structures. Furthermore, a poor connection between the orthogonal walls has been designed to simulate common execution practices. The dimensions of members and connections details were chosen to simulate a T-shaped connection of a tuff masonry building with three floors, as shown in Figure 1a. The specimen height is 1900 mm, the width of the two orthogonal walls are 2000 mm and 1200 mm respectively (Figure 1b,c). The thickness of the two orthogonal walls (i.e. front wall and spine wall) is 400 mm.

The masonry specimen is made by yellow regular Neapolitan blocks (370x250x105 mm) with a traditional regular texture; the mortar thickness is about 10-15 mm. In order to reproduce a weak connection between the two orthogonal walls, the connection between front and spine wall consists of 105 mm in plan view (i.e. about 1/3 of the wall thickness) and it is not constant along the wall height (i.e. 10 on 15 courses along the specimen height).

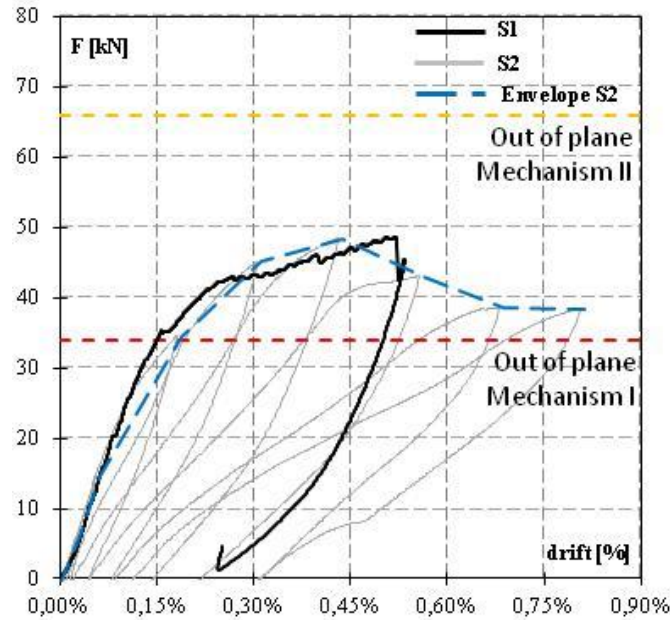
Figure 2. Force - drift relationship: test S1 and S2

The figure shows that the experimental trend of horizontal force - drift relationship recorded on *S2* was very similar to that of specimen *S1*. This confirmed that the repair was effective to restore the initial stiffness of T-shaped masonry wall.

The specimen behavior was characterized by a first linear elastic branch up to horizontal force $F = 35$ kN, corresponding to a drift 0,16% in *S1* test and 0,19% in *S2* test; by increasing the horizontal out of plane

displacement, the curve slope decreased and the peak force ($F_{max} = 48 \text{ kN}$) was attained at a drift 0,52% and 0,44%, in *S1* and *S2* test, respectively. Besides, in *S2* test a post-peak behavior was observed up to a drift 0,81%. Note that, in both tests, the change of slope of the horizontal force - drift curve started at horizontal force values very close to that predicted as the theoretical force to activate out of plane failure Mechanism. This confirms that the connection, even if not fully effective, was sufficient to delay the overturning of the front wall according to Mechanism I.

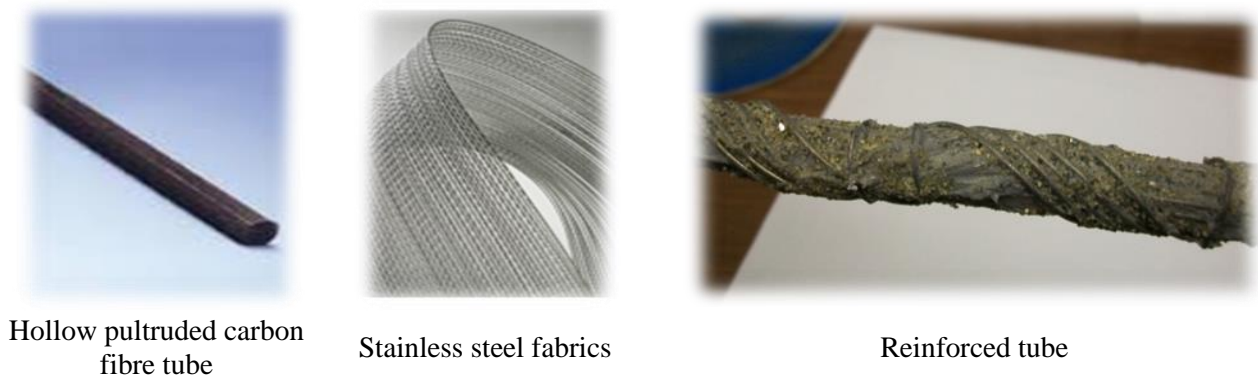
Figure 4. Reinforced hollow pultruded CFRP tube

In order to increase the transverse strength of tubes and the bond between injected mortar and tubes, they were wrapped by using longitudinal and spiral stainless steel fabrics (average failure load 3600 N); the steel fabric was installed around the tube by using an epoxy based mortar as shown in Figure 4.

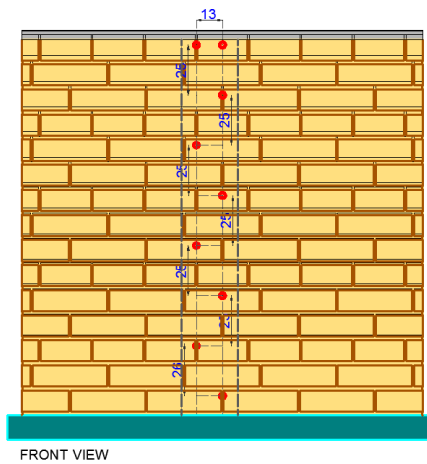
Figure 5. CFRP connection: holes location

The CFRP tubes reinforced with stainless steel fabric were inserted in 30 mm diameter holes with a length of 1200 mm; the layout of holes is depicted in Figure 6. The holes were located along two vertical lines in the connection zone between the front and the spine walls; the horizontal spacing of vertical holes was 130mm while the vertical spacing of holes was 250mm, see Figure 5.

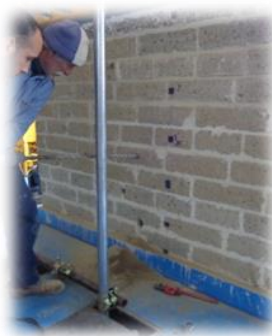
a) Drilling of holes

The installation of the strengthening technique involved the following steps, see Figure 6: i) drilling of holes with 30 mm diameter, 1200 mm length (Figure 6a); ii) filling of the holes by water at low pressure in order to clean the holes - 24 hours before the injection - (Figure 6b); iii) installation of reinforced tubes in the holes and relevant injection nozzles (Figure 6c); iv) installation of pipes to remove air and sealing the holes (Figure 6d); v) injection of superfluid, cement free, fillerized hydraulic binder, based on lime and Eco-Pozzolan, with manual pump (Figure 6e); vi) removing of injection nozzles and sealing of holes with mortar (Figure 6f).

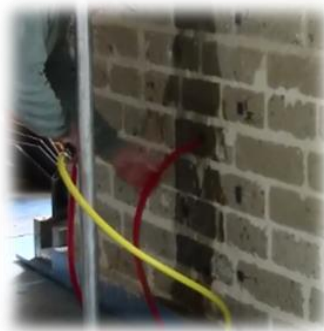
b) Filling of holes

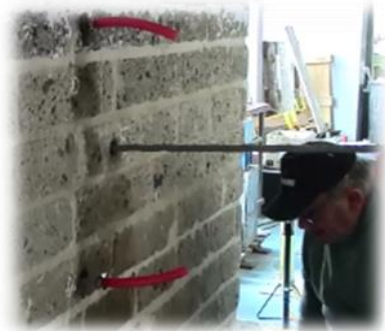
c) Insertion of reinforced CFRP tubes

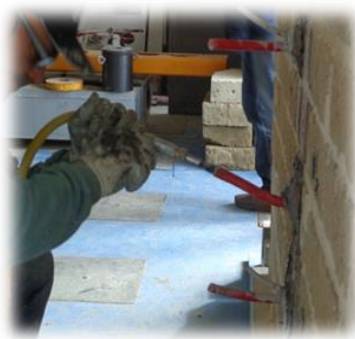
e) Injection of mortar

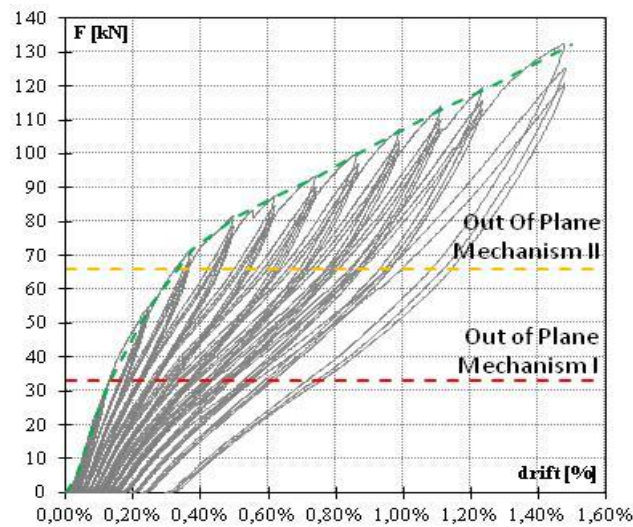
Figure 7. Force - drift relationship: test S3

The strengthened specimen was tested by the simultaneous application of vertical constant loads and horizontal displacements, as for test S2. The loading path of cyclic horizontal displacements in out of plane direction is reported in Table 1; the test on the strengthened specimen, test S3, ended at cycle XII corresponding to a horizontal maximum displacement of 23 mm (i.e. drift of 1.44%). The horizontal force - drift relationship is reported in Figure 8; the envelope curve is depicted by using a dashed line. The horizontal force - drift envelope curve has an increasing trend up to the maximum drift. The curve is characterized by two linear branches with a different slope: the first branch reached a force of 73 kN, and a corresponding drift of 0,31%; the second branch had a lower slope with respect to the first one and ended at a force of 132 kN, corresponding to a drift of 1.44%. The strength increased by a factor of 2.75 with respect to previous tests. Furthermore, the maximum horizontal force was greater than the theoretical one related to the formation of failure Mechanism II. No significant cracks were observed on the specimen up to the end of the test; a rigid rotation of the T-shaped masonry specimen was observed, as confirmed by the cyclic opening and closing of a crack at the base of the specimen on the spine wall (see Figure 8).

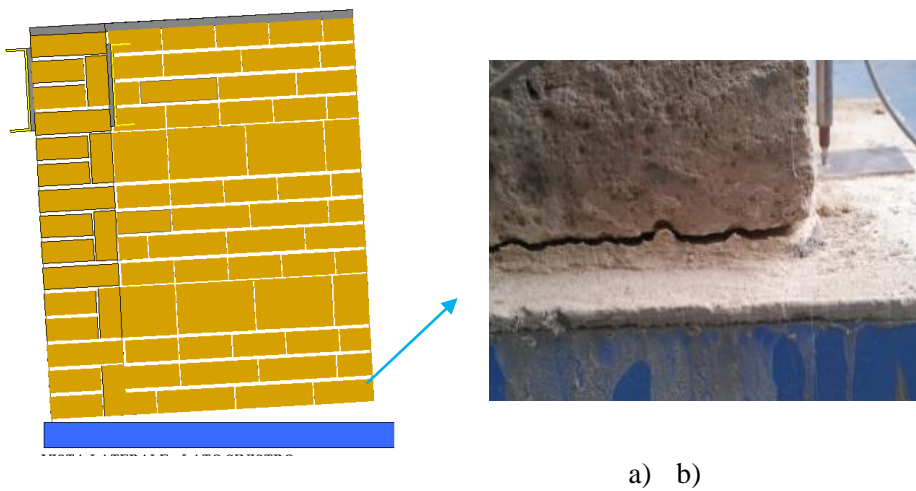
Figure 8. Rigid rotation of the strengthened specimen with innovative composite system
