EXPERIMENTAL AND ANALYTICAL STUDIES ON CRACKING DUE TO CORROSION IN REINFORCED CONCRETE SLAB

This paper aims to present both experimental and analytical studies of reinforced concrete (RC) slabs embedded with multiple reinforcing bars. Crack initiation patterns and crack propagation due to the corrosion of rebar were investigated for RC slabs. The rebar spacing of specimens in this study was 60mm, 120mm and 240mm. Results from electrolytic corrosion experiments, revealed that crack initiation patterns were influenced by concrete depth and rebar spacing. Additionally, crack propagation was more dominant in the horizontal direction than the occurrence pattern. The corrosion weight loss of rebar for initial crack growth cracks was approximately 50 mg/cm² in this study. For crack initiation patterns and crack propagation, similar results were obtained by numerical analysis.

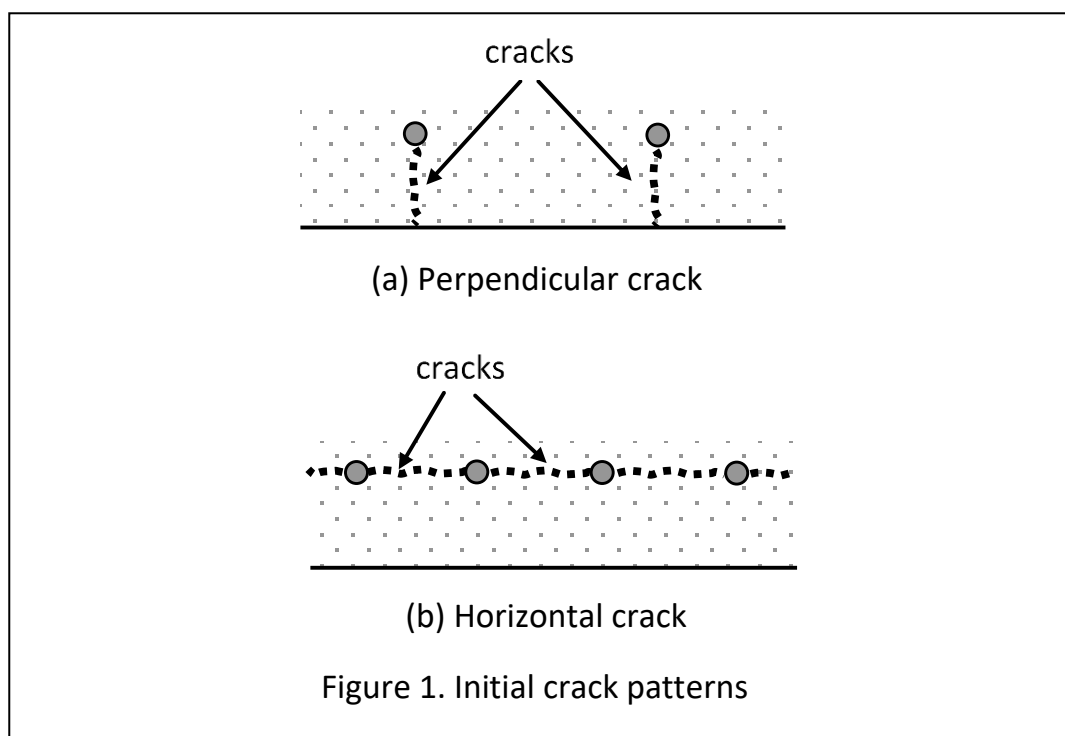
Corrosion often leads to cracking and spalling of concrete due to the production of rust, which occupies a greater volume than the steel that produced it. If the concrete covering the rebars is relatively shallow, and/or the rebars are widely spaced, cracks form perpendicular to the concrete surface (Figure 1a). However, if the concrete covering the rebars is relatively deep, and/or the rebars are closely spaced, cracks form parallel with the concrete surface (Figure 1b)^{1),2)}. Figure 2 shows the propagation of cracks that follow the line of rebar in a concrete beam. The cracks are due to a thin cover of concrete at the bottom of the beam and are expected to expand over time.

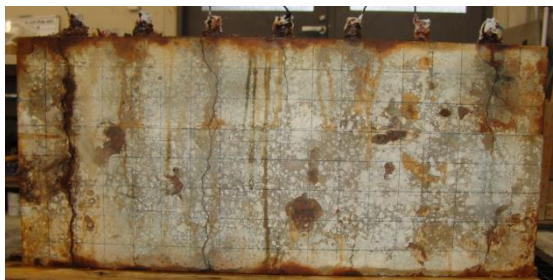
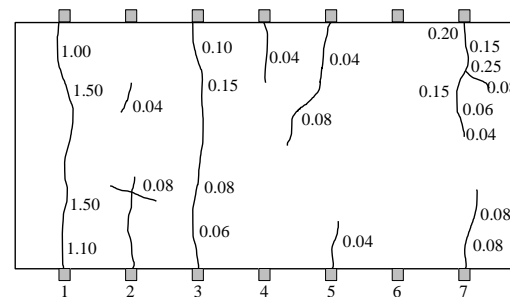
Figure 11. Crack patterns of the specimen with 120 mm interval

Figure 12. Crack sketches and crack widths of the specimen with 120 mm interval (unit: mm)

The accelerated corrosion test was conducted for 670 hours at 1.7A. The rebars were numbered 1~7. Figure 11 shows crack patterns on the specimen with 120 mm spacing. Sketched crack patterns and crack widths are shown in Figure 12. On the end surface, cracks initially appeared in the vertical direction, followed by horizontal cracks propagating between the bars. Slight inclined cracks were observed at bars 1 and 7 which propagated towards the side surfaces of the concrete (Figure 12a). The width of the horizontal cracks ranged from 0.20 mm ~ 0.85 mm. On the bottom surface, the

largest crack width along rebars 1 and 7 was 1.50 mm. Crack widths along rebars 2~6 however, did not exceed 0.15 mm.

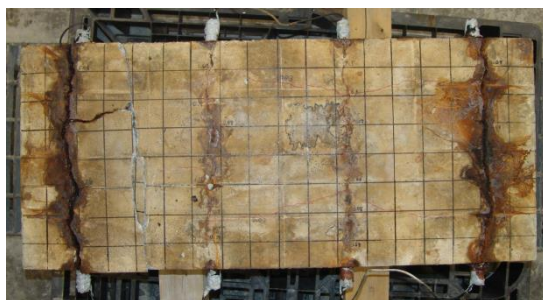
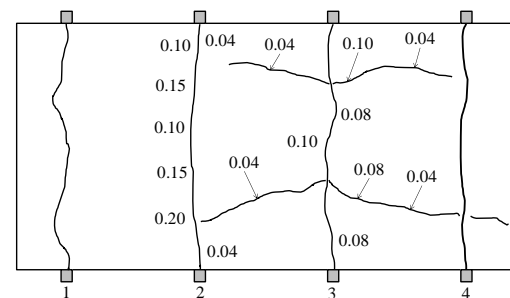
Figure 13. Crack patterns of the specimen with 240 mm interval

Figure 14. Crack sketches and crack widths of the specimen with 240 mm interval (unit: mm)

Figure 13 shows crack patterns on the specimen with 240 mm spacing. The accelerated corrosion test was continued for 857 hours at 1.0A. The rebars were numbered 1~4. Sketched crack patterns and crack widths are shown in Figure 14. We were not able to measure the crack width on the end surface because it peeled off (Figure 13). The crack patterns were similar to the specimen with 120 mm spacing in that the initial vertical cracks did not widen. However, the horizontal cracks extended along the bars with corrosive progression.

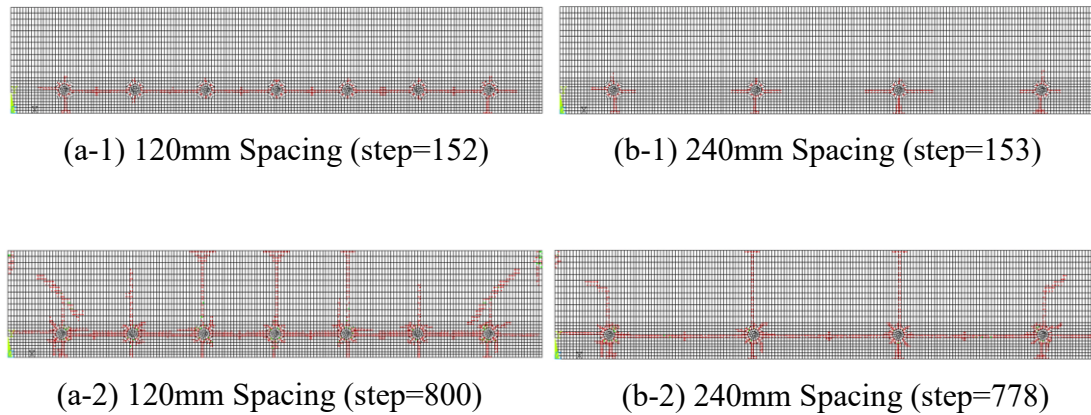
Figure 19. Crack development

Cracks developed at two stages for the specimens with 120 mm and 240 mm spacing (Figure 19). After vertical cracks initially appeared, cracks developed horizontally from each rebar with rust expansion (Figure 19a-1 and Figure 19b-1). The horizontal cracks eventually joined together between rebars (Figure 19a-2 and Figure 19b-2). Cracks to the left and right sides were different from the experimental crack propagation in that the cracks were parallel to the bottom of the specimen. As well, there were more vertical cracks. The progress of horizontal cracks between reinforcing bars was approximately similar to the experimental results. From the analytical crack propagations, it is apparent that cracks in the horizontal direction prominently progress after crack initiation due to rebar corrosion.
