REHABILITATION OF TRANSPORTATION INFRASTRUCTURE IN WEST VIRGINIA WITH FRP WRAPS

Wael Zatar ^{1*} and Hai Nguyen ¹

¹ *Marshall University, College of Information Technology and Engineering, Huntington, West Virginia, United States of America (*corresponding author: zatar@marshall.edu)*

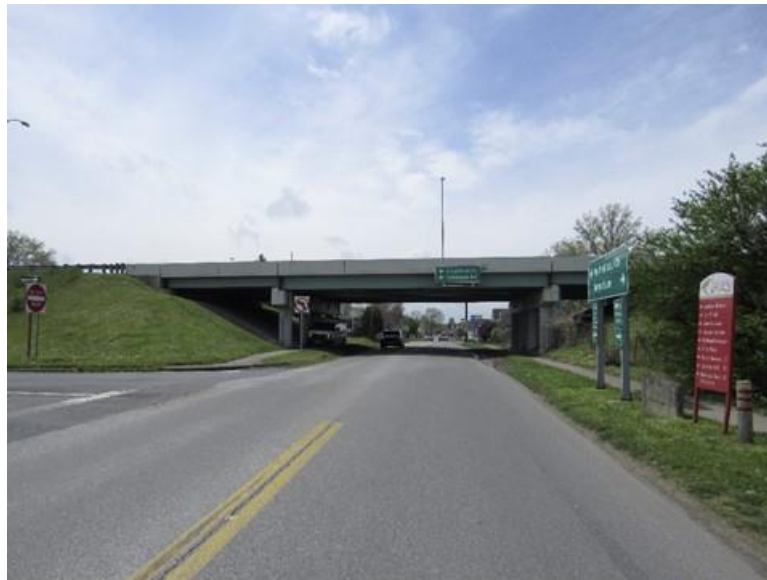
(a) Bridge elevation (looking west) (courtesy: WVDOT 2018 routine inspection report)

Madison Avenue overpass bridge (Figure 1) is located 0.57 miles north of Interstate I-64 in Huntington, West Virginia (District 2, Cabell county). This bridge was built in 1966 with four lanes of traffic and 16,900 average daily traffic (as of 2012). According to WVDOT 2016 bridge inspection report, the structure consists of three steel-beam spans (SSWB) with span lengths of 30'-0", 57'-6" and 25'-6" centerline to centerline of bearings. It is supported at both ends by reinforced concrete stub abutments, which are founded on spread footings, and intermediately by two open-type reinforced concrete piers. The elevation of the bottom of the footing is 567.16 at Abutment No. 1, 551.00 at Piers No. 1 and 2, and 565.79 at Abutment No. 2. The overall length (end to end) of this bridge is 118'-2 ½". The 7" reinforced concrete deck, which includes a ½" wearing course, is 62'-5" wide (parapet to parapet). The asphalt wearing surface is an average 6" thick. The deck width (out to out) is 65'-2". WVDOT 2012 interim inspection report revealed that pier #2 was severely spalled and delaminated. Deck and superstructure were in very good condition while piers and pier caps are in poor condition. The

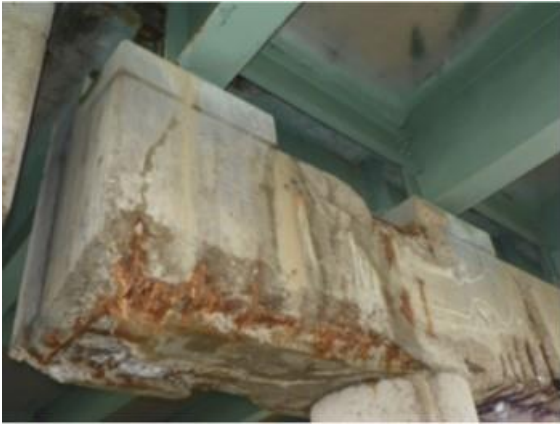
Spalling and exposed rebar on east cap, pier #2

(b) Bridge condition before rehabilitation (courtesy: WVDOT 2012 interim-condition inspection report)

geometry of the bridge was such that the two ends are at different elevations with south end at lower elevation and north end at higher elevation. As the pier caps on the south end were at lower elevation, they are affected severely by the rainwater seeping from this end (Kotha 2013). Pier caps were scheduled for repair beginning March 2012 and they were rehabilitated utilizing concrete patch and GFRP wraps. According to William (2016), total repair cost of this bridge is approximately \$47,637 (\$42 per square feet) while estimated costs to replace piers and/or entire bridge are from 1.2 to 2.5 million dollars. This indicates the cost effectiveness of the FRP-strengthening system. It is predicted that more than one thousand bridges in the state of West Virginia will benefit from this cost-effective repair system using FRP jackets.

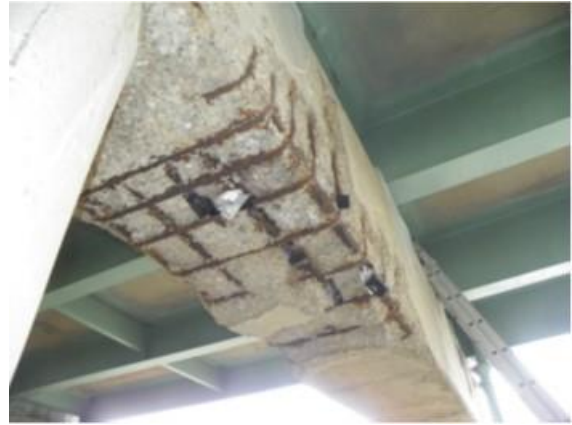
Spalling and exposed rebar on bottom of a cap, pier #2

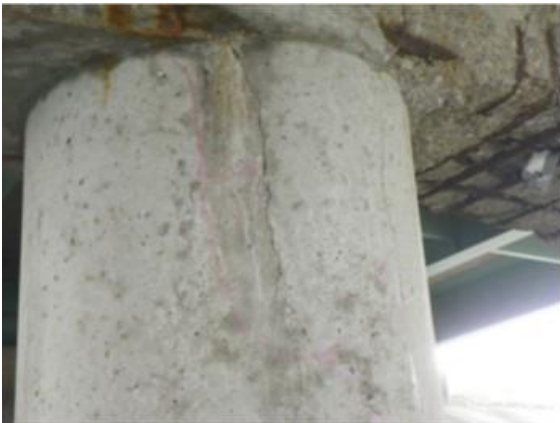
Cracking on column #1, pier #2

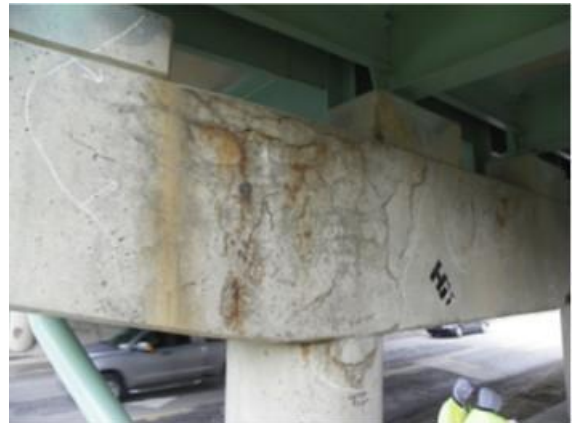
Cracking and delamination on pier #2

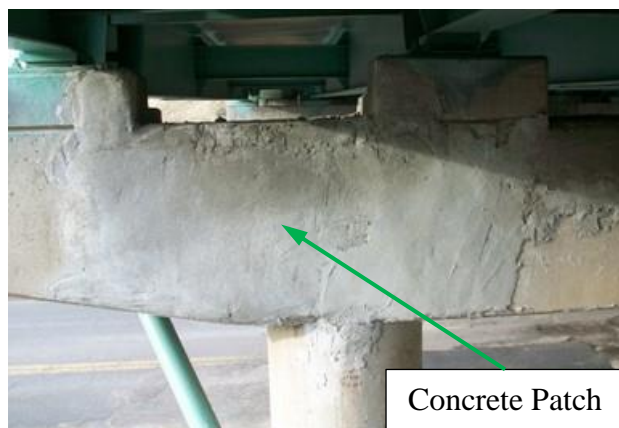
Concrete Patch

(c) Applied concrete patch (top) and locations of GFRP wrap and concrete repair (bottom) (images courtesy of Williams, 2016)

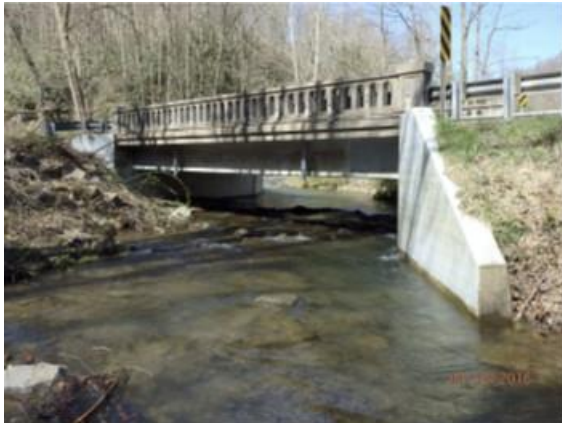
Bridge elevation

Figure 2. Details of Flag Run bridge (courtesy: 2016 WVDOT bridge inspection report)

Flag Run bridge (Figure 2) is located 0.03 miles north of county route 72/6 in Preston county (District 4), West Virginia. This reinforced concrete (RC) bridge was built in 1940 with two lanes of traffic and 650 average daily traffic (as of 2014). It has a single span with total length of 43.2 ft. and a span length of 40 ft. According to WVDOT 2016 bridge inspection report, the bridge superstructure consists of four RC T-beams (33 in. high and 16.5 in. wide) topped with cast-in-place RC slab and supported by two full-height concrete abutments. Entire bottom face and side faces at both ends of T-beams were wrapped with CFRP composites in 2002 to achieve

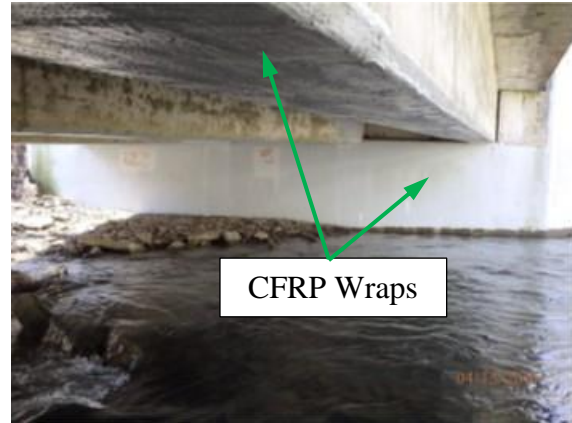
CFRP wraps in abutment #1 and underside of a T-beam

an HS-25 design loading. Abutments were also wrapped with CFRP and the backwalls were patched.

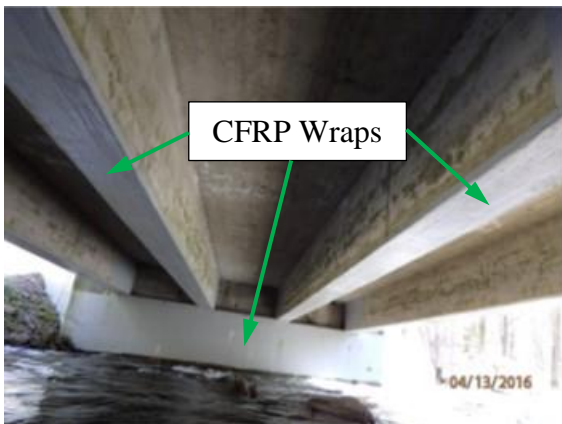
Overview of CFRP wraps in T-beams and an abutment

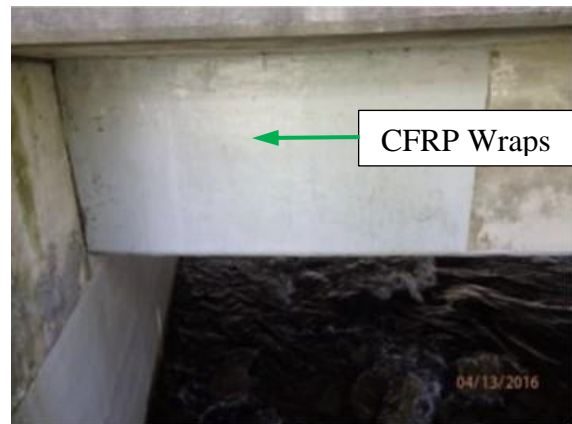
CFRP wraps at the end of a T-beam
