UT INSPECTION PRACTICE FOR ANCHOR BOLTS

Ali Abdullah Al-Shehry

Engineering Division; Sea Water Injection Department; Saudi Arabian Oil Company. O. Box 11656 Dhahran 31311 Saudi Arabia, Email<shehaa2h@aramco.com>

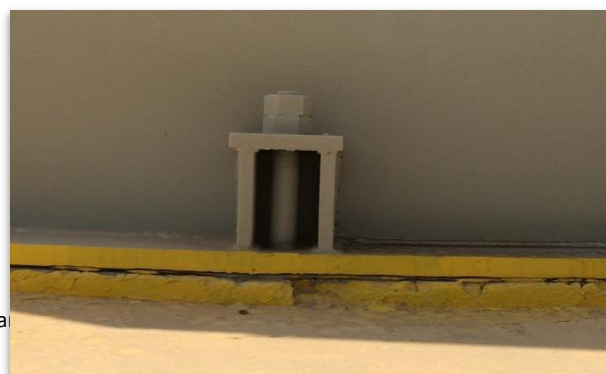
Visual inspection of the existing embedded anchor was performed at the subject facility to detect the deficiencies in the anchor bolts of aging structures. Figure 1. shows typical external view of the embedded anchor bolts and the concrete foundation. Neither no signs of cracks on the concrete foundation nor signs of corrosion on the embedded anchor bolts were found.

Figure 1. typical external view of the embedded anchor bolts and the concrete foundation

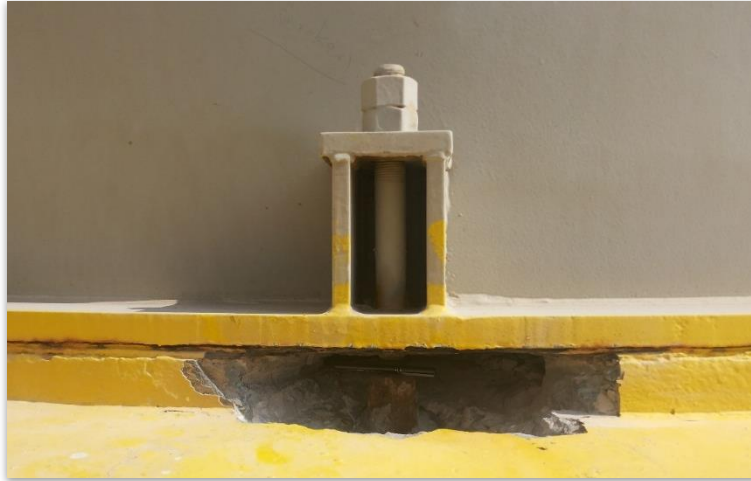
It can be seen from the figure that the anchor bolts and the foundation are in a good condition, however after performing the conventional method of inspecting the embedded anchor bolts by chipping the concrete structure to assure that it is in a good condition, the anchor blot were found broken as shown in figures 2 and 3.

Figure 2. view of the broken anchor bolt and the chipped foundation

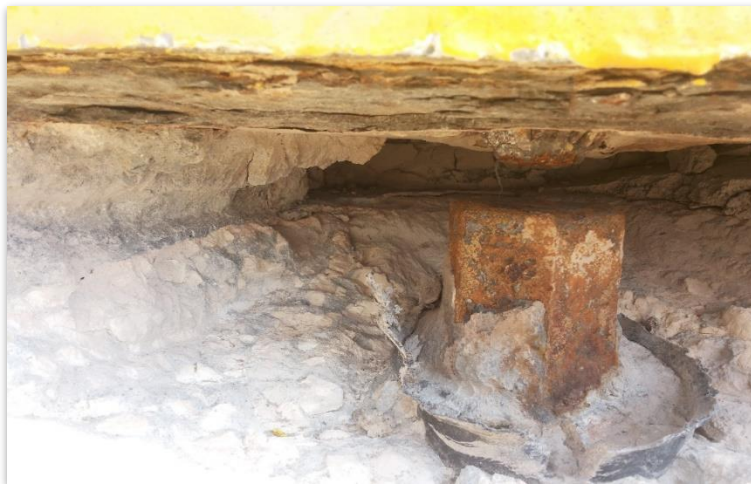
Figure 3. view of the broken anchor bolt

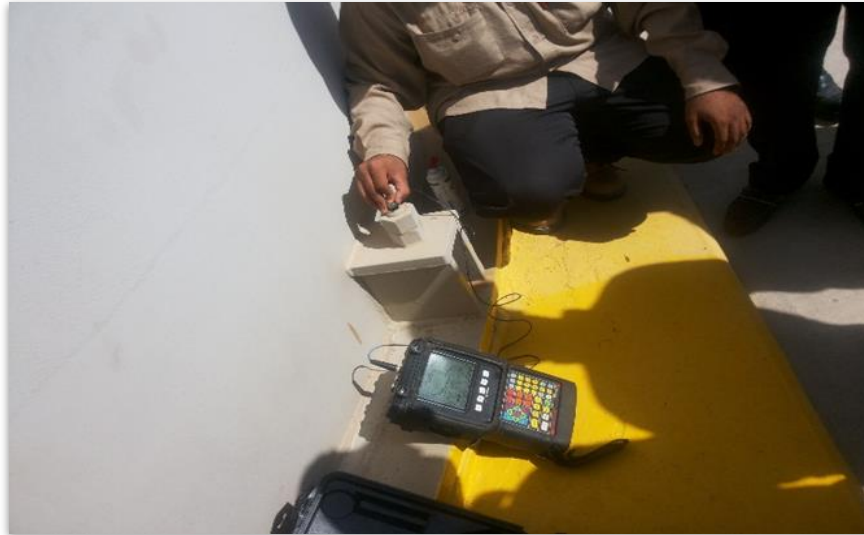
It was difficult to perform the conventional method and exposing all the embed anchor bolts where 448 anchor bolts have to be exposed at the subject facility. Thus, ultrasonic testing technique was performed to determine the condition of the embedded anchor bolts as shown in figure 4.

Figure 4. view of performing the UT technology

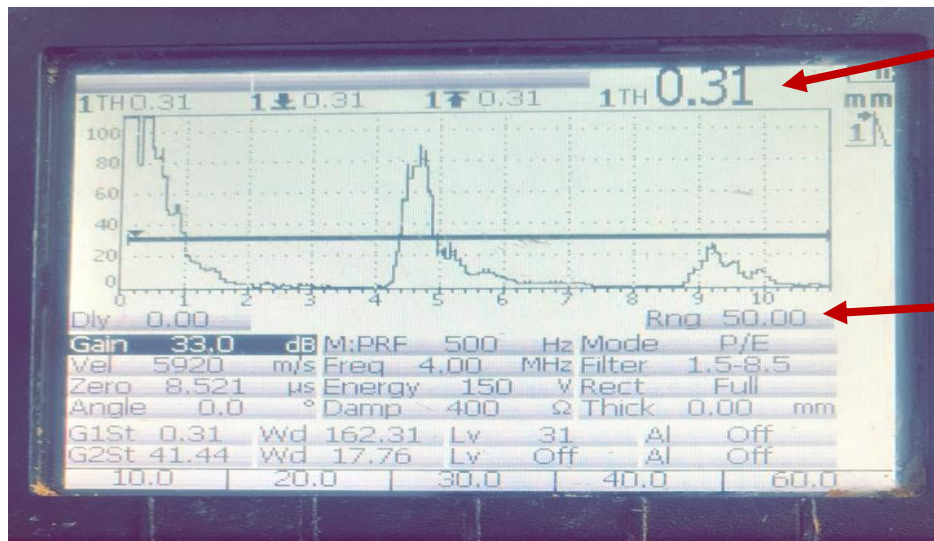
Data is acquired by using a hand-held, battery-operated ultrasonic flaw detector as shown in figure 5. Non-destructive UT is implemented using straight-beam configuration. Therefore, the range highlighted in figure 5. was increased to the total length of the existing anchor bolt which was 1165 mm. Figure 6. shows the UT small probe called ultrasonic transducer that was used in order to launch longitudinal wave to the surface of the anchor bolts that being tested.

Figure 5. view of the UT device screen

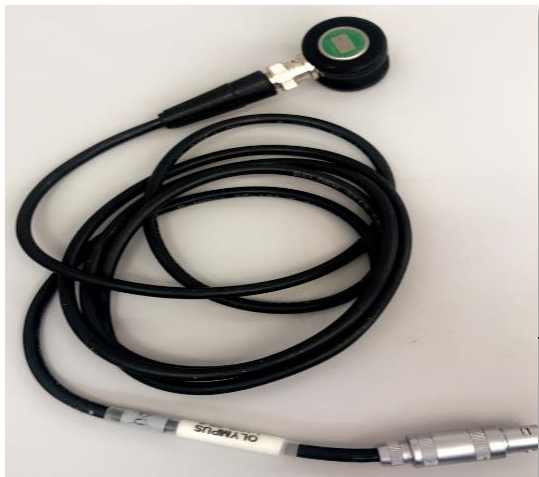
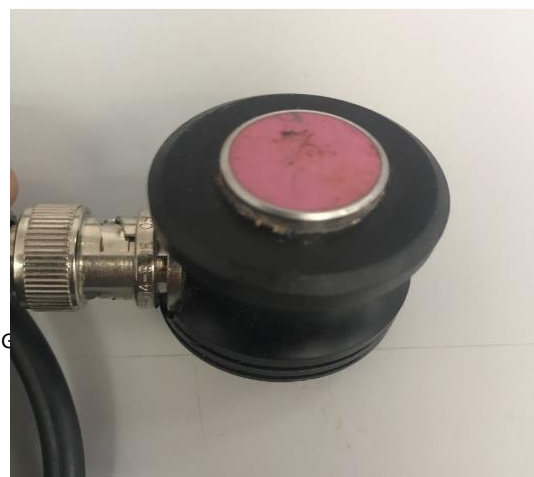
Figure 6. views of the UT probe transducer
