Fatigue testing of glass/epoxy joints in timber up to the endurance limit.

P A Claisse, T J Davis and B Masse

Civil Engineering Group, Coventry University, Priory Street, Coventry, CV1 5FB

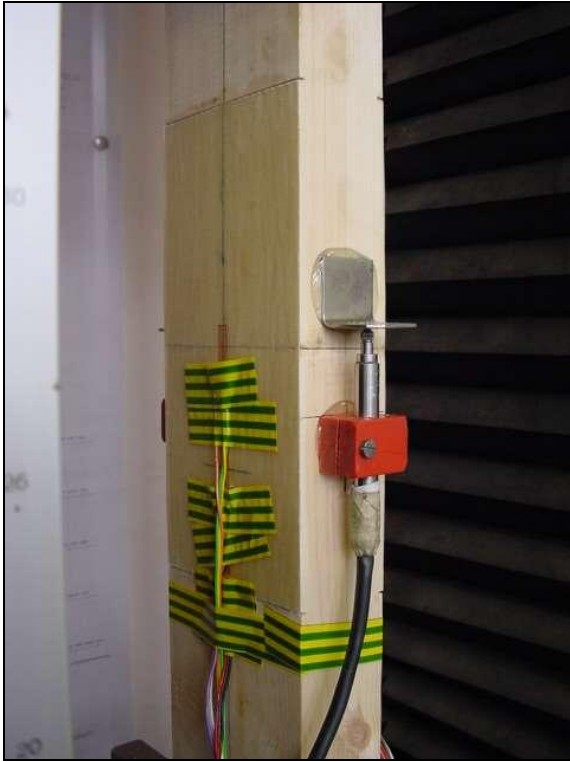
Figure 5 Sample in position ready for the fatigue test.

PVC and steel brackets were glued onto the timber in order to hold the LVDTs in position. The LVDTs measured displacements at the gap position between the brackets located on either piece of timber. They were fixed in a symmetrical arrangement to check any misalignment of the sample. Strain gauges were used only to measure strains in the glass fibre/epoxy layer. They were embedded directly at the surface of the composite matrix in the epoxy, with a thin coat added on top of it, while the samples were fabricated. Strain gauges were positioned in a same arrangement on each side of the sample. LVDT and strain gauges locations on the sample are shown in figures 4 and 5.

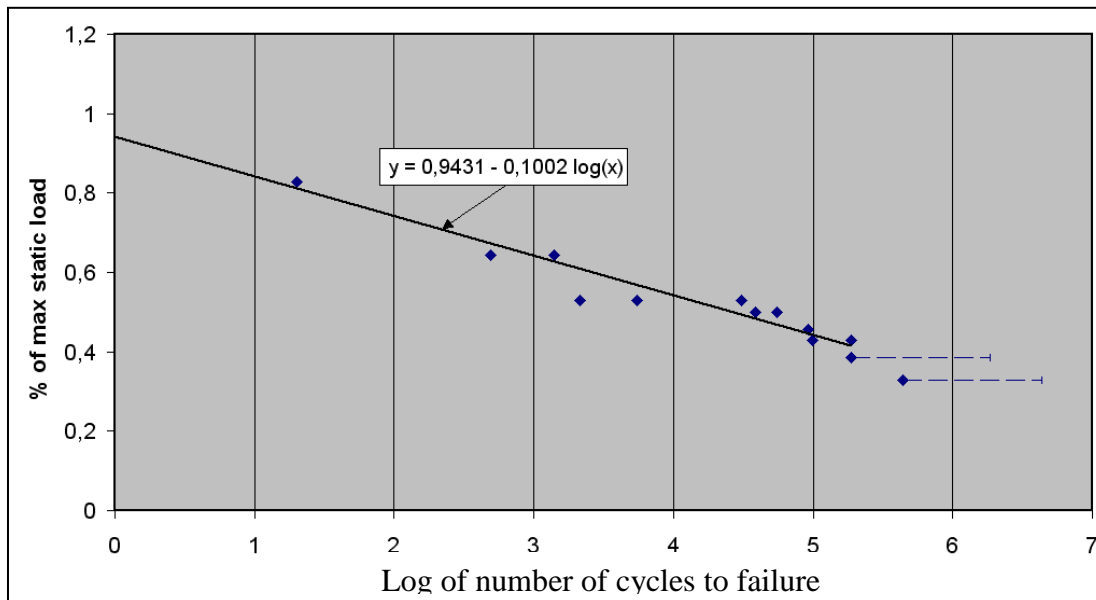
Figure 6 S-N normalised curves

The results presented in table 4 are plotted in the S-N curve with linear maximum load versus logarithmic scale of the number of cycles, as shown in figure 6. The graph clearly indicates the linear relationship between the results of maximum load versus the logarithmic of the number of cycles.

Figure 6 shows that the “ten percent” rule applies well to the data reported here. The trend line equation shown in figure 6 fits very well the previously presented equation (1) that characterised the S-N behaviour of composite materials. In fact, the material constant C' is equal to 0.94, which is very close to one. The slope of the curve b is equal to 0.1002 that corresponds to the optimum slope, according to conclusions from the DOE/MSU Database: A slope b equal to 0.10 defines the good materials as the curve is approaching the best fatigue behaviour that can be obtained for glass fibre laminates in tensile fatigue (see figure 17).

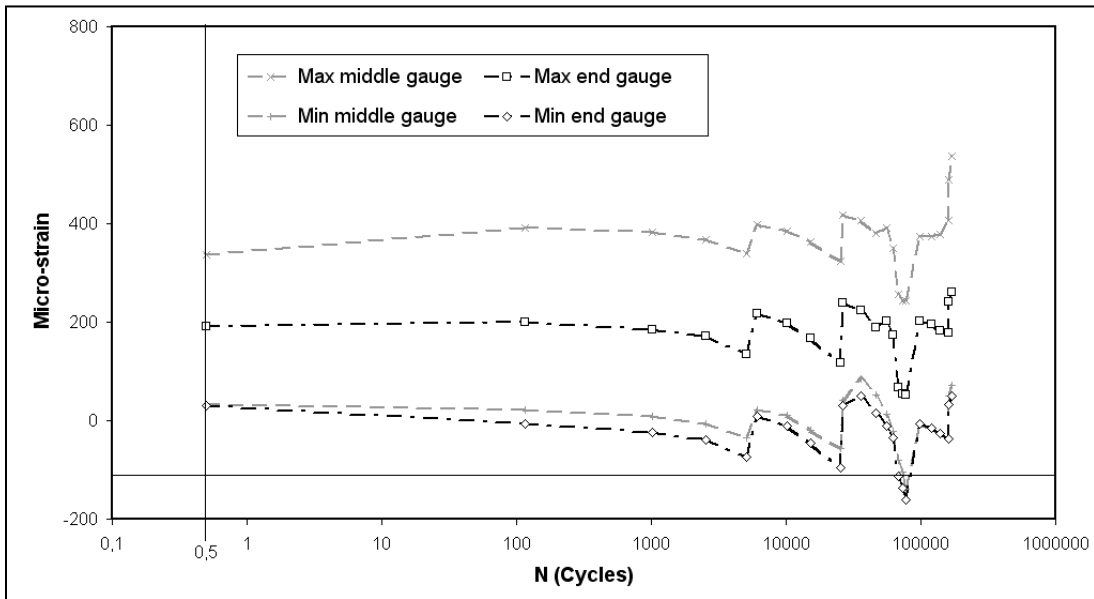
Figure 10 Maximum and minimum middle and end strains recorded at maximum and minimum cyclic loads of 16 kN and 1.4 kN for sample 11A

Some joints were equipped on both faces with strain gauges in the middle and end of the glass fibre. Some of the results obtained are shown in figure 9. Because of the locations on the glass fibre, the results of middle and end strains are always lower than those obtained from the gap strains. Figure 10 shows that for a sample that was tested at slightly lower cyclic loads, such as sample 11A the strain distributions are radically different.

At lower cyclic loads, the middle and end strains behave in a different manner across the sample's fatigue life. Maximum and minimum values display the same curve shape. All values of strains remain very steady up to around 10000 cycles. Then the behaviour becomes more chaotic but still relatively constant up to the failure. It is interesting to notice that the strain distributions have the same shape and amplitude in the middle gauges as in the end gauges. Near failure, each strain has hardly increased. This clearly demonstrates that at lower cyclic loads there is less plastic strain developing. In fact middle and end strains are less affected by the cyclic loads. In theory, at some sufficiently low cyclic load, the strain distribution all over the composite surface will remain constant during the fatigue: This low load will correspond to the endurance limit of the joint.

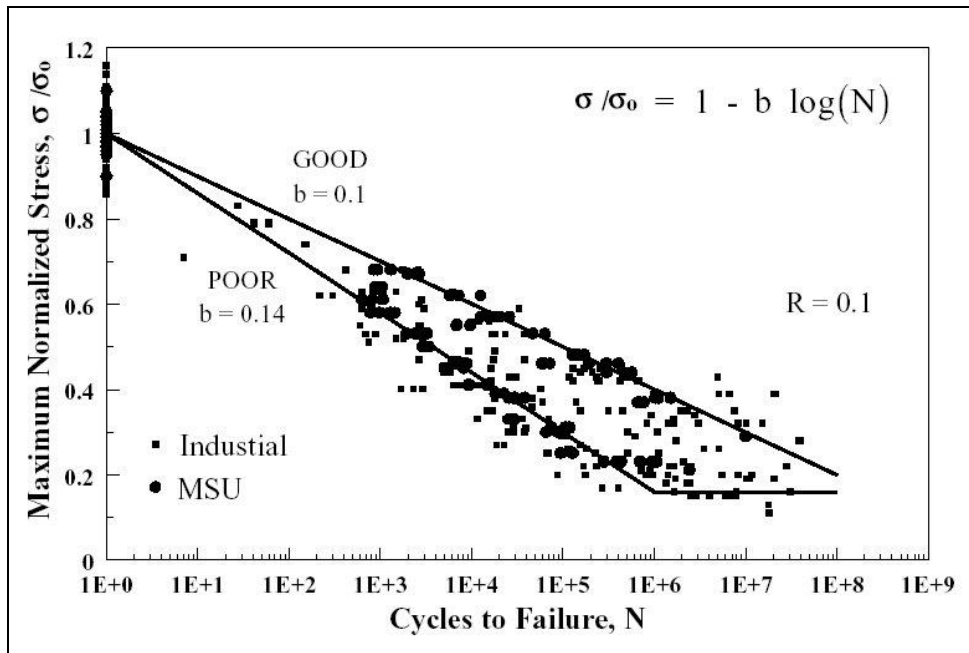
Figure 17 Extremes of normalised S-N tensile fatigue data from glass fibre laminate at $R = 0.1$ (from reference 5).

Equation (1) was used to characterise the DOE/MSU database. This formulation has led to the “ten percent” rule that is typically used as a general rule-of-thumb for the tensile fatigue behaviour ($R \approx 0.1$) of unidirectional composites. The fatigue strength of the composite is reduced by ten percent by each decade of fatigue cycles, when C is one and b is equal to 0.1 (i.e. the fatigue exponent m is equal to 10). This form is typically used for composites when comparing different material systems because it normalises out variations in the static strength. A large number of data points from the DOE/MSU database are plotted in figure 17.

These data are for glass fibre composites with at least 25% fibre content in the loading direction tested at $R = 0.1$. When applying equation (1), the good materials have a slope b of 0.10 and the poor have a slope b of 0.14. The good materials in this figure are approaching the best fatigue behaviour that can be obtained for glass fibre laminates in tensile fatigue. The small apparent variation in the fatigue slope b produces significant differences in high endurance fatigue performance. As shown in figure 17, at 20% of static strength, the good materials have almost 2.5 orders of magnitude longer life than the poor materials.
