## **Durable Retrofitting of Concrete Structures**

### **ABSTRACT**

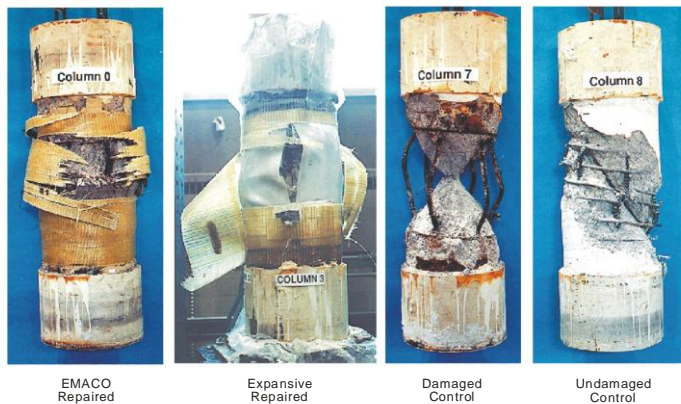
**Fig. 4. Column Specimens after Testing**

Both the repaired columns performed better than the damaged unrepaired column. The Exp-repaired column, in which plastic sheet formwork was used, did not display as good a performance as the Emaco-repaired column in which no formwork was used. At large strains the plastic sheet of the formwork in the Exp-repaired column opened out and caused premature failure of FRP wrap and the column as shown in Figure 4. The axial load carrying capacity of the Emaco-repaired specimen was as large as the control undamaged column. Its ductility and energy dissipation capacity exceeded those of the undamaged control column.
