The University of Wisconsin Milwaukee Centre for By-products Utilization Second International Conference on Sustainable Construction Materials and Technologies June 28 - June 30, 2010, Università Politecnica delle Marche, Ancona, Italy. Proceedings of Honouree sessions ed. T Naik, F Canpolat, P Claisse, E Ganjian, ISBN 978-1-4507-1487-7 http://www.claisse.info/Proceedings.htm

Monitoring of a Very-High Performance Concrete Bridge

Luigi Biolzi¹, Sara Cattaneo¹, Gianpaolo Rosati¹, Gianluca Guerrini²

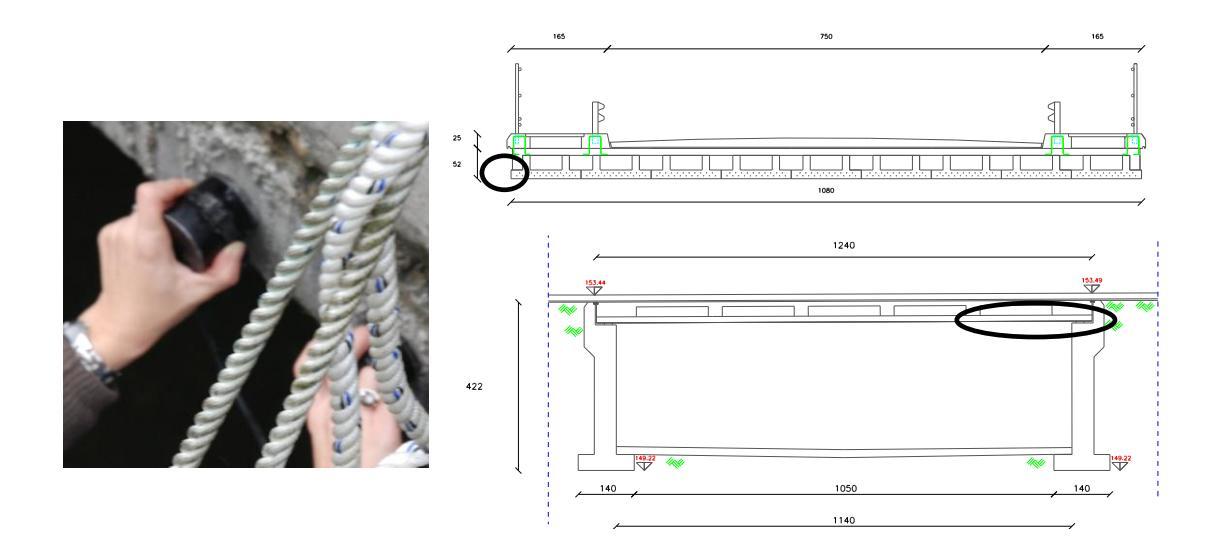
The indirect transmission arrangement was applied on the lateral surface of the bridge (Fig.1). The measurements were taken at a distance of 150mm, 300mm and 450mm.

Figure 1. Location of ultrasonic pulse velocity tests

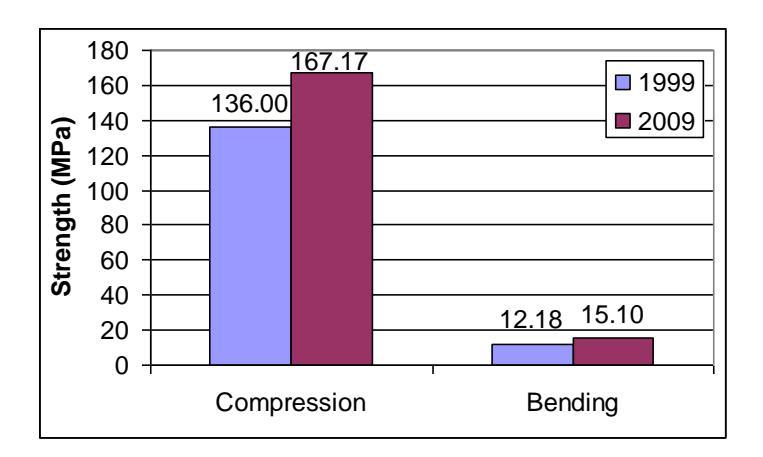
The comparison between these results and the strength evaluated in 1999 (28 days) is shown in Fig. 2.

Both compressive (cubes) and bending strengths increased, and the strengths of 1999 were about 81% of current strength. The strength evolution is reported in Fig.3.

Figure 2. Comparison between 1999 and 2009 test results

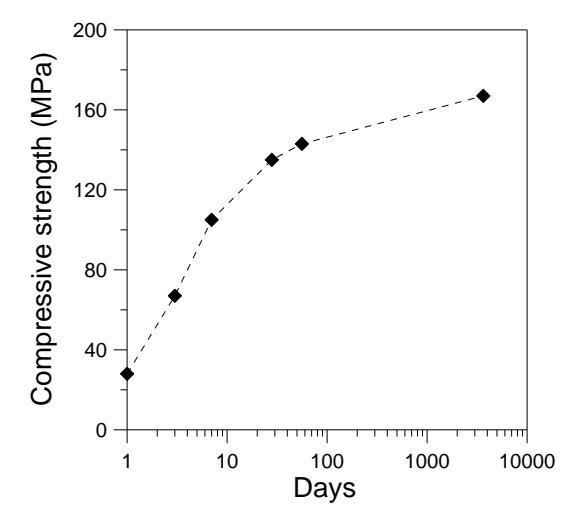
Figure 3. Compressive strength evolution

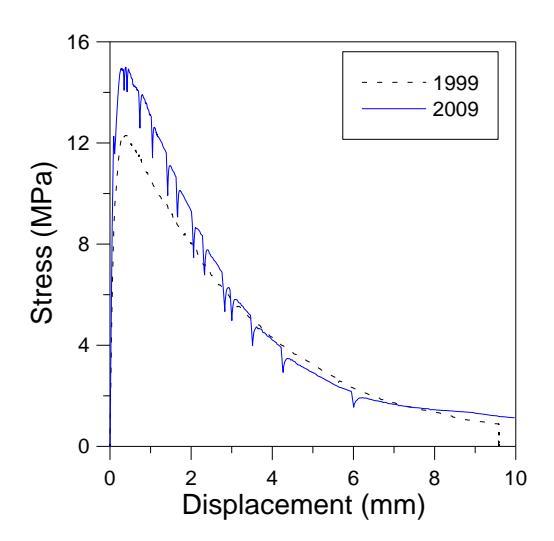
A comparison between typical stress-displacement (at midspan) curves from bending tests is reported in Fig.4. The aging of the material is beneficial in term of the overall stress-displacement behaviour and therefore an improved structural behaviour is expected.

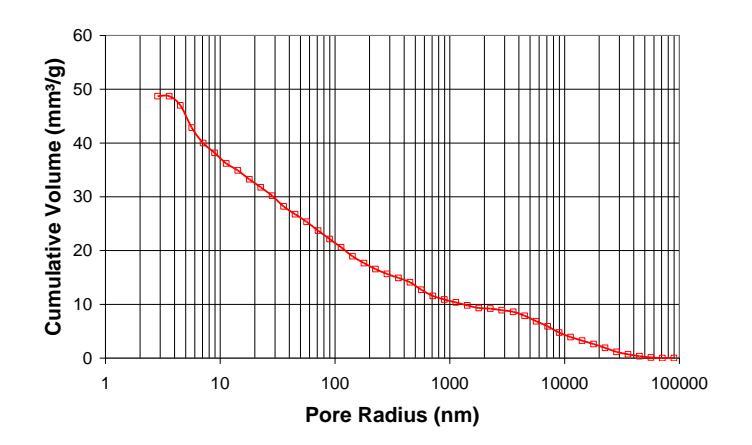
The total porosity (Mercury intrusion porosimetry) was $4874 \text{ mm}^3/\text{g}$, the cumulative and the relative volume are reported in Fig.6 and 7 respectively.

It can be observed that the pores are uniformly distributed and that the most of them has a very small size (radius less than 10nm). Therefore, as determined through porosimetry an insignificant effect on porosity and pore size distribution of concrete was noticed in the aged concrete.

Figure 6. Cumulative volume

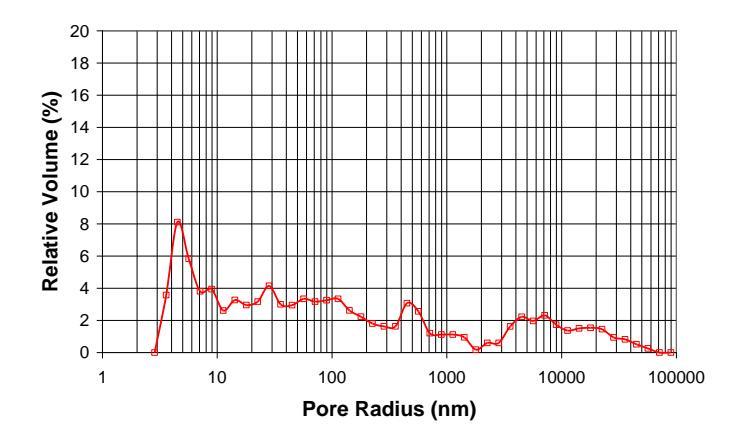
Figure 7. Relative volume
