Long Term Effects of Section Repair Method applied to PC Girders damaged by Chloride Attack

ABSTRACT

This paper reports the results of follow-up survey on the repair effect at about 10 years after applying three types of section repair methods to a real pre-tensioning PC girder damaged by chloride attack. In this research, three repair materials were used for each method, such as polymer-cement mortar including corrosion inhibitor with lithium nitrite, non-shrinkage cement mortar including corrosion inhibitor with amino alcohol, cement paste and mortar with chlorine ion adsorbent. Also, these methods were partially applied under PC wires passed through the repaired and the unrepaired portions. As a result, it was found that the repair effects could be expected for about 10 years in case of less than about 4.5 kg/m³ of chlorides contained in the unrepaired portion, although corrosion cracks due to macro-cells occurred near the boundary of the repaired and the unrepaired portions in case of about 6.8 kg/m³.

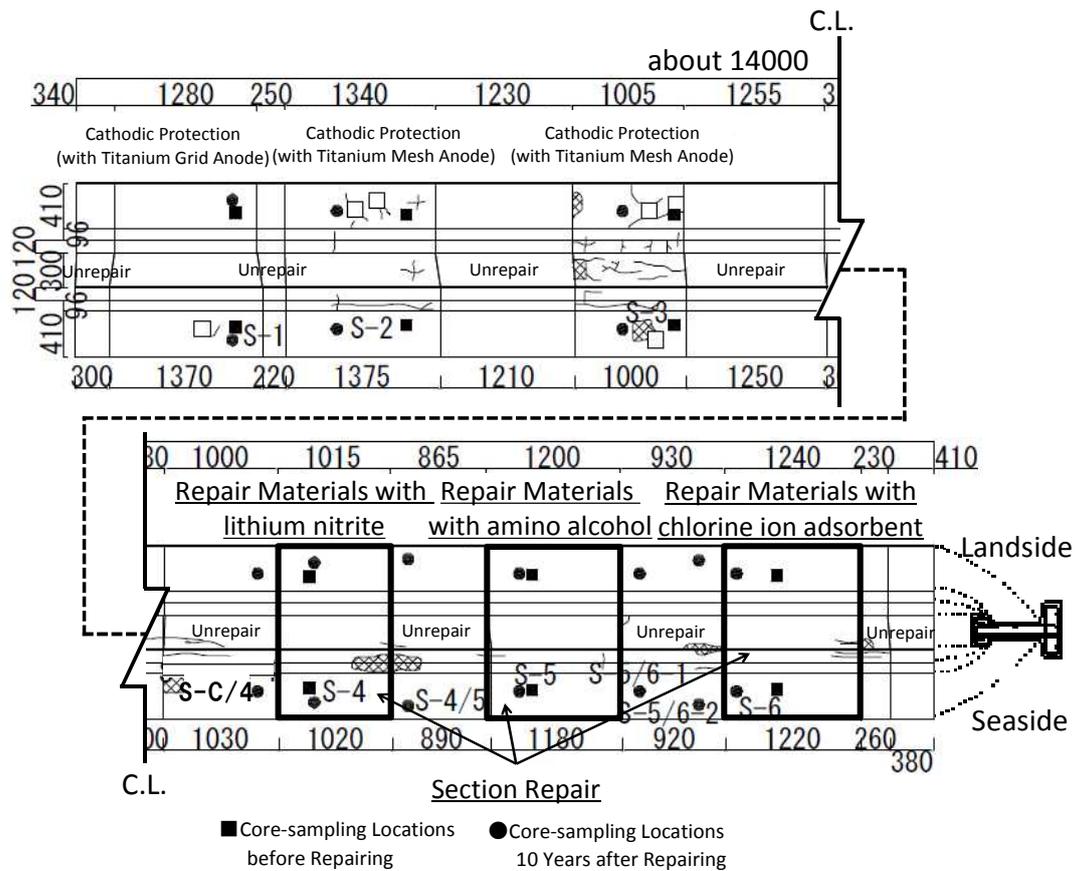
Figure 3. Scope of Application of Each Repair Method (G15 ; Unit:mm)

methods. At that time, some repaired traces were observed on the surface. A lot of traces on the seaside surface were observed but few traces on the landside surface were observed. Particularly, some cracks due to chloride induced corrosion were observed on the seaside surface at the end of span in G15.

Outline of Applied Section Repair Methods. Three types of section repair methods were applied to the portions shown in Figure 3. The following repair materials were used for each method respectively; one was the styrene-butadiene rubber type polymer-cement mortar including corrosion inhibitor with lithium nitrite (Sugiura, A. et al., 2001). The second was the low heat and non-shrinkage mortar including corrosion inhibitor with amino alcohol

In this study, in order to figure out the influence of steel corrosion due to macro-cells, each section repair method was applied in the range of about 1.0 m to the longitudinal direction of the girders by remaining the unrepaired portions of about 1.0 m between the repaired portions. The cover concrete was removed to the extent that the whole surface of stirrups and the outer half surface of PC wires were exposed. Also, the rust on the reinforcement was removed by wire brushing. The repaired sections for all methods were recovered so that 30 mm of the design cover thickness of stirrups was ensured.

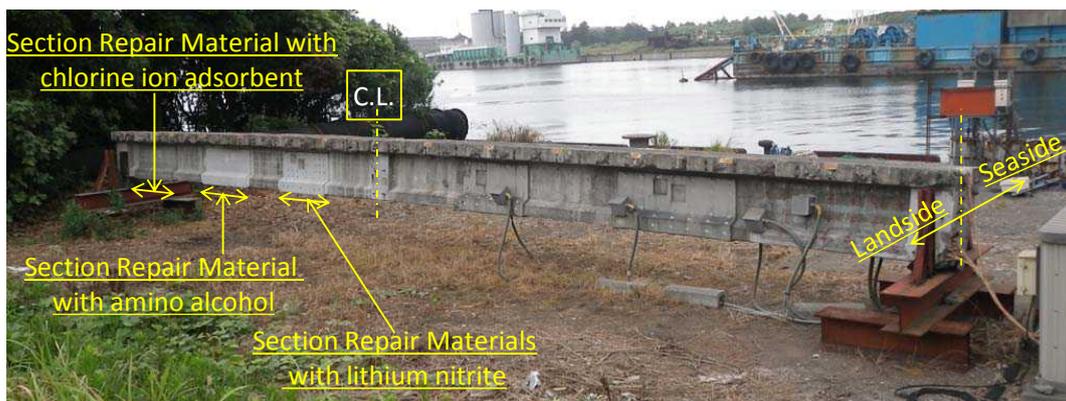
Figure 4. Exposure Situation of G15

In this research, in order to investigate the repair effects of existing repair countermeasures against chloride attack, various methods were applied to G14 and G15. The scope of application of each repair method to G15, which is the investigation object of this paper, is shown in Figure 3. After applying these methods, G15 have been exposed on the Pacific Ocean side, Tokyo bay, Japan (see in Figure 4), while G14 on the Sea of Japan side, Niigata, Japan.
