Effect of Grout Filling Condition on Corrosion of Prestressing Steel in Existing Prestressed Concrete Bridges

Shu Kobayashi^{1*}, Yuichi Kitano^{1*}, Hideaki Taniguchi^{1*}, Yasushi Kunitomi^{1*}
Yoshitomi Kimura^{2**} and Taku Hanai^{3***}

¹Japan Prestressed Concrete Contractors Association, JAPAN,

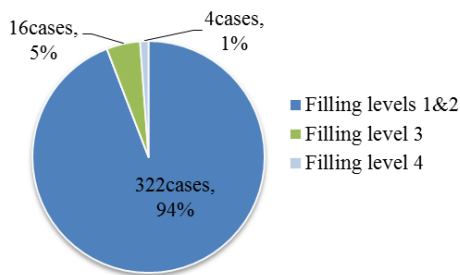
Figure 3. Investigation results of grout filling level (E bridge)

Results of confirmation of grout filling conditions are shown in **Figure 3** and **Figure 4**. Among 342 cases investigated, filling levels 1 & 2 and filling levels 3 & 4 accounted for 322 cases (94%) and 20 cases (6%), respectively. While the ratio of cases with filling levels 3 & 4 found in cables anchored at upper deck was relatively high (particularly in the bend portion), there were also some cases involving cables anchored at girder end. Additionally, grout filling condition with a focus on cables anchored at upper deck is shown in **Figure 5**. According to this, filling level 4 was located at up to 0.5 m below the upper deck. In addition, as grout stuck to the duct, it was found that the void cavity ran further back. (**Figure 6**) By contrast, the grout was filled in the upward bend portioning section of the opposite side. Based on such a condition, the effect of bleeding is unlikely, and it is inferred that an unfilled part was left along the down grade line of the grout injection side (due to rapid injection of grout with high fluidity) where the grout flowed too fast.

Additionally, it was confirmed that for the total of 342 cases investigated, the main cable of this bridge has nearly no corrosion, and no trace of water penetration was confirmed in the duct of cable anchored at upper deck where unfilled grout was confirmed.

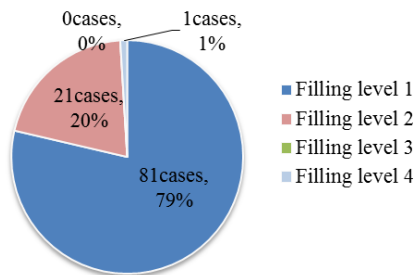
Figure 9. Investigation results of grout filling level (C bridge/ the first span)

Grout filling condition. Figure 9 shows grout filling investigation results in the first span, and Figure 10 shows the grout filling levels of the first, fourth, and fifth spans as grout filling level by locations. The investigation in the first span covered 103 cables located in each individual main girder cut plane, and identified 102 cases (99%) of filling levels 1 and 2, 0 case of filling levels 3, and 1 case (1%) of filling levels 4. Focusing on filling levels 1 and 2, while many localized voids were found in the first span, grout filling was excellent for a large majority of locations. The area near C3 cable of G3 girder in the first span, where breakage of PC steel was confirmed, was the only location where unfilled grout was confirmed.

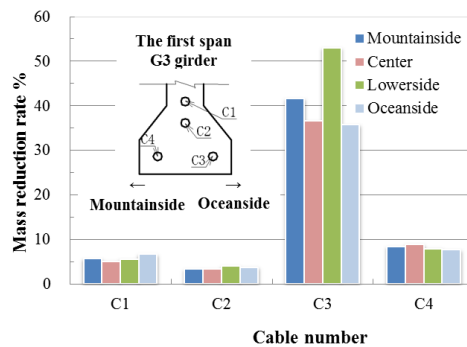
Figure 12. Relation between cable location and corrosion amount (Comparison among the same members of C bridge)

Mass reduction rate. Figure 12 shows the mass reduction rate of C1 thru C4 cables collected from the same material when the first span G3 girder was cut and demolished. Based on this, although the mass reduction rate exceeded 35% and breakage of 13 steel wires were identified for C3 cable, the mass reduction rate was 10% or less and no breakage was identified for the rest of cables.

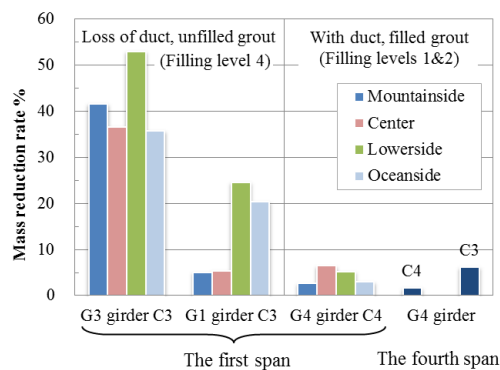
Figure 13. Relation between damage condition and amount of cable corrosion (Comparison among members having the same covering in C bridge)

Additionally, **Figure 13** shows the mass reduction rates of G3 girder C3 cable in the first span (which has the most significant damage), and cables having the same covering in the first span including G1 girder C3 cable (which has the second most significant damage), G4 girder C4 cable (which used to be an undamaged sound part, but newly damaged), and G4 girder C3 and C4 cables (which has the highest damage outside of the first span) in the fourth span. This time, the mass reduction rate exceeded 10% where cracking was significant enough to separate concrete in areas with loss of duct and unfilled grout (or, it fell off during duct sheath removal) as shown in the above **Figure 7**. However, the mass reduction rate was 10% or less, averaging about 4%, where the extent of cracking remained in the longitudinal direction axial cracks at the bottom surface of lower flange as shown in **Figure 14**.
