Investigation of Deteriorated RC Slabs on Steel Girder by Chloride Attack of Deicing Salt

Keywords. RC slab, Chloride attack, Deicing salt, Deterioration, Investigation

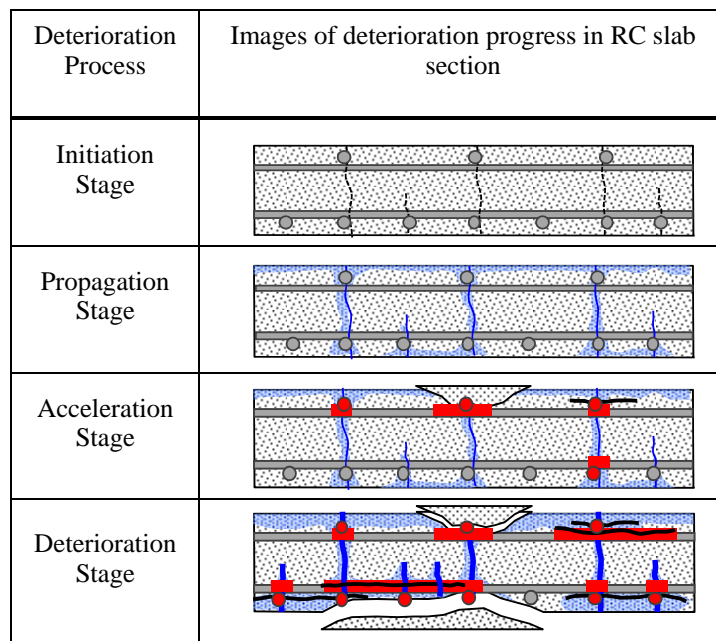
Figure 4. Deterioration progress in RC slab on steel girder

- 1) Deicing salt (NaCl) spread over the road surface melts into water, which can be either rain or melted snow, and the solution infiltrates into pavement and forms a pool on the upper slab surface.
- 2) The pooled solution further infiltrates into slab through cold joints or vertical passing-through cracks caused by drying shrinkage and temperature expansion/contraction .
- 3) Salinity in the solution destroys passive membrane of rebar and initiates corrosion.
- 4) Corrosion expansion forms cracks and slab delamination. Deterioration further develops as the solution infiltrates through cracks and spaces formed by a lost cover. (Refer to Fig 4)

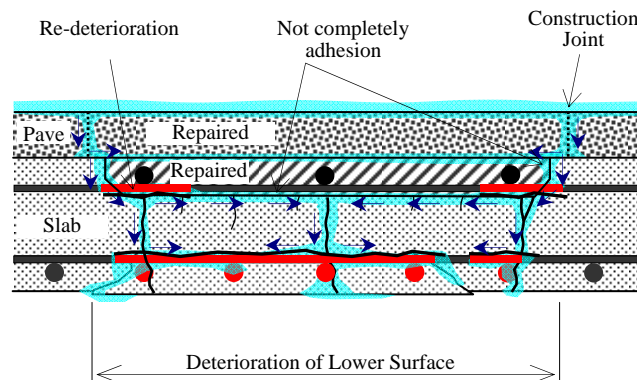
Figure 18.An image of deterioration developed under the repaired area

In the case of an urgent repairing, such as a pothole(peeling of pavement) repairing, repairers cannot necessarily work in a good condition in terms of weather or time constraint. As a result, the repair work may not be totally satisfactory in quality. The repaired part of the slab may not completely adhere to the base slab, of which boundary could easily develop into water leakage channel. Accordingly, such inappropriate repair work causes deterioration of the base slab (Refer to Fig. 18).
