Environmental Durability of Hybrid FRP Girder

Hybrid FRP (HFRP) girder is a pultruded FRP member with I shape cross section that contains carbon fibers in the flange part to increase the rigidity of the member and that the other part is made of GFRP. There are some recent application studies of these materials as the main members of FRP footbridges. HFRP is also expected to have a good resistance under severe corrosive environmental conditions for steel; however there are not enough data to confirm this performance of these materials. The authors carried out accelerated weathering test for 4000 hours and water immersion test at 40 degree for 12 months for the HFRP specimens, and evaluated its durability by bending test and interlaminar shear test. Although the results of interlaminar shear test showed slight reduction in the strength, the durability of HFRP was good and was not so different from that of GFRP.

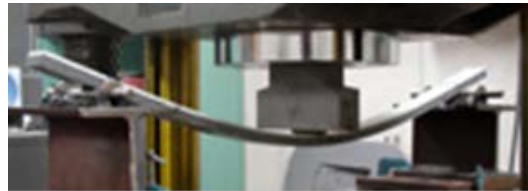
Figure 2 Bending test of flange specimen

Bending test was performed according to JIS K 7017- “Fibre-reinforced plastics composites– Determination of flexural properties”. The test was conducted by three-point loading. In flange parts, span length/flange thickness was 40 and flange length/ flange thickness was 50. In web parts, span length/web thickness was 20 and web length/ web thickness was 30. In the bending test of flange specimen, width of specimen was 30mm and span length was 560mm. In the bending test of web specimen, width of specimen was 15mm and span length was 180mm. Figure 2 shows the bending test of flange specimen.

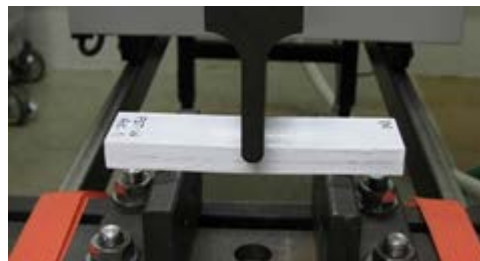
Figure 3 Interlaminar shear test of flange specimen

Interlaminar shear test was performed according to JIS K 7057-” Fibre-reinforced plastic composites – Determination of apparent interlaminar shear strength by short-beam method”. The test was conducted by three-point loading. In the tests, span length/thickness was 5 and length/ thickness was 10. Loading velocity was 1mm/min. and interlaminar shear strength was calculated by using equation (1). Figure 3 shows the interlaminar shear test of flange specimen.

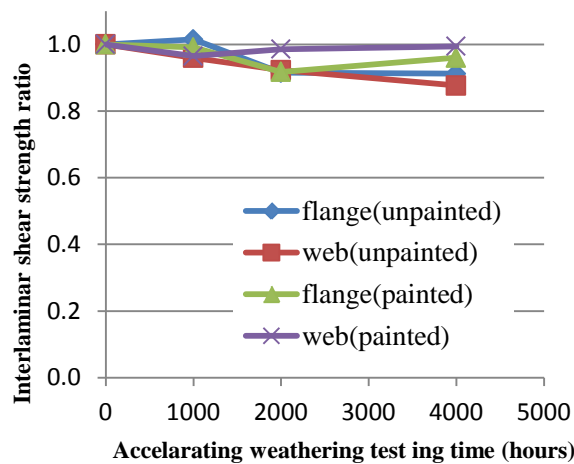
Figure 6 Interlaminar shear strength ratio vs. accelerating weathering test time

Figure 6 shows the relationship between accelerated weathering test time and the interlaminar shear strength ratio (interlaminar shear strengths/initial values). According to the Figure 6, the strength of the unpainted specimens tended to decrease slightly in accordance with the elapsed time compared with the strength of the painted specimens.

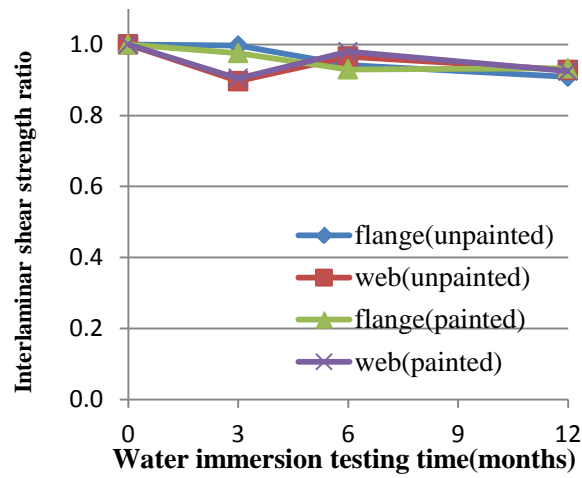
Figure 7 Interlaminar shear strength ratio vs. water immersion test time

Table 8 and Table 9 show interlaminar shear test results of flange part and web part, respectively. In this test, both painted specimens and unpainted specimens were examined. In both cases of painted flange specimens and unpainted specimens, interlaminar shear strengths tended to decrease slightly in accordance with the elapsed time. In the case of painted web specimens, as with the flange portion, interlaminar shear strengths tended to decrease slightly in accordance with the elapsed time. Figure 7 shows the relationship between water immersion test time and the interlaminar shear strength ratio (interlaminar shear strengths/initial values). According to the Figure 7, interlaminar shear strengths of all cases tended to decrease slightly in accordance with the elapsed time and interlaminar shear strengths after one year were approximately 0.93 to 0.91 of the initial values. From the above results, the painting on the specimens has not a protective effect against the water immersion test.
