# An Experimental Study on the Deterioration of Surface Coating on Steel Structure

K. Kobayashi

School of Civil Engineering, Chubu University, Japan

**ABSTRACT:** This study aimed at clarifying the corrosion mechanism of steel with surface coating in a marine environment. The corrosion progress of steel materials with tar-epoxy coatings that had been exposed in a marine environment for one and 19 years, respectively, and a steel material with a tar-epoxy coating that had been submerged in a chloride solution at 40°C for 1200 hours, were investigated. Some specimens were provided with artificial defects to investigate the effect of a coating defect on the progress of deterioration. In the splash zone, corrosion of steel extends from the defect in a radial direction, and the speed of corrosion depends on the size of the defect. In the tidal zone and the submerged zone, on the other hand, corrosion of steel extends in a vertical direction at the edge of the defect and not in a radial direction.

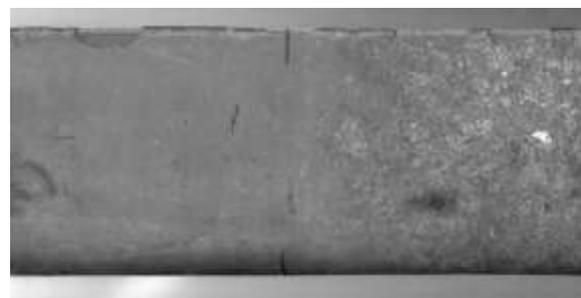
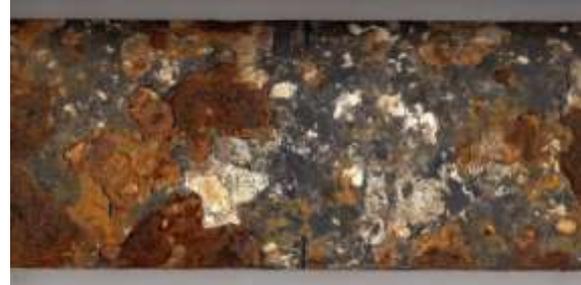
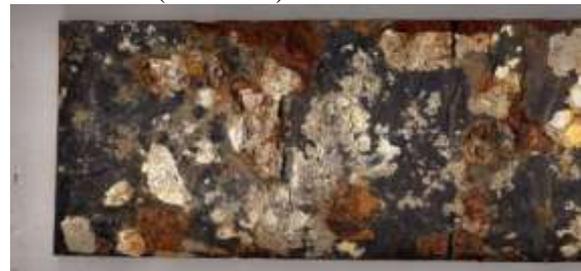
Figure 6. Long-term exposure specimen

a. 2-2-W (splash zone)

b. 4-1-W (tidal zone)

c. 6-2-W (submerged zone)

Figure 6 shows examples of the specimens that were deteriorated during the 19 years exposure in the marine environment. As shown in this figure, debonding and delamination were observed in the surface coating and corrosion had occurred in many regions of the steel. The deterioration was more severe in the regions that had been in the tidal and submerged zones, where marine fouling organisms were observed.

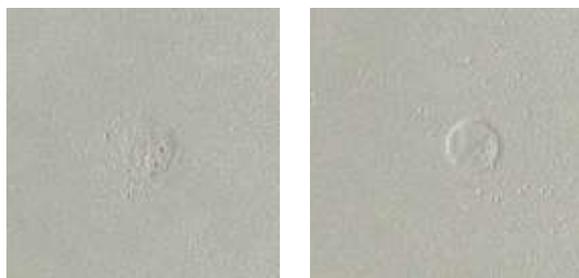
Figure 13. Specimens after being removed corrosion products and surface coating

a. AP-12 (splash zone)      b. TP-12 (tidal zone)

c. SP-12 (submerged zone)

Figure 13 shows examples of the short-term exposure specimens after the surface coating has been removed. Figure 14 shows the three dimensional shape of the corroded area of the short-term exposure specimens.

This is why a circular groove was formed by corrosion along the circumference of the defect in the specimens TP and SP, as shown in Figures 13 and 14 (Fig. 17c).
